Use Of Impact Mapping For Planning The Infrastructure In Tourist Caves - Case Study: Maquiné Cave, Brazil

USE OF IMPACT MAPPING FOR PLANNING THE INFRASTRUCTURE IN TOURIST CAVES - CASE STUDY: MAQUINÉ CAVE, BRAZIL

Luciana Alt

Vitor Moura

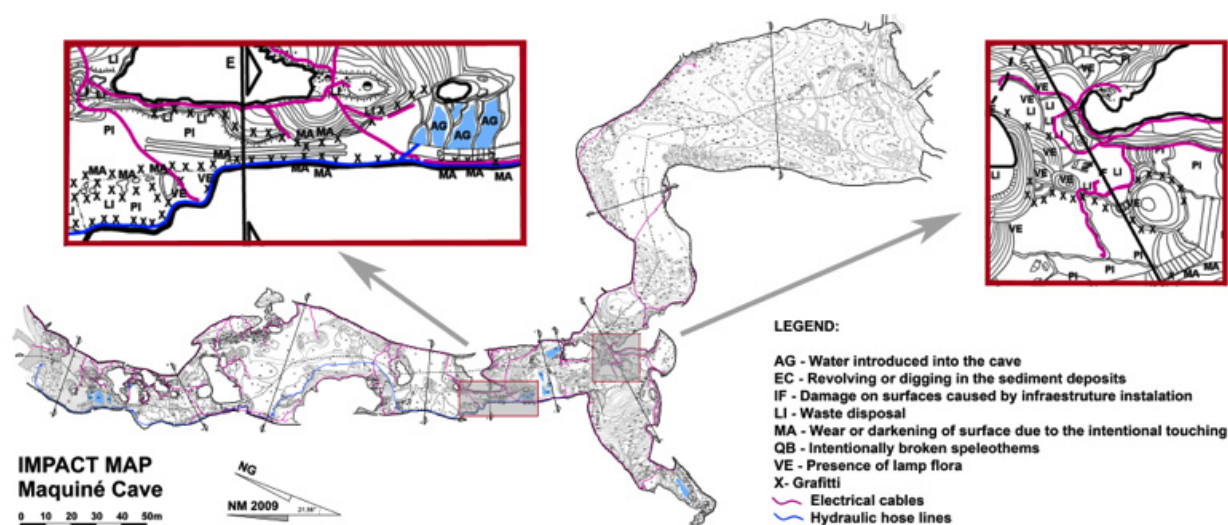
Figure 2. Impact map
Synthesis of the impacts and problems of the lighting system.

Through the Impact Map (Figure 2) it was found that the development of lamp flora occurred more intensively near high power lamps (halogen, metal halide and mixed vapor). In addition to the aesthetic impact of color change the presence of lamp flora (Figure 3-f) can induce surface corrosion in speleothems by biochemical and biophysical

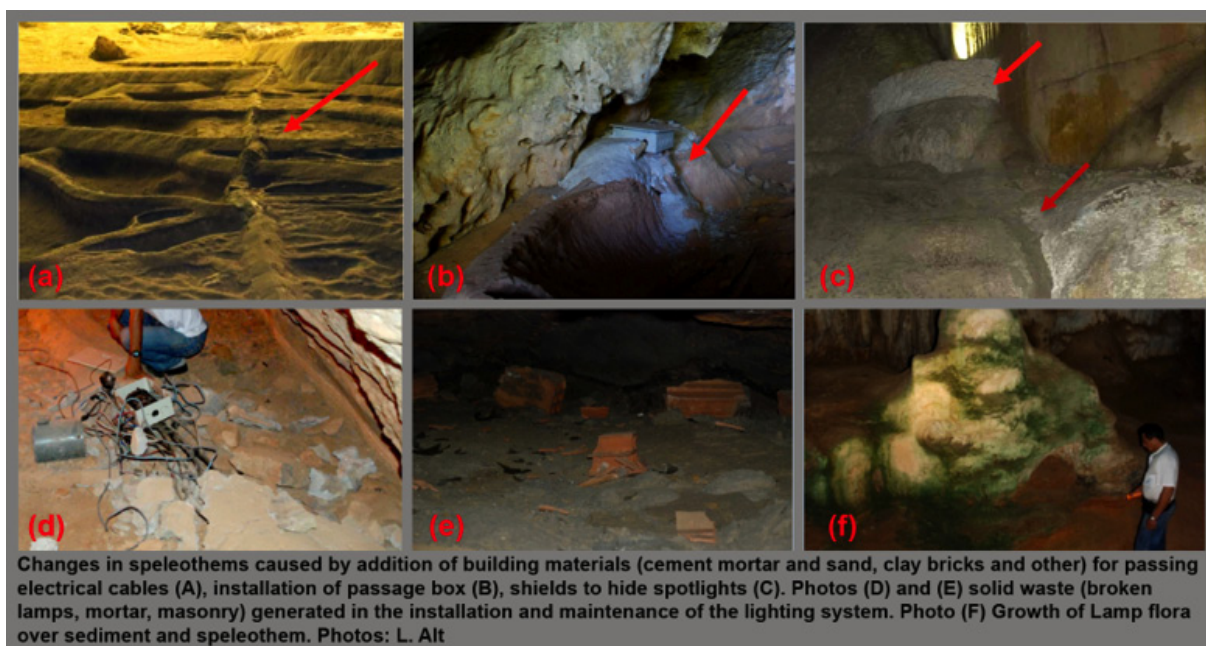
Spotlights located near speleothems cause glare, make them unattractive and cause large variations in surface temperature and humidity, which contributes to the deterioration of speleothems (Veni, 1997). Furthermore, heterogeneous and insufficient lighting of the floor generates risk to visitors and contributes to the widespread stepping on speleothems.

The main cabling of the lighting system runs in one side of the cave, interspersed with passage boxes, from which are derived the secondary wiring to spotlights and control boxes. To hide the wiring cement mortar was applied over speleothems, sediment or rock surfaces and in some places the cabling was buried. To hide the spotlight low walls of masonry were built (Figure 3-a,b,c). At some points, it is clear that the speleothems were intentionally broken for the installation of the electrical system. Burying the cables disturbs the original sediment stratigraphy. Such changes are potentially harmful in archaeological or paleontological sites. The techniques used to hide wires and spotlights are also impactful, as the adhesion of the cement mortar can produce physical and chemical changes in speleothems and rock surfaces, besides volumetric changes that generate large visual impact, compromising the attractions.

Figure 3. Examples of the impacts and problems of the lighting system.

The lighting system demanded frequent maintenance, either for bulb replacement, revisions in the cabling and electrical contacts. The use of cement mortar cords made the maintenance process difficult or impossible (Figure 3-d). In some locations the installation of new mortar strings over the existing exceeds 30 cm in height, increasing the visual impact. In addition, the constant maintenance on the system causes stepping of fragile speleothems. Unfortunately, much waste from this activity was improperly abandoned in the cave (Figure 3-e). Some of these wastes, such as electric bulb fragments, represent an imminent environmental risk, apart from being sharp they may contain toxic heavy metals.

At several points there are electrical cable splices without proper connectors and tangled cables without support with friction points to speleothems and rocks. This disorganization offers risks for the electrical system and for the maintenance agents and visitors, since these points can create contacts with energized elements. Furthermore, when the lighting system is switched on, it generates constant noise and electromagnetic fields, which can potentially interfere with bat dynamics.

These executive projects of the new lighting system shall be performed in accordance with current best practices, providing: (I) reduction of hotspots by the replacement of high power lamps with Light Emitting Diode (L.E.D); (II) reduction of the development of photosynthetic organisms in the aphotic zone, by using an appropriate wavelength according to Olson (2006), (III) removal of mortar cords and low walls that cause visual impact in attractions, with consequent restoration of these surfaces, (IV) removal of all the lighting infrastructure that will be deactivated and waste from the old system, (V) reduction of speleothem trampling in maintenance through the use of safe, high durability and low maintenance materials (tinned copper cables, waterproof fittings and spotlights), (VI) reduction in alterations in sediment, speleothems and rock surfaces by using apparent wiring and spotlight installed over removable bases made of inert materials. These projects should be harmonized with the walkway project, so that the main wiring can be installed with the walkway.

The new lighting system shall enhance the existing attractions, through the proper placement of the spotlights, showing the natural speleothem colors. The system should be trigger sequenced, illuminating only the chamber with visitors. Spotlights should not be focused on Primitive zones. The use of techniques that cause irreversible impacts on the cave, such as drilling, breaking, applying cement mortar and other products over speleothems and other surfaces should be avoided. To increase the safety of visitors, guides and maintenance staff an emergency lighting system should be installed, and the pathway and the narrow places should be properly lighted.

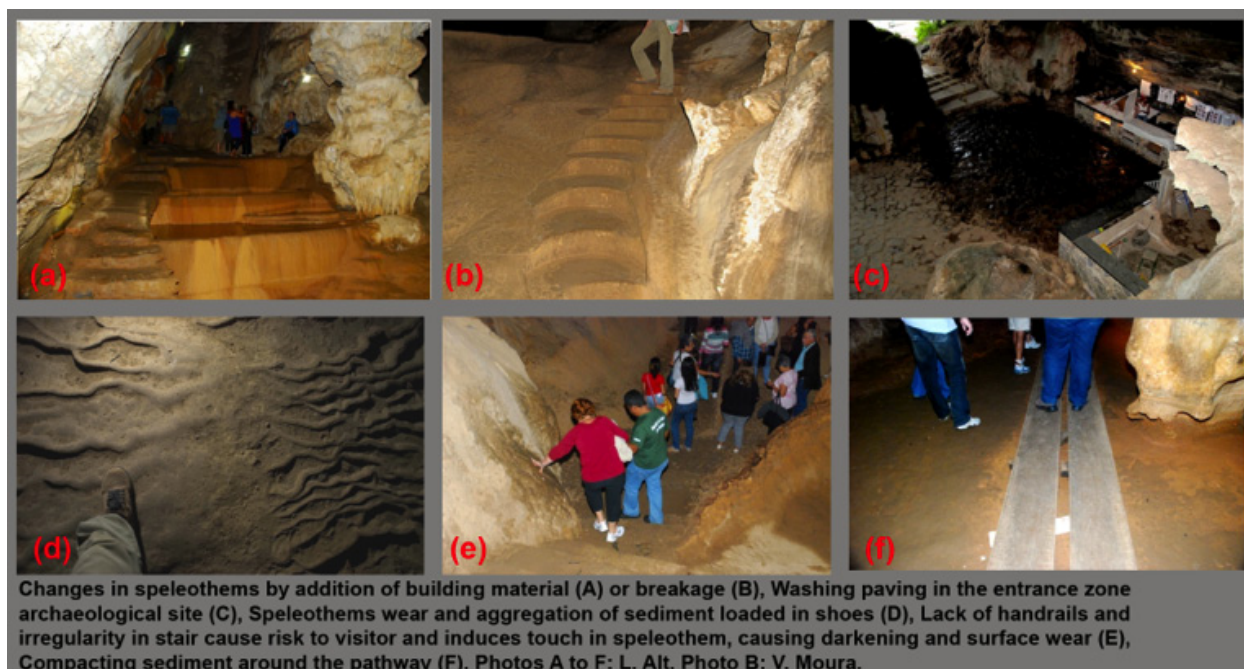
Figure 4. Examples of impacts related to installation and operation of the pathway system.

removal, (II) by adding materials (stone and cement mortar) over speleothems or sediment; (III) by the combination of these two techniques (Figure 4- a, b, c). These techniques in many instances caused irreversible damage, such as speleothem breakage, physical and chemical surface changes, visual impacts and the potential loss of visitors.

Stairways and walkways have irregular and/or slippery flooring which together with the lack of handrails and guardrails generates discomfort, walking difficulty, and imminent risk of falls and injuries to visitors. The risk increases when groups cross to each other in narrow walkways and stairways beside abrupt drops. Lack of handrails and guardrails induces the visitor to touch speleothems and other surfaces, causing darkening and in some cases surface wear (Figure 4-e).

To increase the adherence of stairs and walkways surfaces, a cement mortar mixed with sediment taken from inside the cave was applied. This practice causes sediment removal in sites with paleontological potential and can potentially destroy microhabitats for invertebrate fauna. Another practice commonly used is floor washing, which may cause changes in the fauna, relative humidity, and can stain speleothems and other surfaces (Figure 4-c).

In some areas of the cave, as in the entrance zone, there is an excess of infrastructure (wide sidewalk area, shop desks, turnstiles, gate) (Figure 4-c). However, this hall houses a prehistoric archaeological site. Flooring installation caused changes in sediment, possibly disrupting their original stratigraphy, which can cause irreversible damage to archaeological sites. The entrance flooring also changed the runoff water dynamics, probable causing suppression of vegetation and microhabitats to the epigeal fauna, which, according to Ferreira and Souza (2012), may have influenced the delicate ecosystem dynamics in the cave. This wide sidewalk area induces a dispersed flow of visitors, encouraging touch and interference on existing rock art panels.

These executive projects should specify inert and safe materials for the cave environment, according to Werker (2006) and other references, with design and construction techniques that cause minimal visual and physical impact to the cave, which should be demonstrated through 3D modeling, sketches and / or photo inserts. The materials and techniques used must be highly durable, providing ease and low maintenance cost. The use of techniques that cause irreversible impacts on the cave should be avoided. Where possible, the old stairs should be removed and speleothems restored. This project shall comply with cave zoning and the places established for the pathway.

The delineation of the pathway will concentrate the impacts of visitation in a restricted area, reducing problems such as trampling over speleothems, sediments and fauna, graffiti, intentional touching or speleothems breaking and other impacts in the cave.

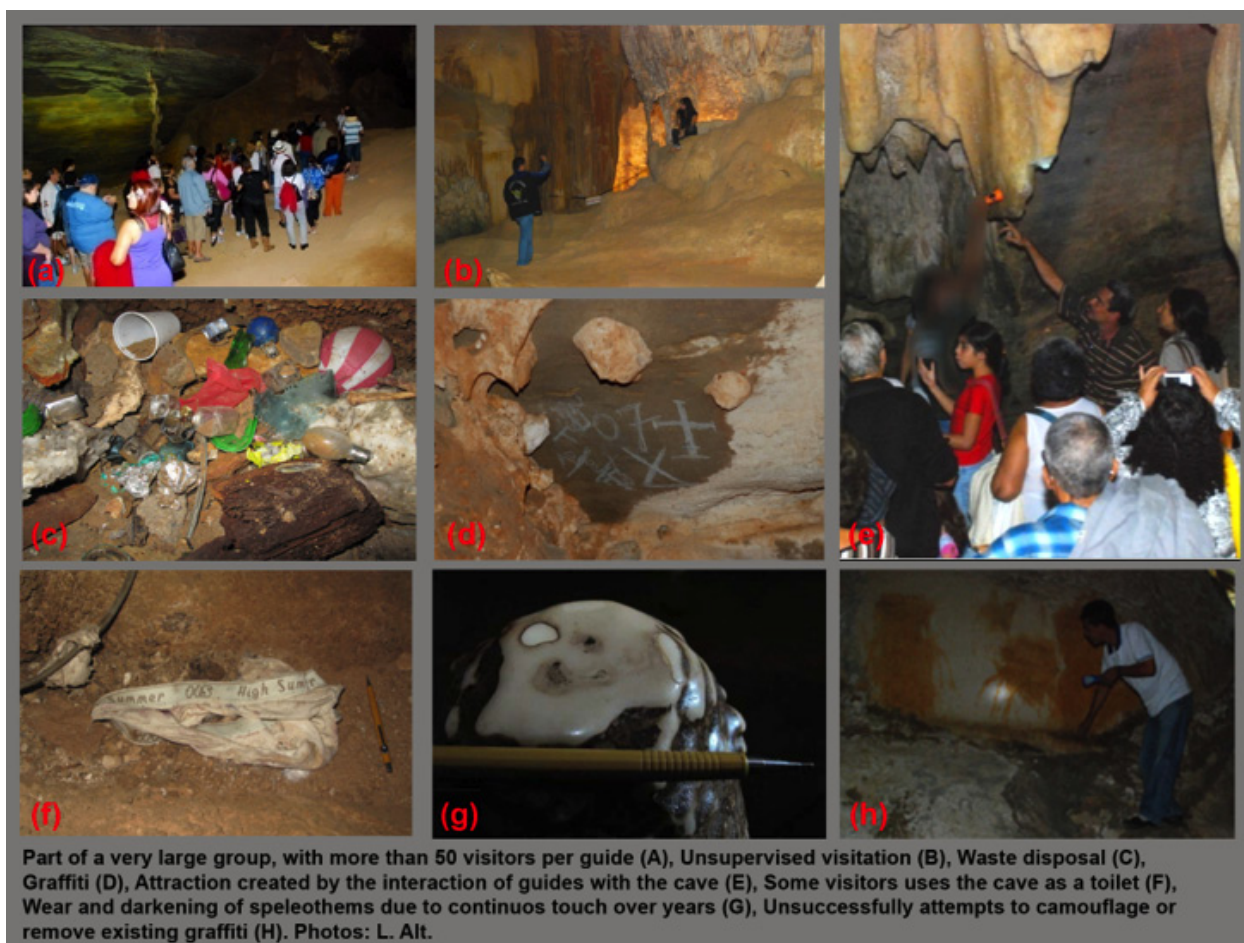
Figure 5. Examples of impacts and issues related to visitors flow management.

(Figure 5-a), making it impossible to control the whole group, especially in the narrow section between the big chambers. In these places, where the guide loses visual contact with the group, there are large concentrations of graffiti over speleothems and rock surfaces.

Some attractions are created by the interaction of guides with the cave, when they beat speleothems, in order to produce sound, or jump hard on the floor, to show that the floor is “hollow” (Figure 5-e). This kind of action does not have educational value and encourages visitors to touch the speleothems - causing darkening and introduction of surface corrosion - and jump over several parts of the route - which generates sediment compaction, damage to speleothems and possible impacts on the cave fauna.

Another problem is that some guides complete their tours in the last visited chamber, allowing visitors to return unsupervised to the entrance of the cave (Figure 5-b). This favors the occurrence of many impacts like graffiti,

Numerous unsuccessful attempts to camouflage or remove existing graffiti by applying cement, artificial pigments, clay, sanding, and other techniques were observed. The use of these techniques caused even greater visual impact and physicochemical changes on cave surfaces (Figure 5-h).

Restoration of damaged surfaces including: (I) restoration of the main surfaces with graffiti, marks of

trampling or unsuccessful attempts at camouflaging graffiti; (II) restoration of speleothems and other surfaces after removal of infrastructure such as stairs, bulkheads, and cement mortar cords.
