## NCKRI REPORT OF INVESTIGATION 6

# GEOPHYSICAL INVESTIGATION OF FLOOD-INDUCED SINKHOLE COLLAPSES, LAKEWOOD REGION, EDDY COUNTY, NEW MEXICO

Lewis Land  
Lasha Asanidze

June 2014

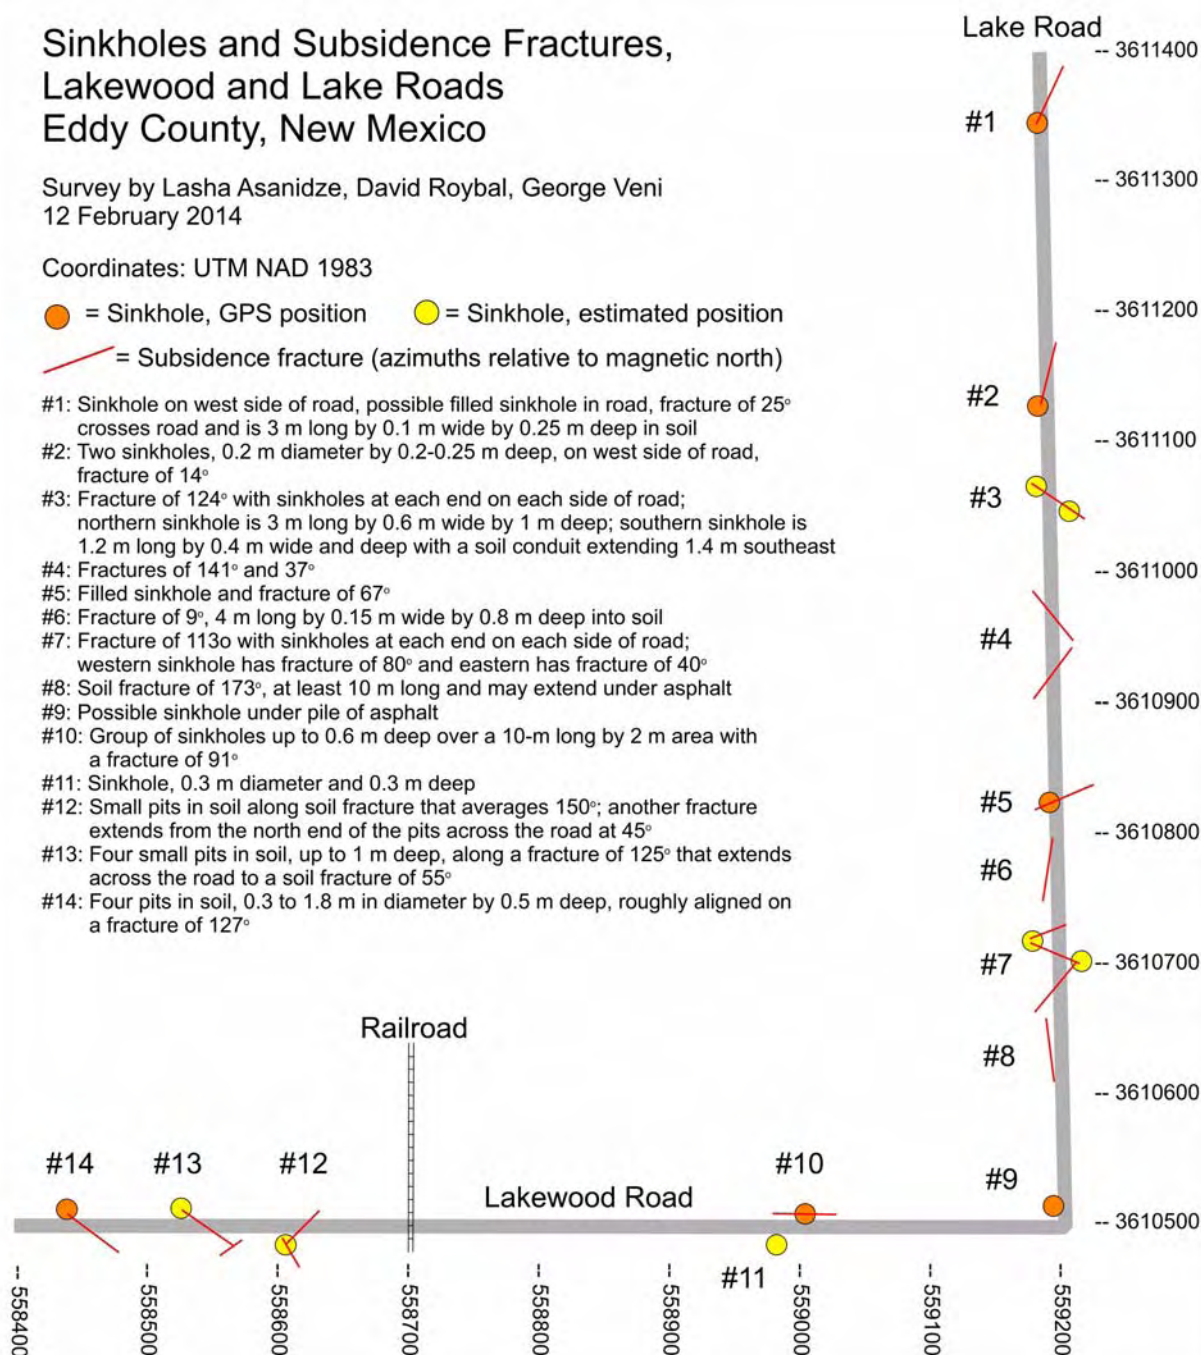
- #1: Sinkhole on west side of road, possible filled sinkhole in road, fracture of 25° crosses road and is 3 m long by 0.1 m wide by 0.25 m deep in soil

- #2: Two sinkholes, 0.2 m diameter by 0.2-0.25 m deep, on west side of road, fracture of 14°
- #3: Fracture of 124° with sinkholes at each end on each side of road; northern sinkhole is 3 m long by 0.6 m wide by 1 m deep; southern sinkhole is 1.2 m long by 0.4 m wide and deep with a soil conduit extending 1.4 m southeast

- #4: Fractures of 141° and 37°
- #5: Filled sinkhole and fracture of 67°
- #6: Fracture of 9°, 4 m long by 0.15 m wide by 0.8 m deep into soil
- #7: Fracture of 113° with sinkholes at each end on each side of road; western sinkhole has fracture of 80° and eastern has fracture of 40°

- #8: Soil fracture of 173°, at least 10 m long and may extend under asphalt
- #9: Possible sinkhole under pile of asphalt
- #10: Group of sinkholes up to 0.6 m deep over a 10-m long by 2 m area with a fracture of 91°

- #11: Sinkhole, 0.3 m diameter and 0.3 m deep
- #12: Small pits in soil along soil fracture that averages 150°; another fracture extends from the north end of the pits across the road at 45°

- #13: Four small pits in soil, up to 1 m deep, along a fracture of 125° that extends across the road to a soil fracture of 55°
- #14: Four pits in soil, 0.3 to 1.8 m in diameter by 0.5 m deep, roughly aligned on a fracture of 127°

Figure 1. Reconnaissance survey of sinkholes and subsidence fissures in Lakewood area.

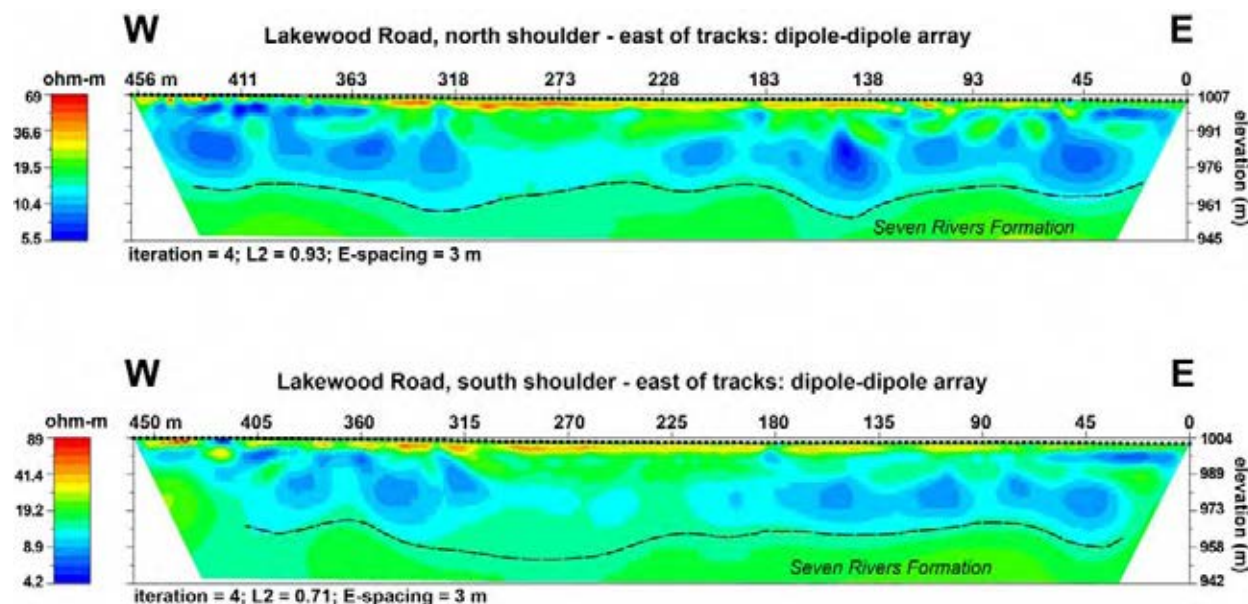
Figure 3. Electrical resistivity profiles conducted along the north and south shoulders of Lakewood Road, east of the BN&SF railroad tracks.

A small, distinctive pod of relatively high resistivity occurs approximately 8 m below ground level at the west end of the south shoulder profile at 420 m, overlain by a near-surface interval of low-resistivity. A subdued reflection of this feature is also present on the north shoulder profile. Resistivity values are too low for this feature to be caused by an air-filled cave, but it may

represent a shallow cavity filled with unconsolidated sediment.

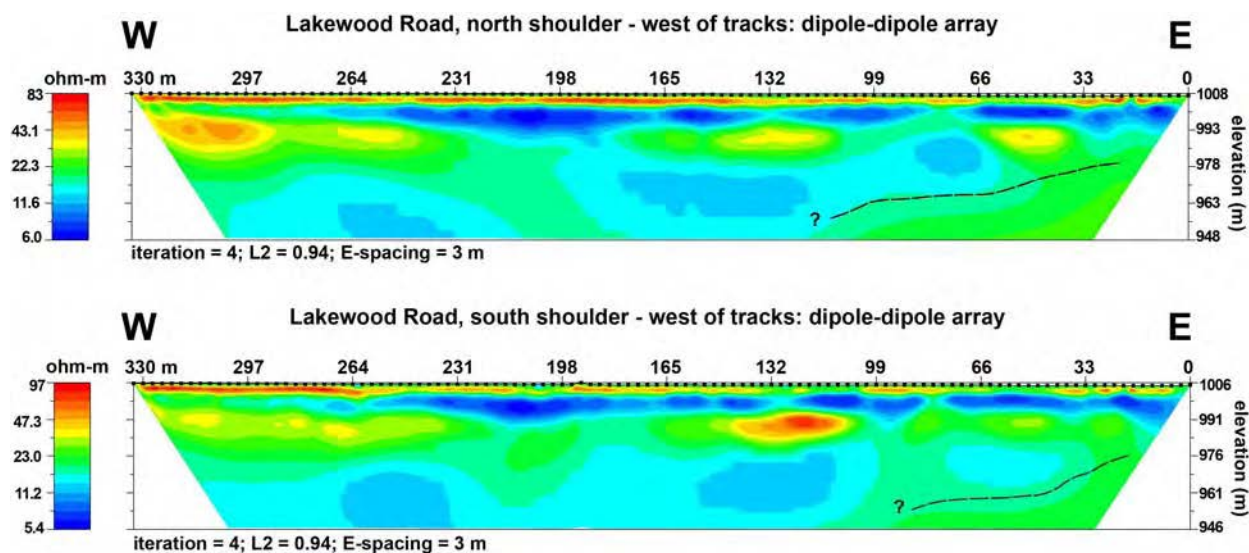
A thin layer of high resistivity is also present on the profiles west of the railway, reflecting air-filled pore space in sand and gravel of the soil horizon. This layer is underlain by 40 to 50 m of generally lower resistivity material of the Pecos River floodplain. However, several lenticular bodies of higher resistivity are also present within this section. One distinctive high-resistivity lens is present on the south shoulder profile between 110 and 140 m, approximately 15 m below ground level. A more laterally extensive high resistivity layer occurs beneath the west end of the north shoulder profile. Subdued reflections of both of these features are also present on the opposite shoulder profiles. Because of their geometry and their presence within the alluvial section, we interpret these features as lenticular bodies of coarse sand and gravel in the unsaturated zone; it is unlikely that they represent caves. In spite of the presence of several small sinkholes along the shoulders of Lakewood Road west of the railway, no obvious subsurface cavities are visible on the ER profiles.

Figure 4. Electrical resistivity profiles conducted along the north and south shoulders of Lakewood Road, west of the BN&SF railroad tracks.

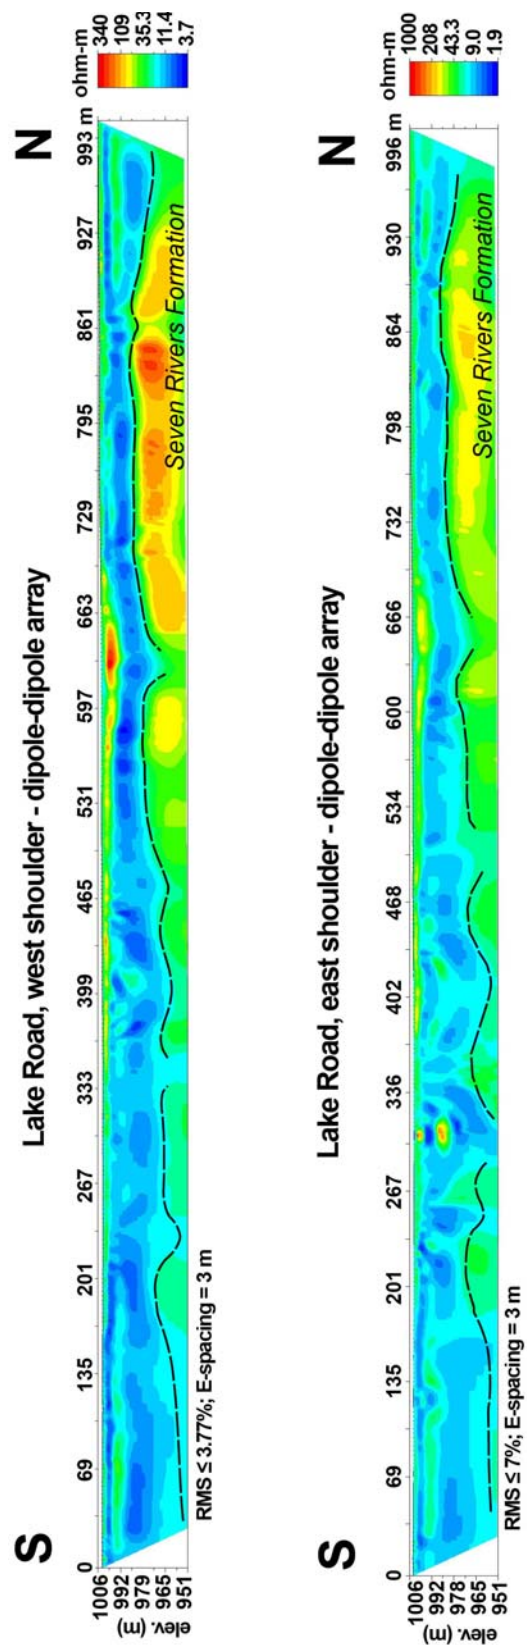
The higher resistivity section that represents the Seven Rivers Formation is interrupted in several places, reflecting the paleotopography developed on the top of the formation. One of these breaks occurs on the west shoulder profile between 600 and 650 m, where a sag in the top of the unit most likely represents a filled sinkhole. Subsidence over this feature appears to have caused a local near-surface accumulation of coarser sediment, as indicated by an overlying lenticular high resistivity zone. This feature is also visible on the east shoulder profile between approximately 630 and 670 m. Several less defined breaks in the Seven Rivers profile may also represent filled sinkholes.

A small but well defined pod of higher resistivity occurs at 305 m on the east shoulder profile, approximately 5 m below ground level. A second high resistivity pod occurs directly beneath the first at approximately 20 m below ground level. These features are likely to represent subsurface cavities partially filled with sediment, or two segments of a fissure adjacent to or extending beneath the roadway. A 4-m long soil fracture was identified near this section of the ER profile during the February, 2014, reconnaissance survey (Figure 1, number 6).

Figure 5. Electrical resistivity surveys conducted along the west and east shoulders of Lake Road.

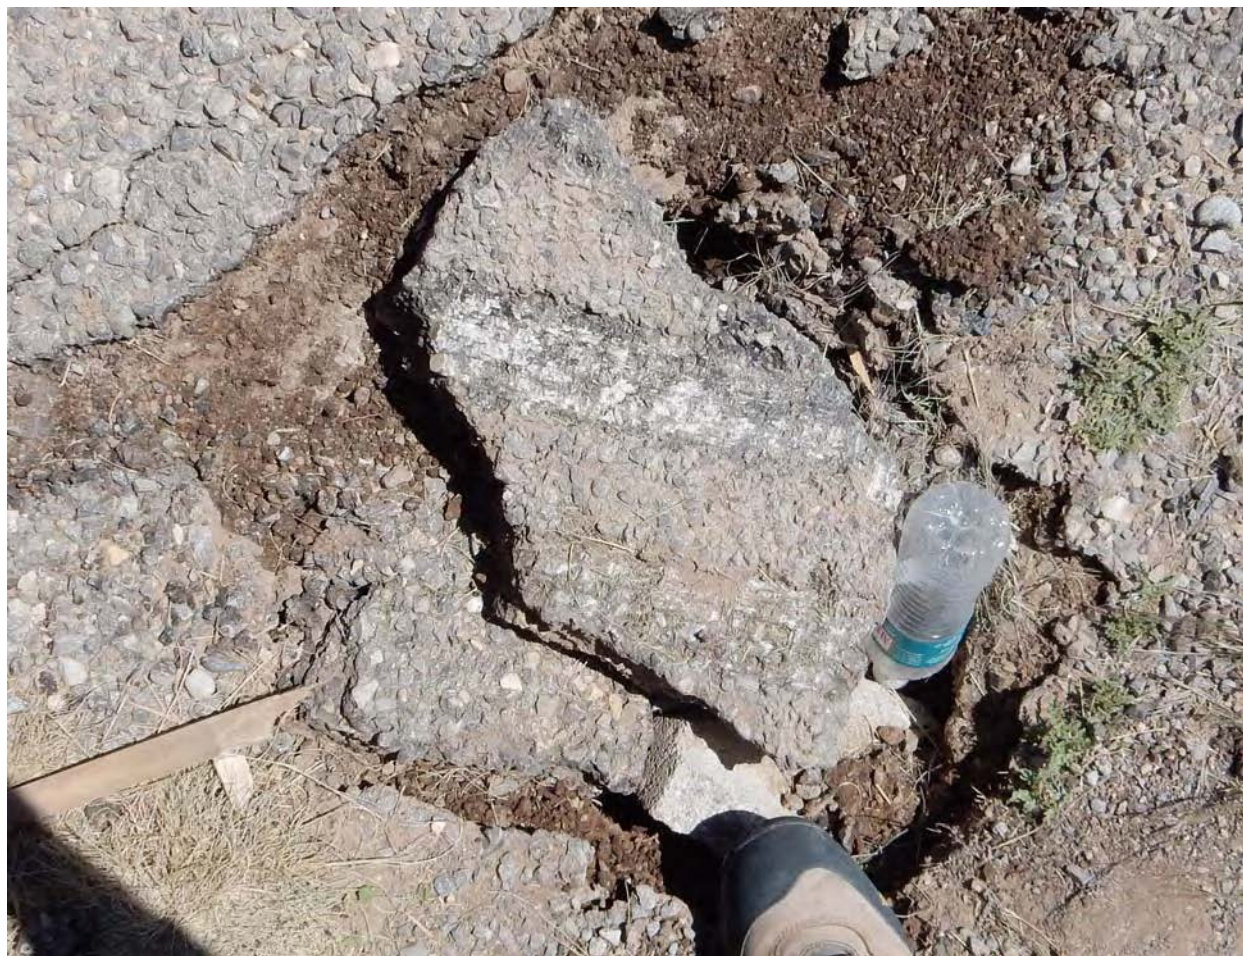
*Figure A-1. Small collapse sinkhole, south side of Lakewood Road, filled with asphalt rubble; 0.46 m diameter. 559048, 3610704, 5 m.*

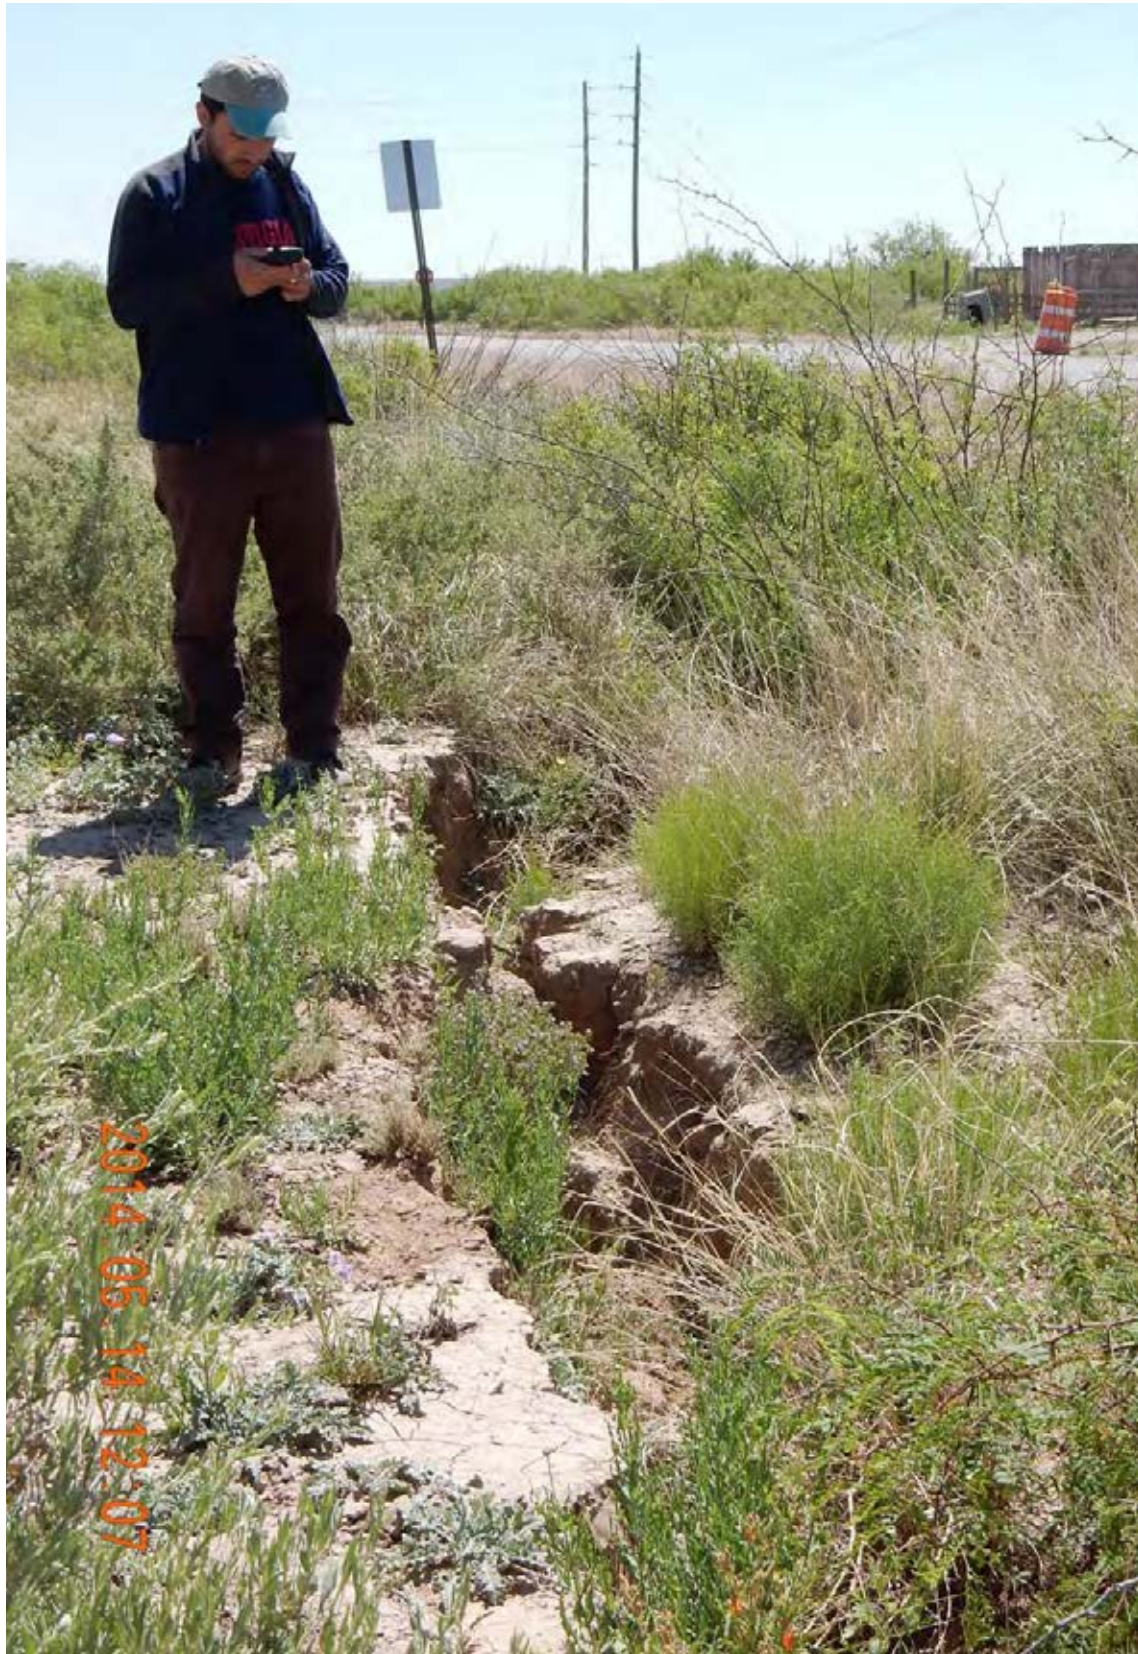
Figure A-2. Soil fracture, north side of Lakewood Road. Length ~18 m, width 0.5 – 1.5 m, depth 0.5 – 1.0 m, azimuth 102°. 559027, 3610715, 4 m.

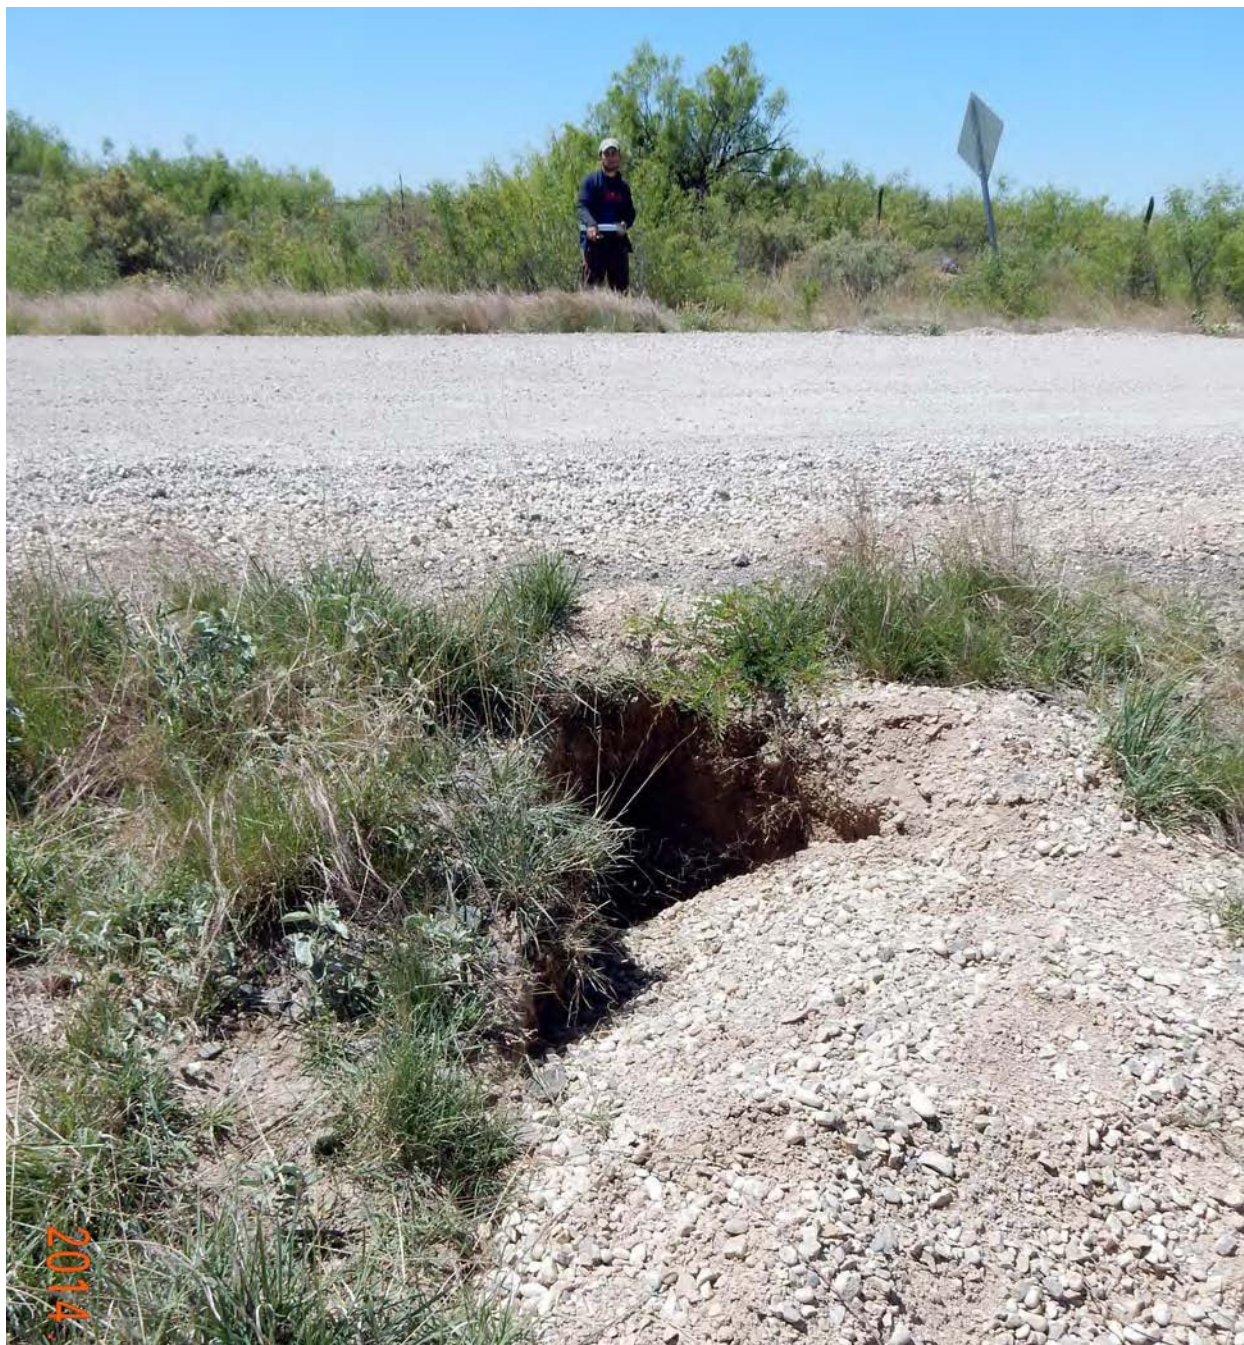
*Figure A-3. Soil fracture mostly filled with gravel, north side of Lakewood Road. Pavement damage suggests fracture most likely extends beneath road to opposite shoulder, where asphalt slabs may cover fracture extension. Length, ~18 m (assuming fracture extends beneath road), width 1.4 m, depth where not filled 0.6 m, azimuth 20°. 559008, 3610714, 3 m.*

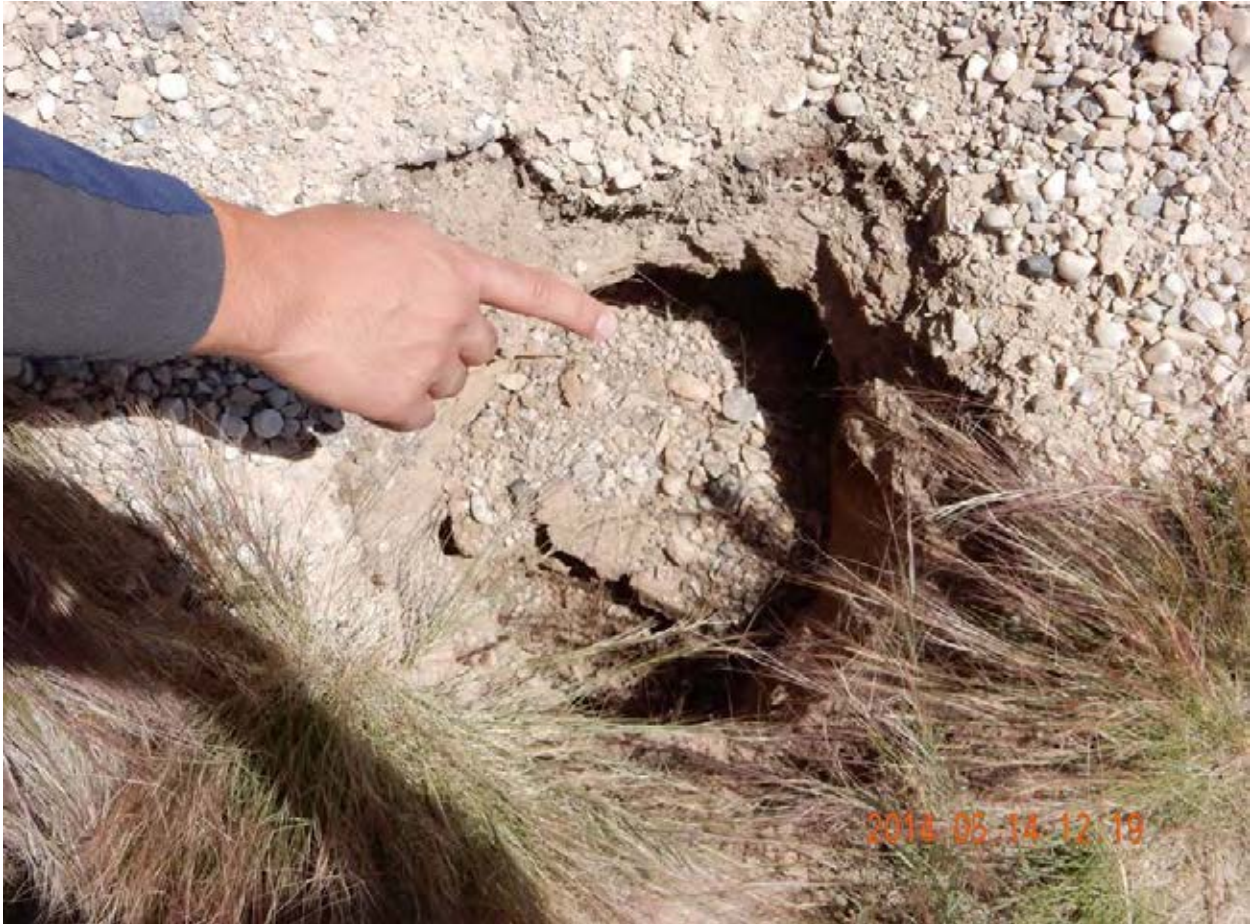
*Figure A-4. Small sinkhole, south side of Lakewood Road. Diameter, 0.4 m, depth, 0.44 m. 558997, 3610704, 3 m.*

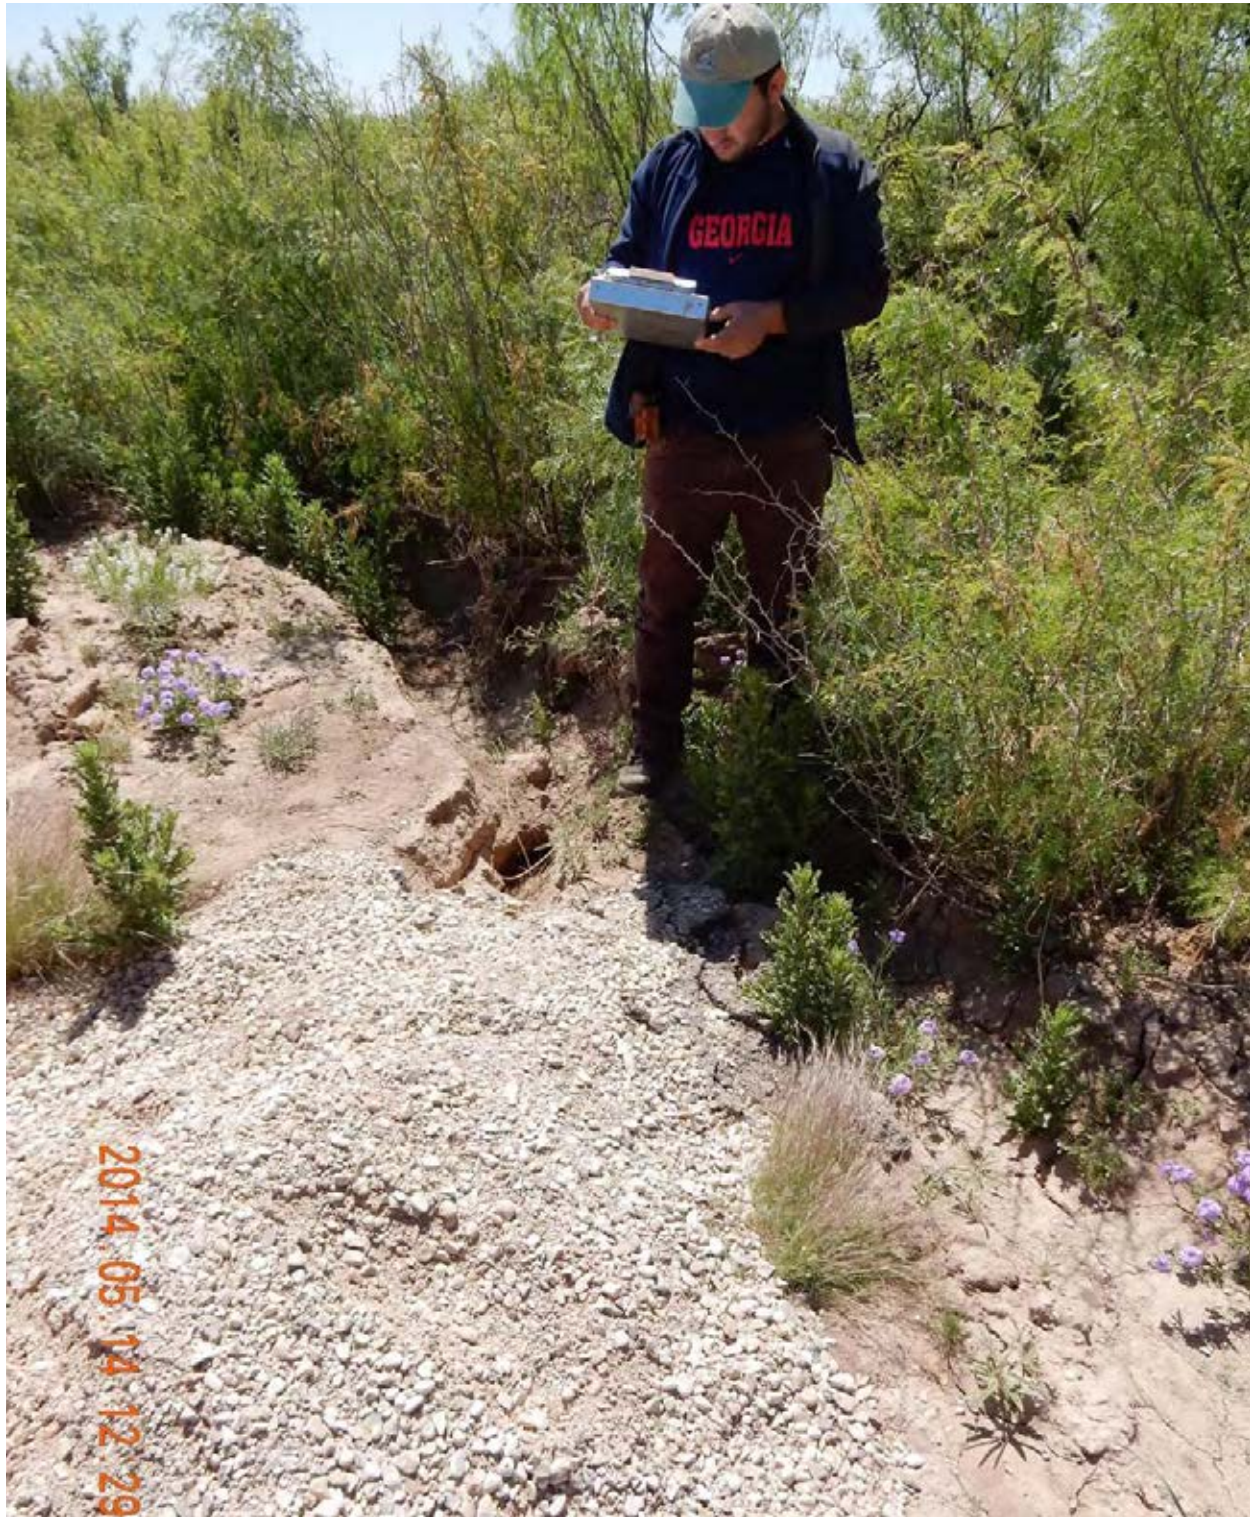
Figure A-5. Soil fracture, south side of Lakewood Road, mostly filled with gravel. Pavement damage indicates fracture extends beneath road to opposite shoulder, where a recent pile of gravel probably buries north end of feature. Length >10 m (assuming fracture extends beneath road), width 0.4 m, depth where not filled, 0.4 m, azimuth 137°. 558944, 3610701, 4 m.

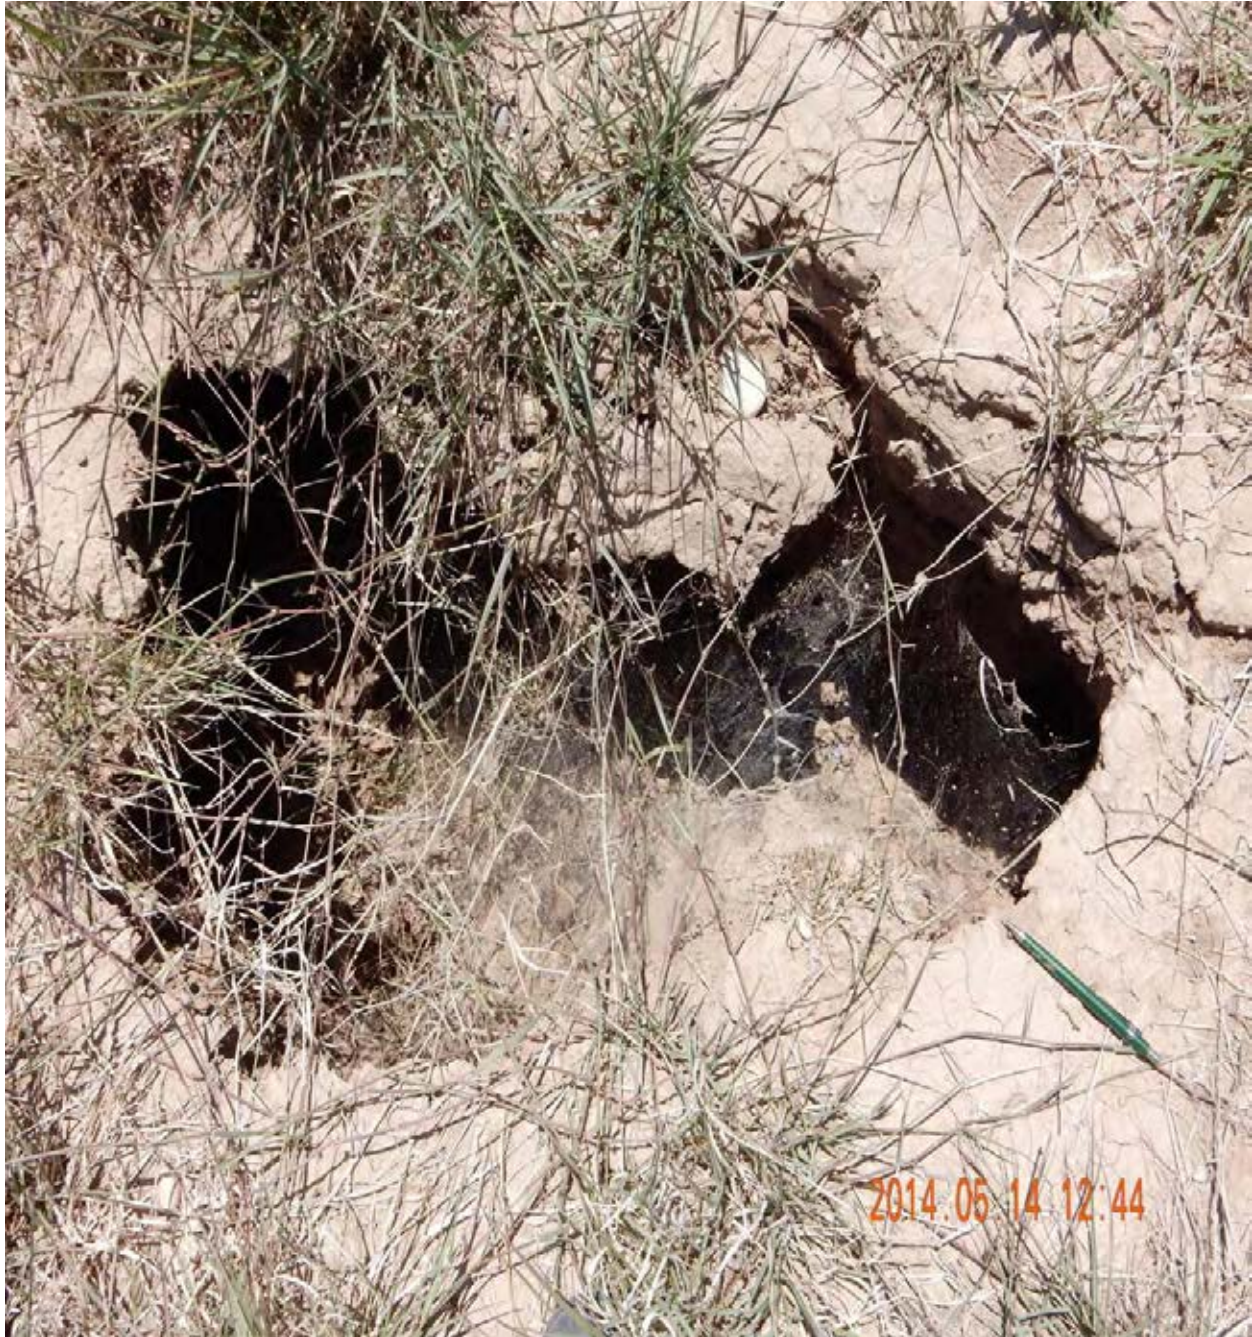
*Figure A-6a. First of a pair of sinkholes following a soil fracture, south side Lakewood Road. Length 0.6 m, width 0.2 m, depth 0.9 m, fracture azimuth 62°. 558449, 3610702, 2 m.*

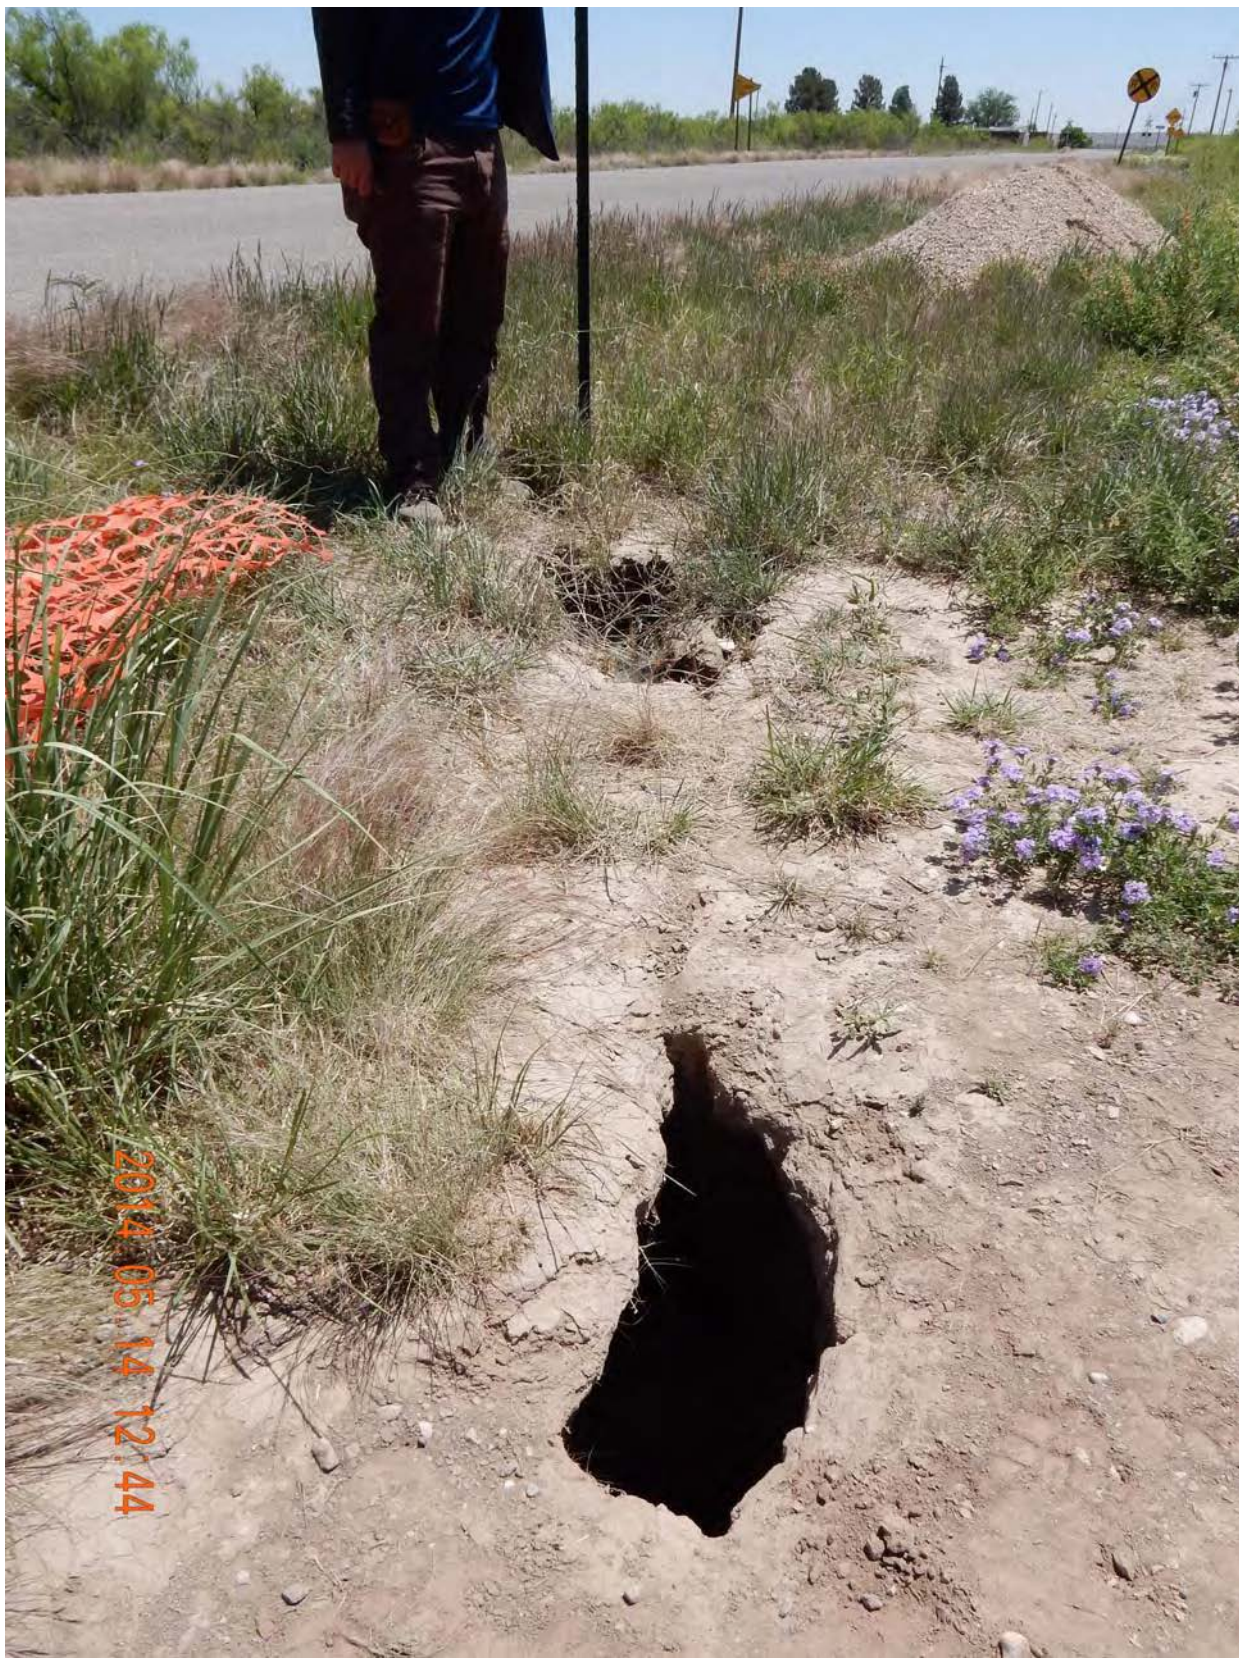
Figure A-6b. Second of a pair of sinkholes following a soil fracture, south side Lakewood Road. Length 0.83 m, width 0.41 m, depth 0.63 m, fracture azimuth 62°. 558449, 3610702, 2 m.

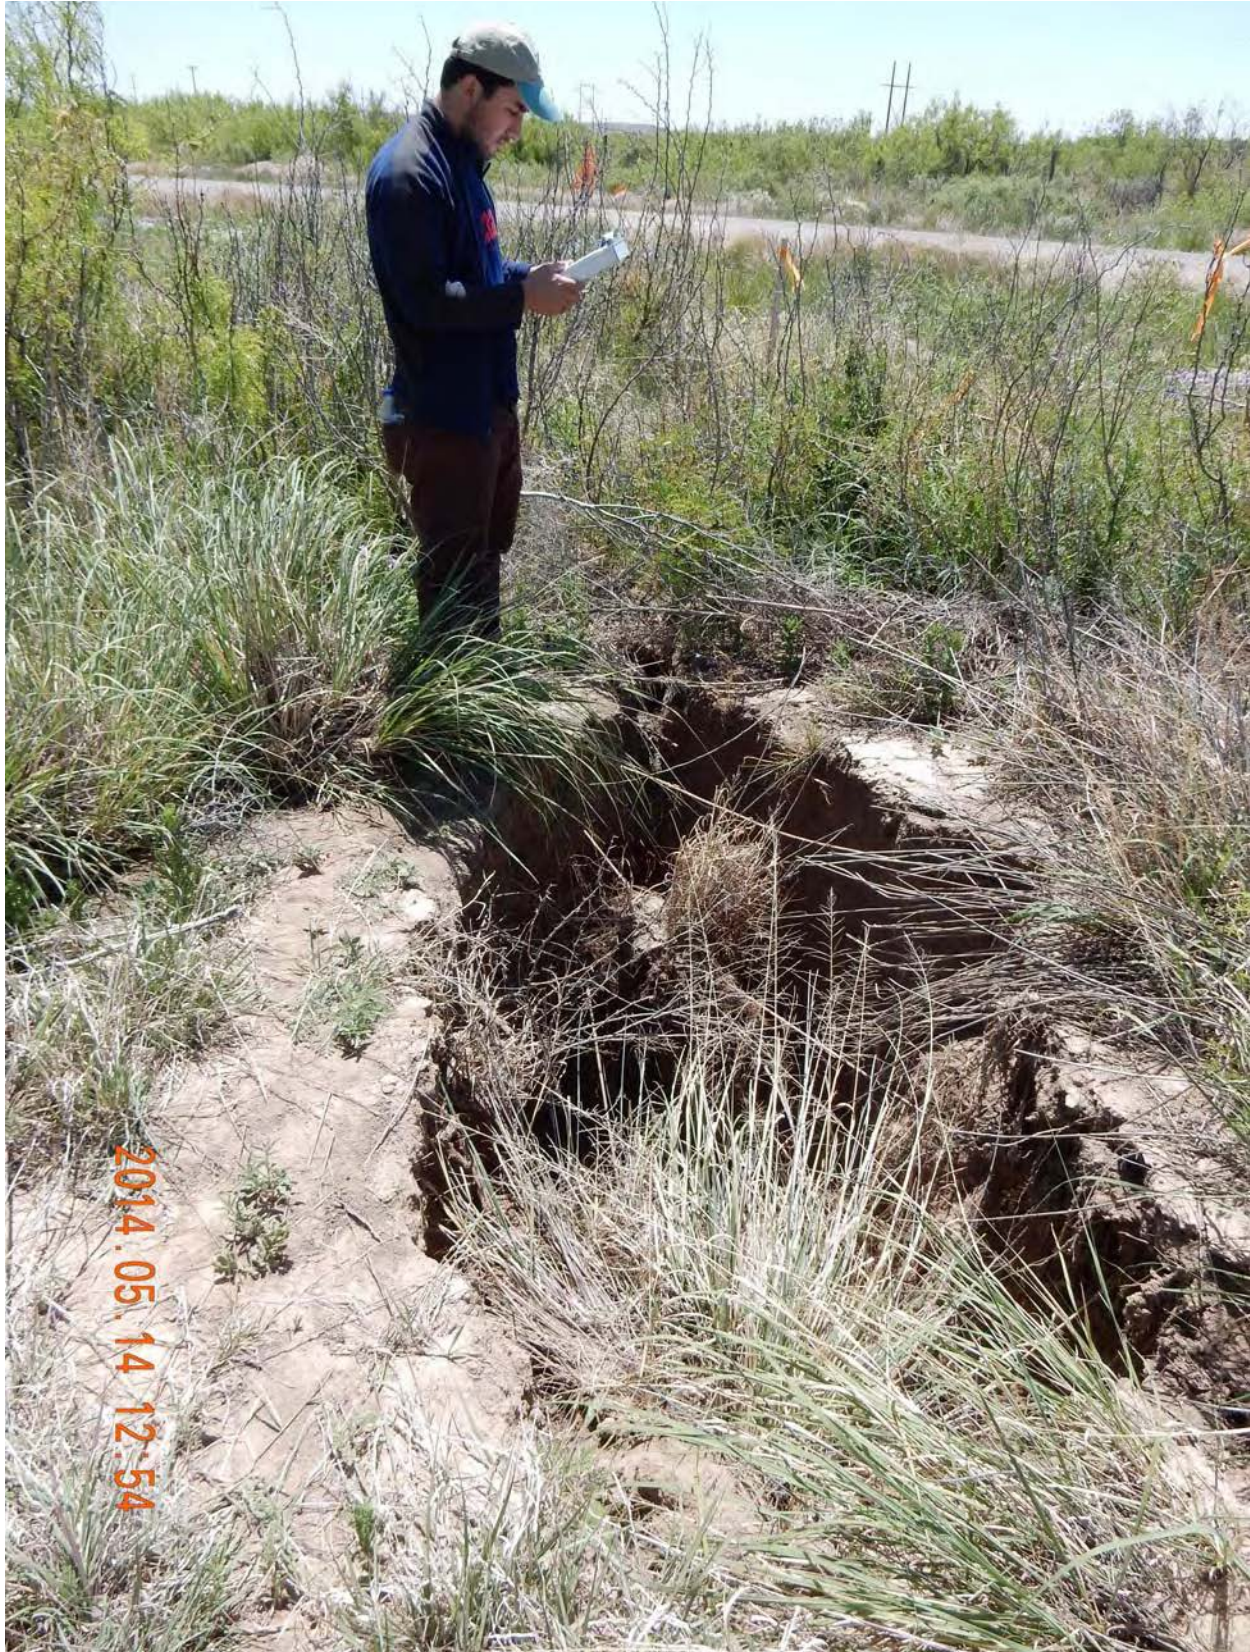
Figure A-7. First sinkhole in a cluster of five, north side Lakewood Road. First three sinkholes occur in a line oriented  $122^{\circ}$ . Length 3.2 m, width 1.35 m, depth 2.3 m. 558430, 3610719, 3 m.

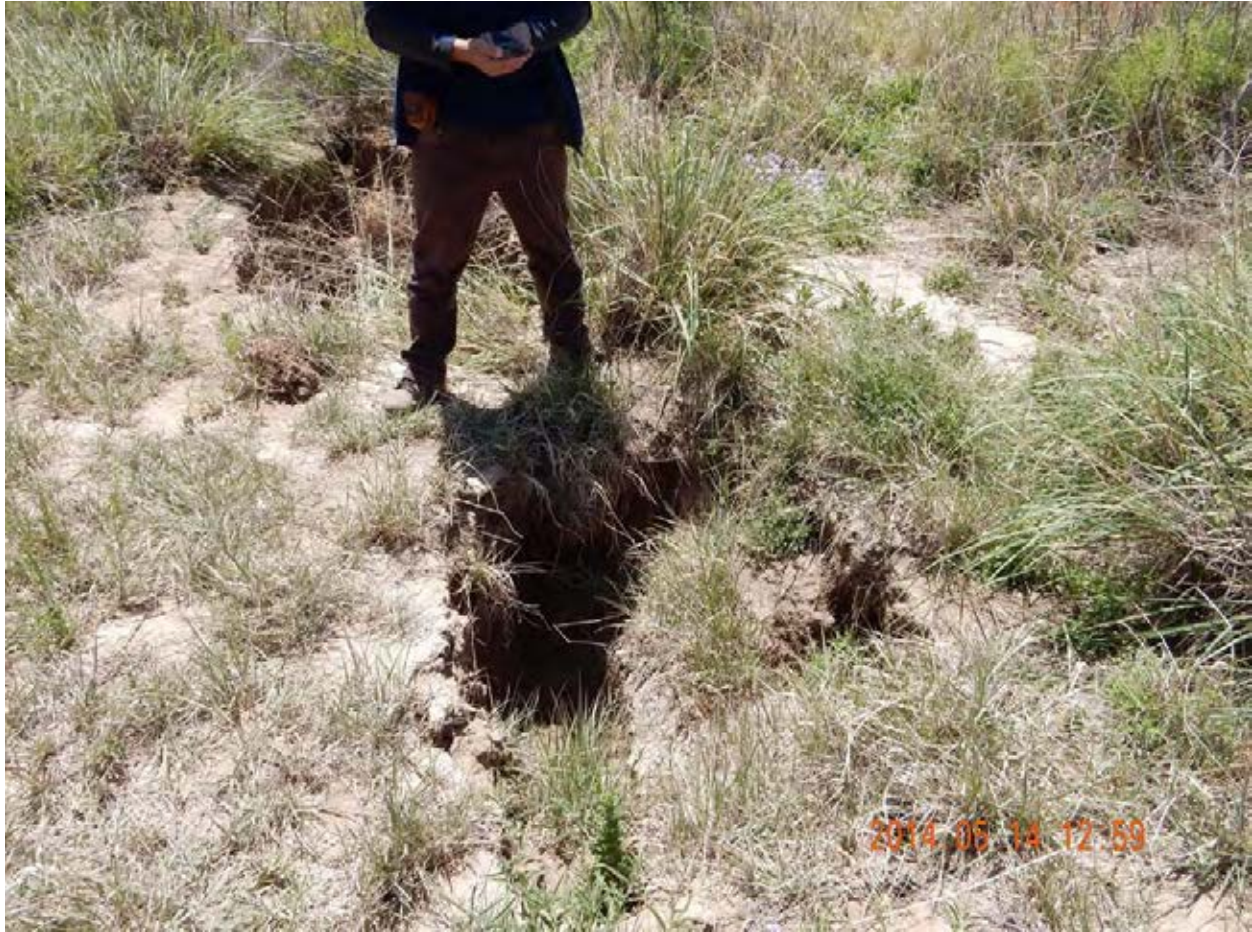
*Figure A-8. Second sinkhole in a cluster of five, north side Lakewood Road. Length 1.58 m, width 1.0 m, depth 0.85 m. 558429, 3610721, 3 m.*

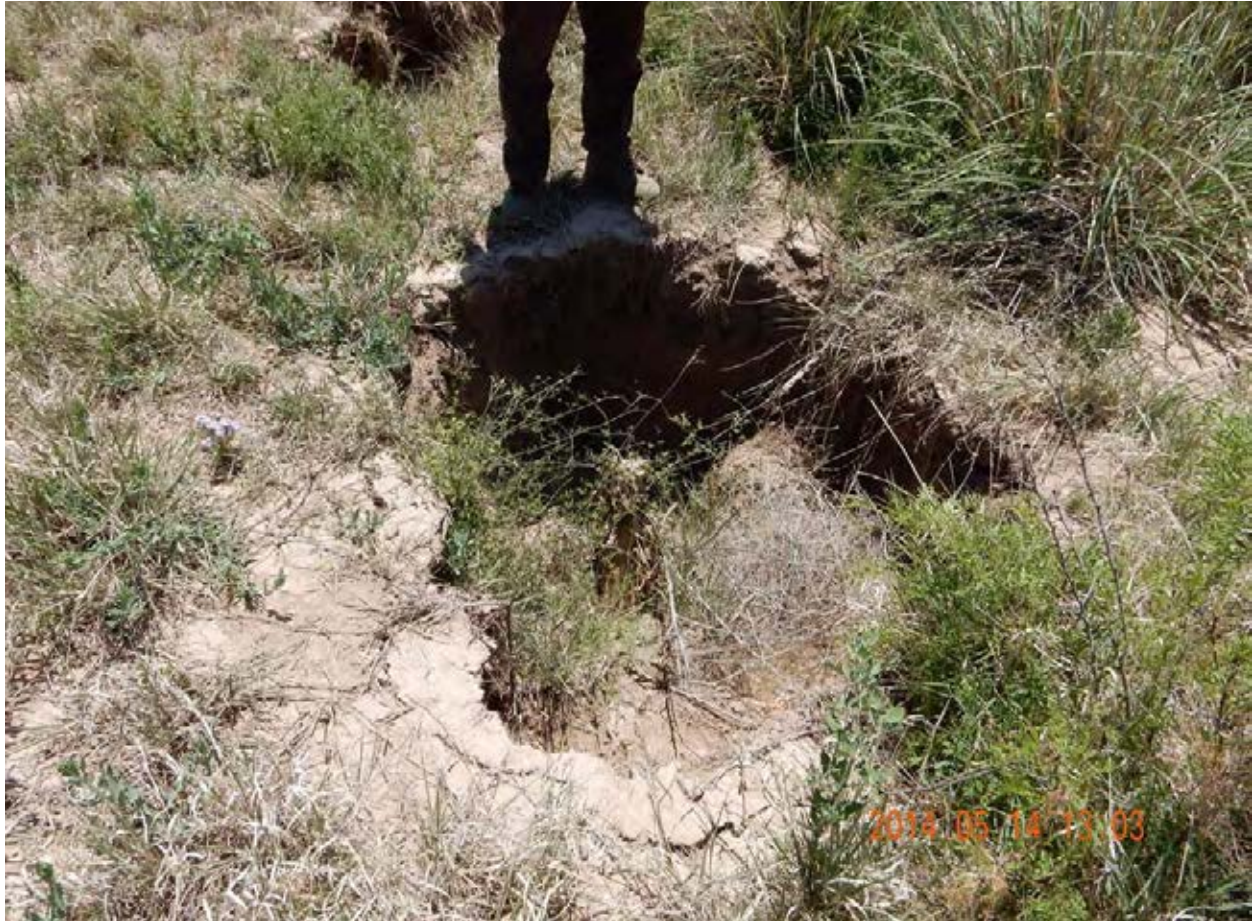
*Figure A-9. Third sinkhole in a cluster of five, north side Lakewood Road. Length 1.7 m, width 1.52 m, depth 0.9 m. 558427, 3610724, 3 m.*

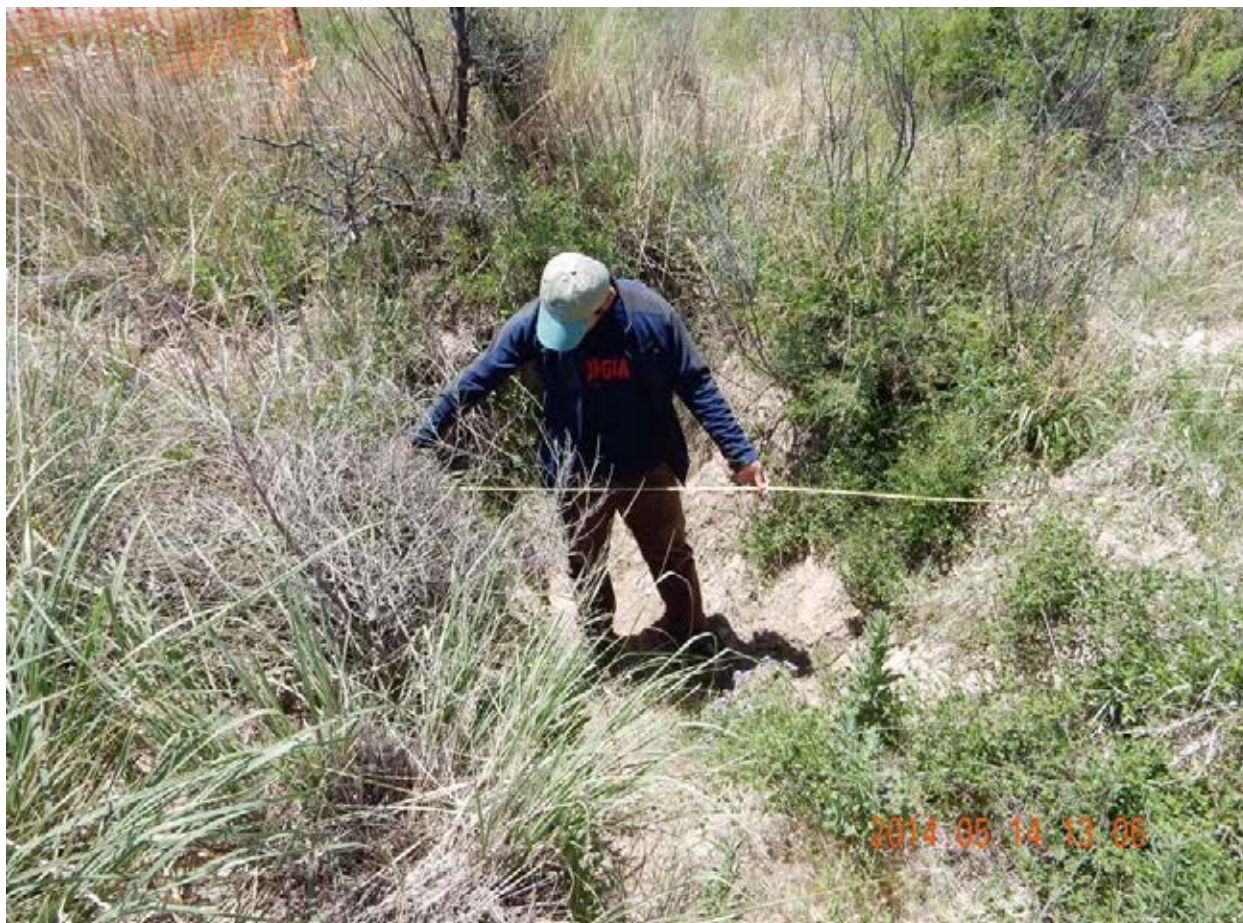
*Figure A-10. Fourth sinkhole in a cluster of five, north side Lakewood Road. Length 3.6 m, width 1.92 m, depth 1.0 m. 558423, 3610719, 3 m.*
