## NCKRI REPORT OF INVESTIGATION 6

# GEOPHYSICAL INVESTIGATION OF FLOOD-INDUCED SINKHOLE COLLAPSES, LAKEWOOD REGION, EDDY COUNTY, NEW MEXICO

Lewis Land  
Lasha Asanidze

June 2014

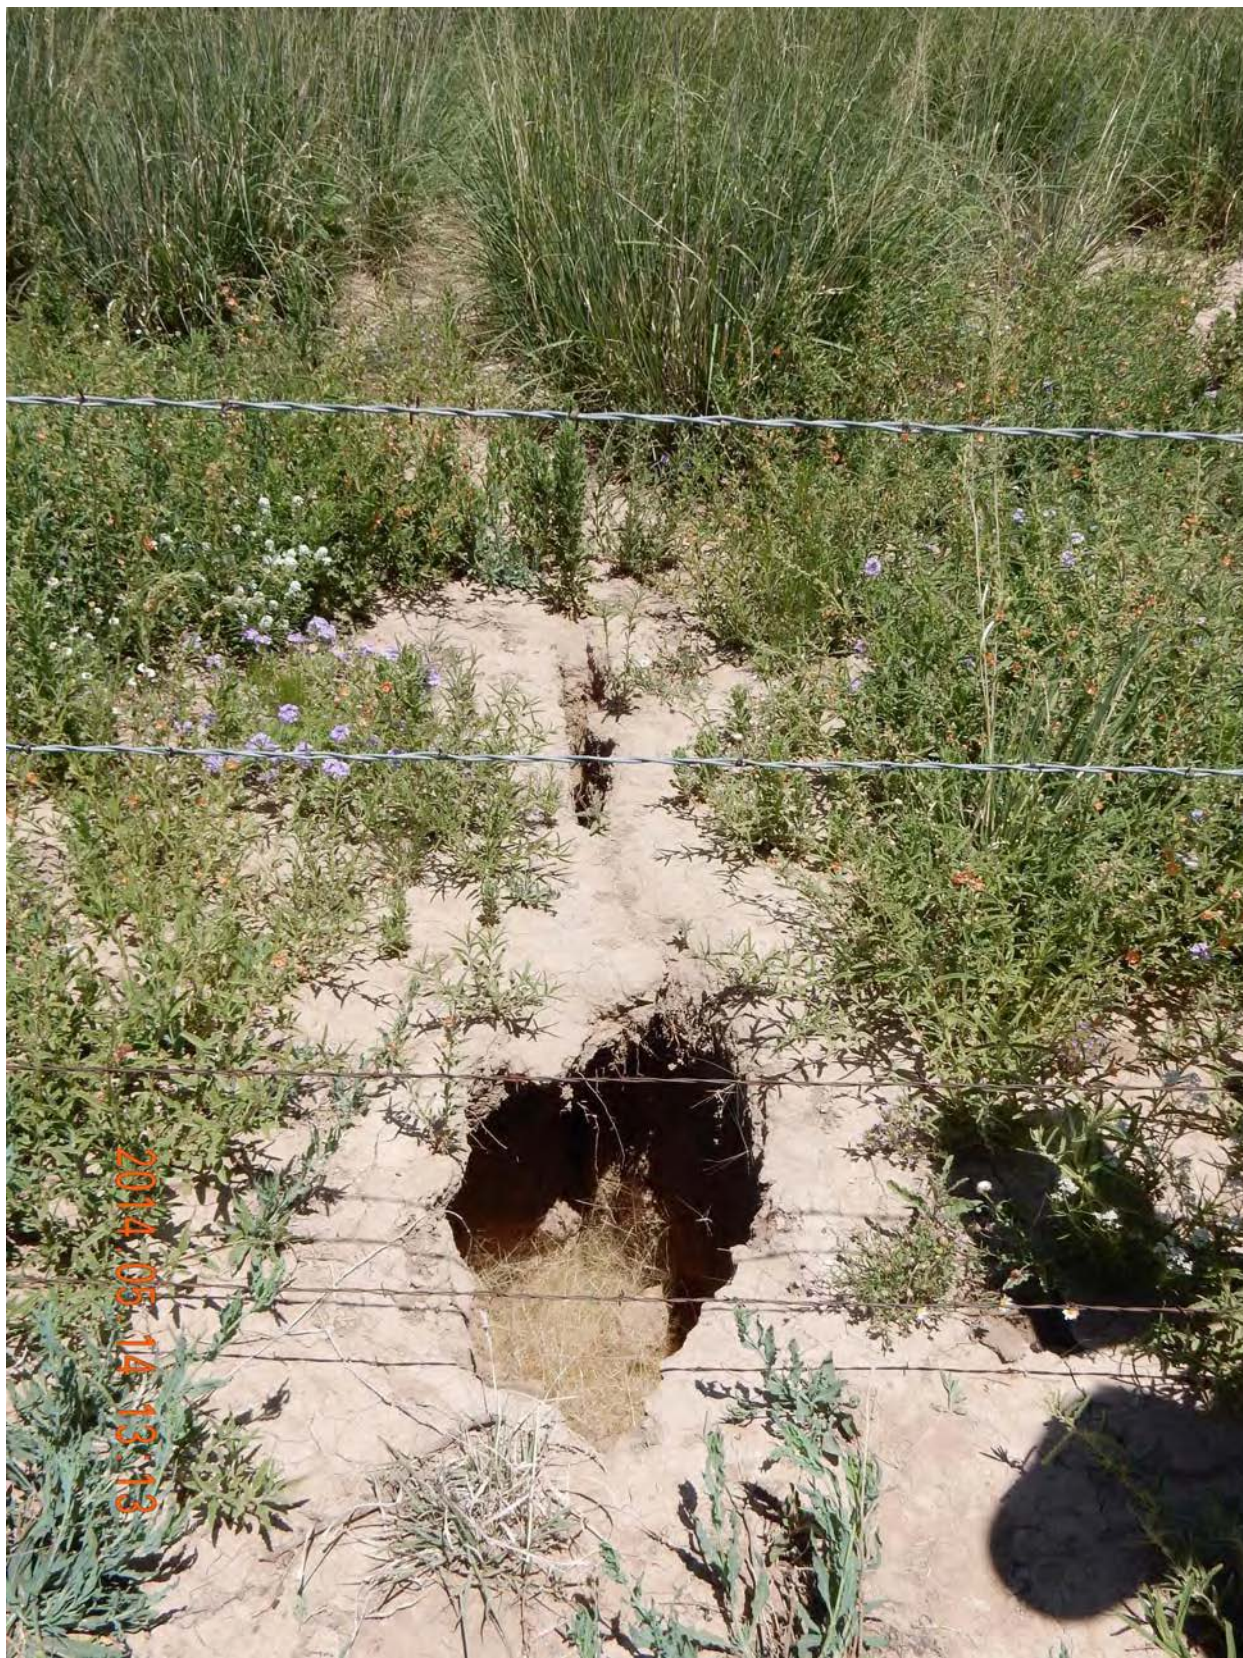
Figure A-11. Fifth sinkhole in a cluster of five, north side Lakewood Road. Length 0.84 m, width 0.38 m, depth 0.84 m. Sinkhole follows fracture with azimuth of 177°. 558427, 3610725, 3 m.

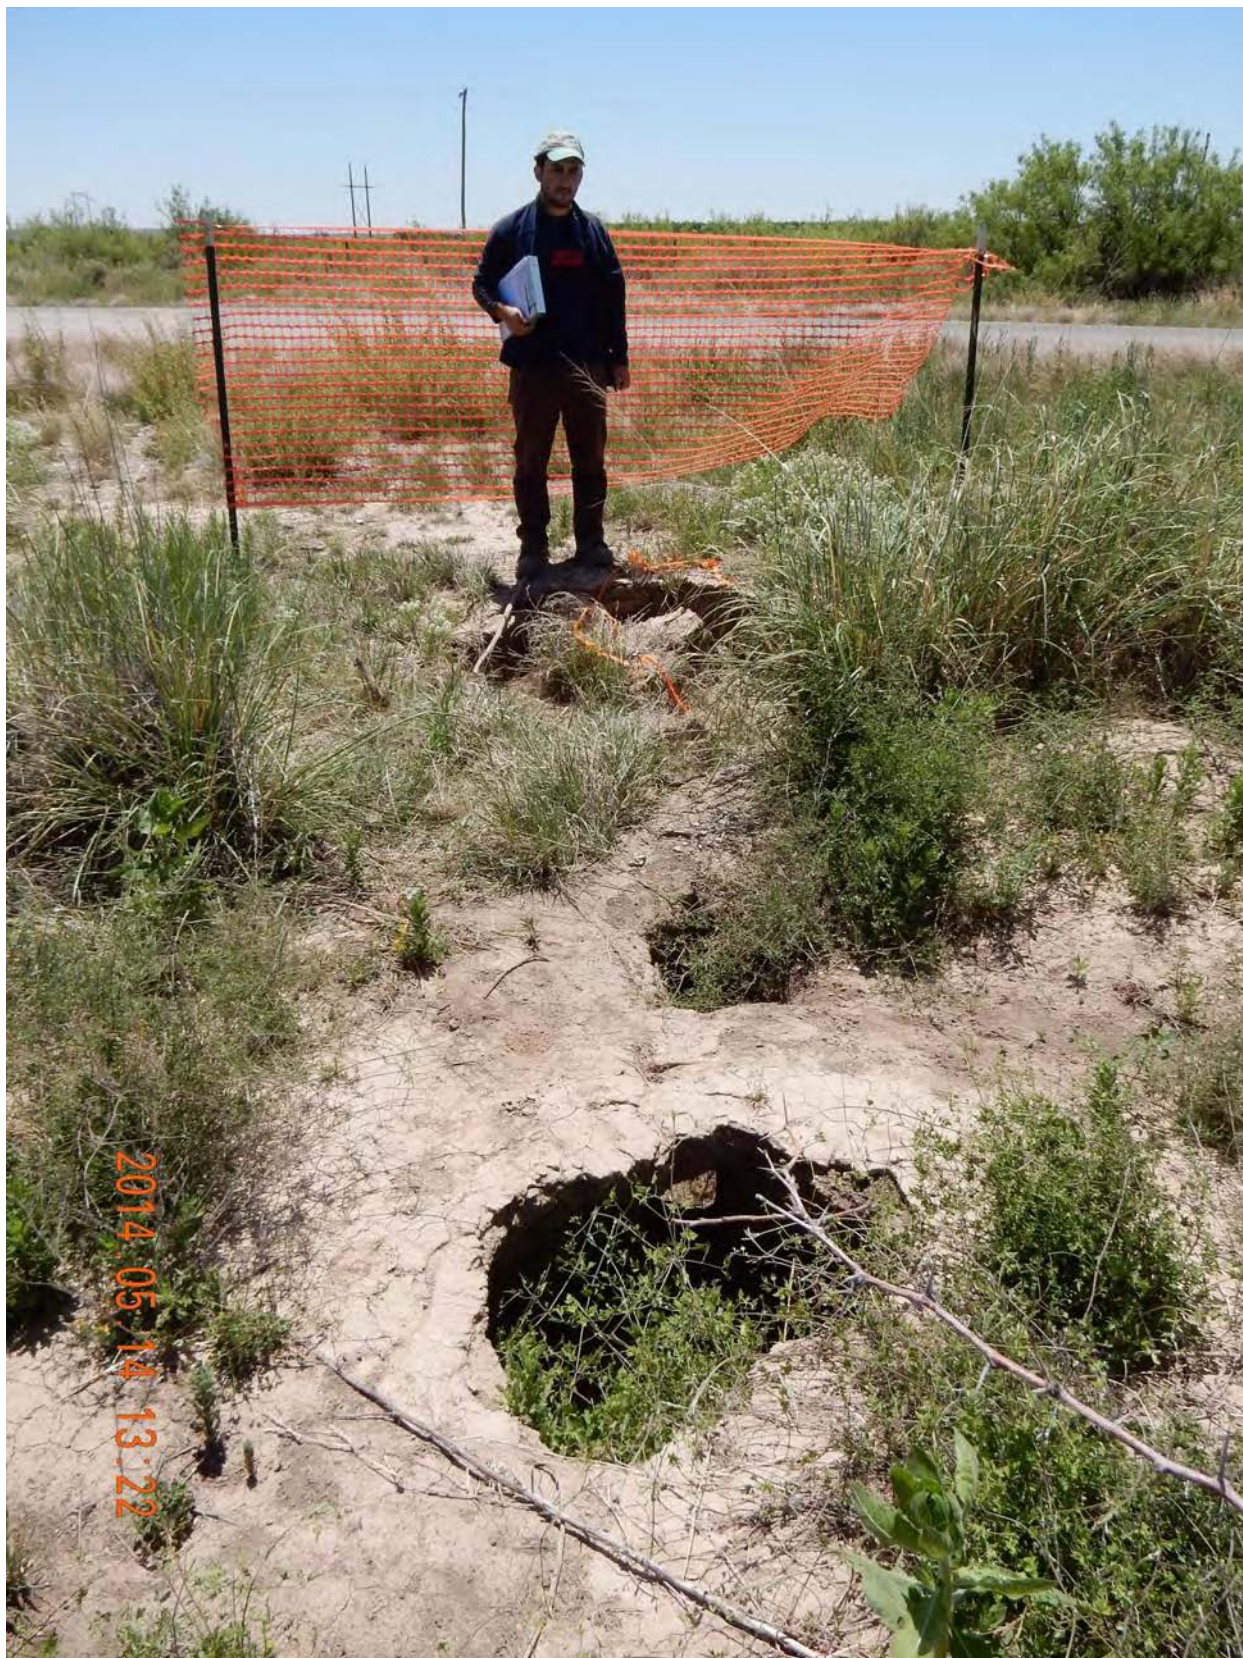
Figure A-12a. Line of three sinkholes, north side Lakewood Road. Line of sinkholes is oriented azimuth  $146^{\circ}$ . 558392, 3610717, 3 m.

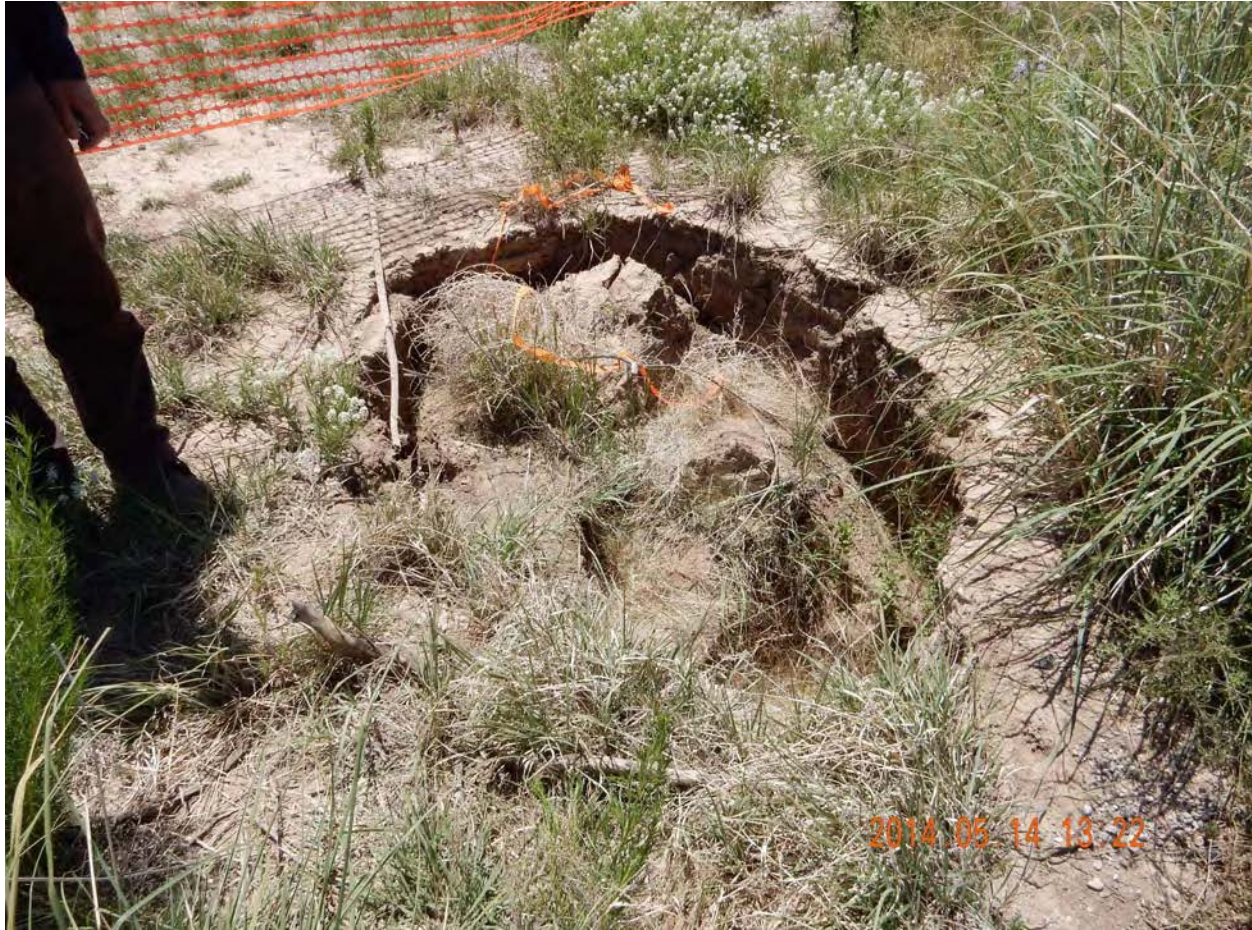
*Figure A-12b. First of three sinkholes in line, north side of Lakewood Road. Length 1.78 m, width 1.45 m, depth 0.87 m. 558392, 3610717, 3 m.*

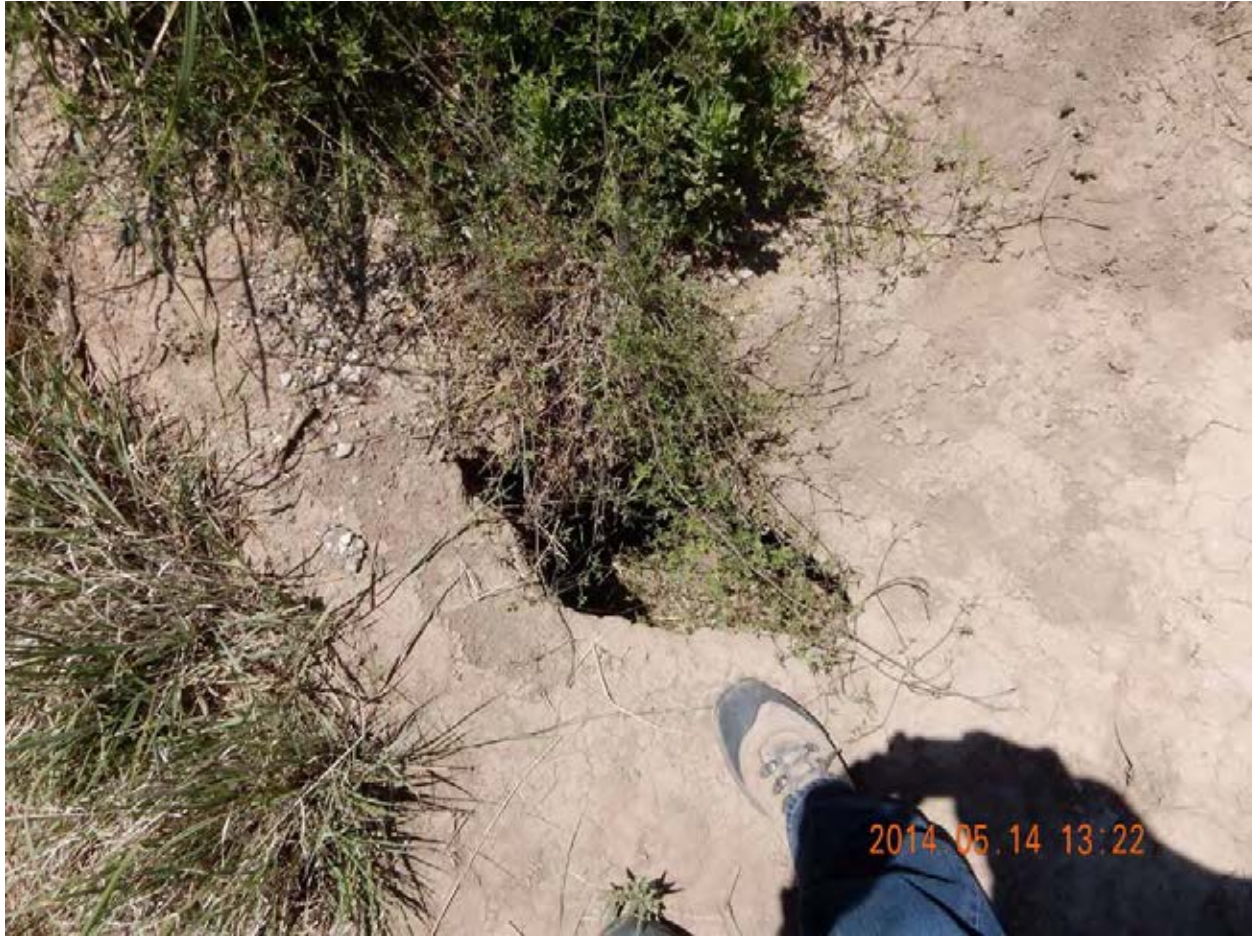
*Figure A-12c. Second of three sinkholes in line, north side of Lakewood Road. Length 0.56 m, width 0.35 m, depth 0.69 m. 558392, 3610717, 3 m.*

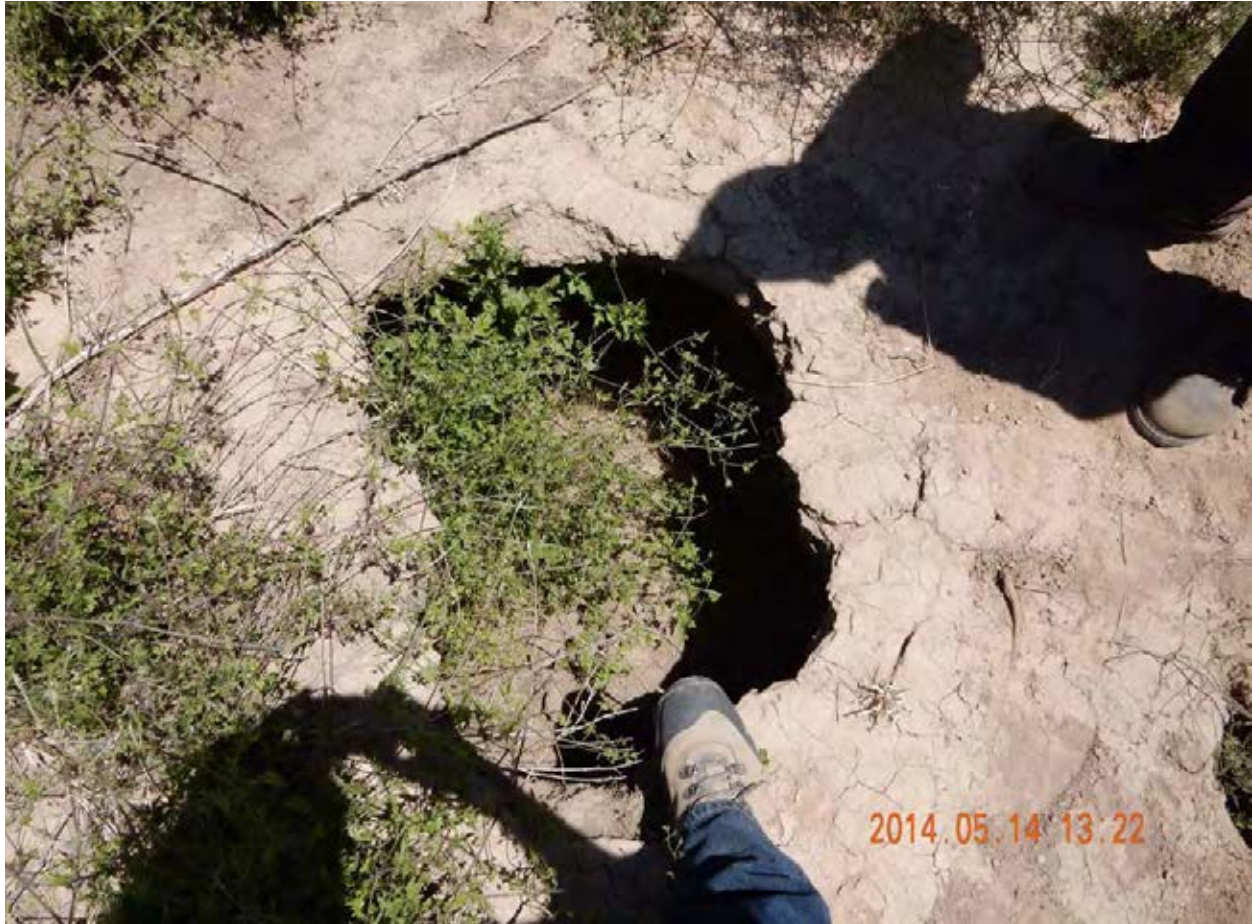
*Figure A-12d. Third of three sinkholes in line, north side of Lakewood Road. Length 0.73 m, width 0.46 m, depth 0.57 m. 558392, 3610717, 3 m.*

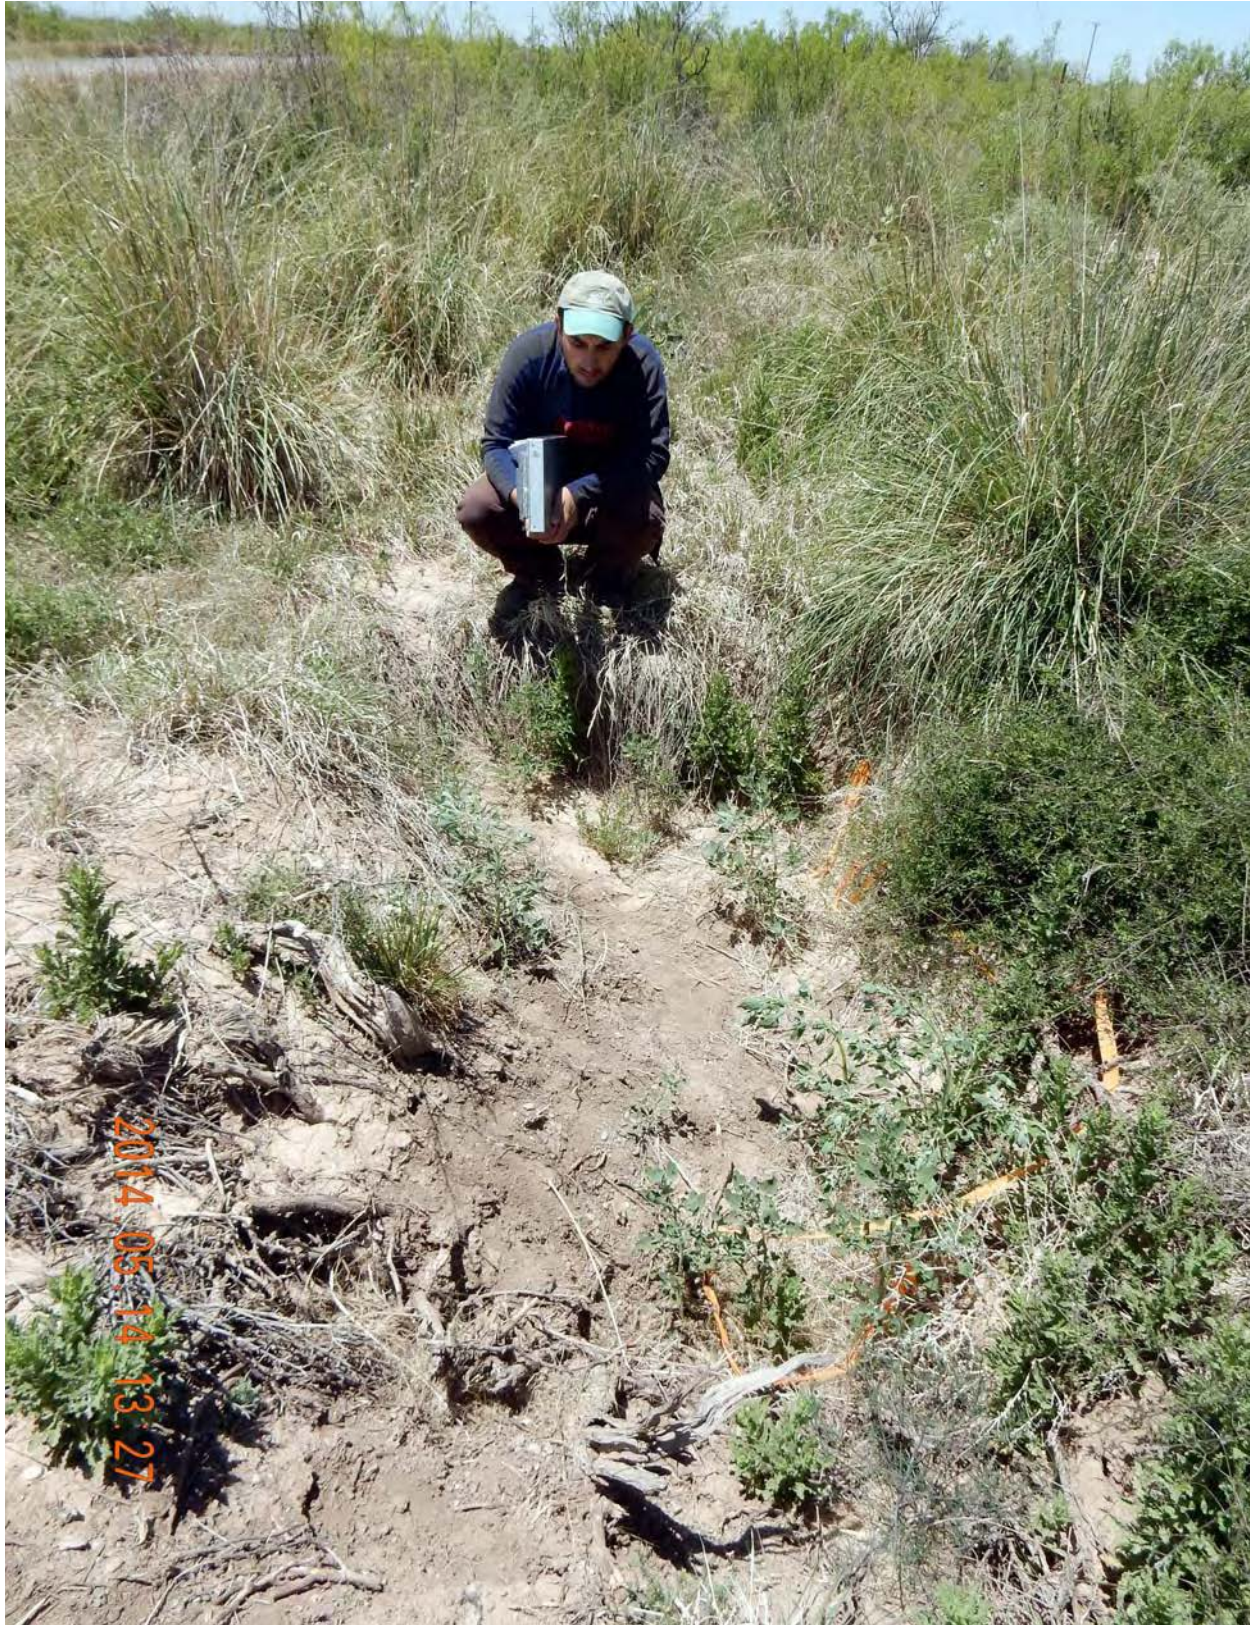
Figure A-13. Sinkhole, north side Lakewood Road. Length 2.67 m, width 1.7 m, depth 0.64 m. 558385, 3610719, 3 m.

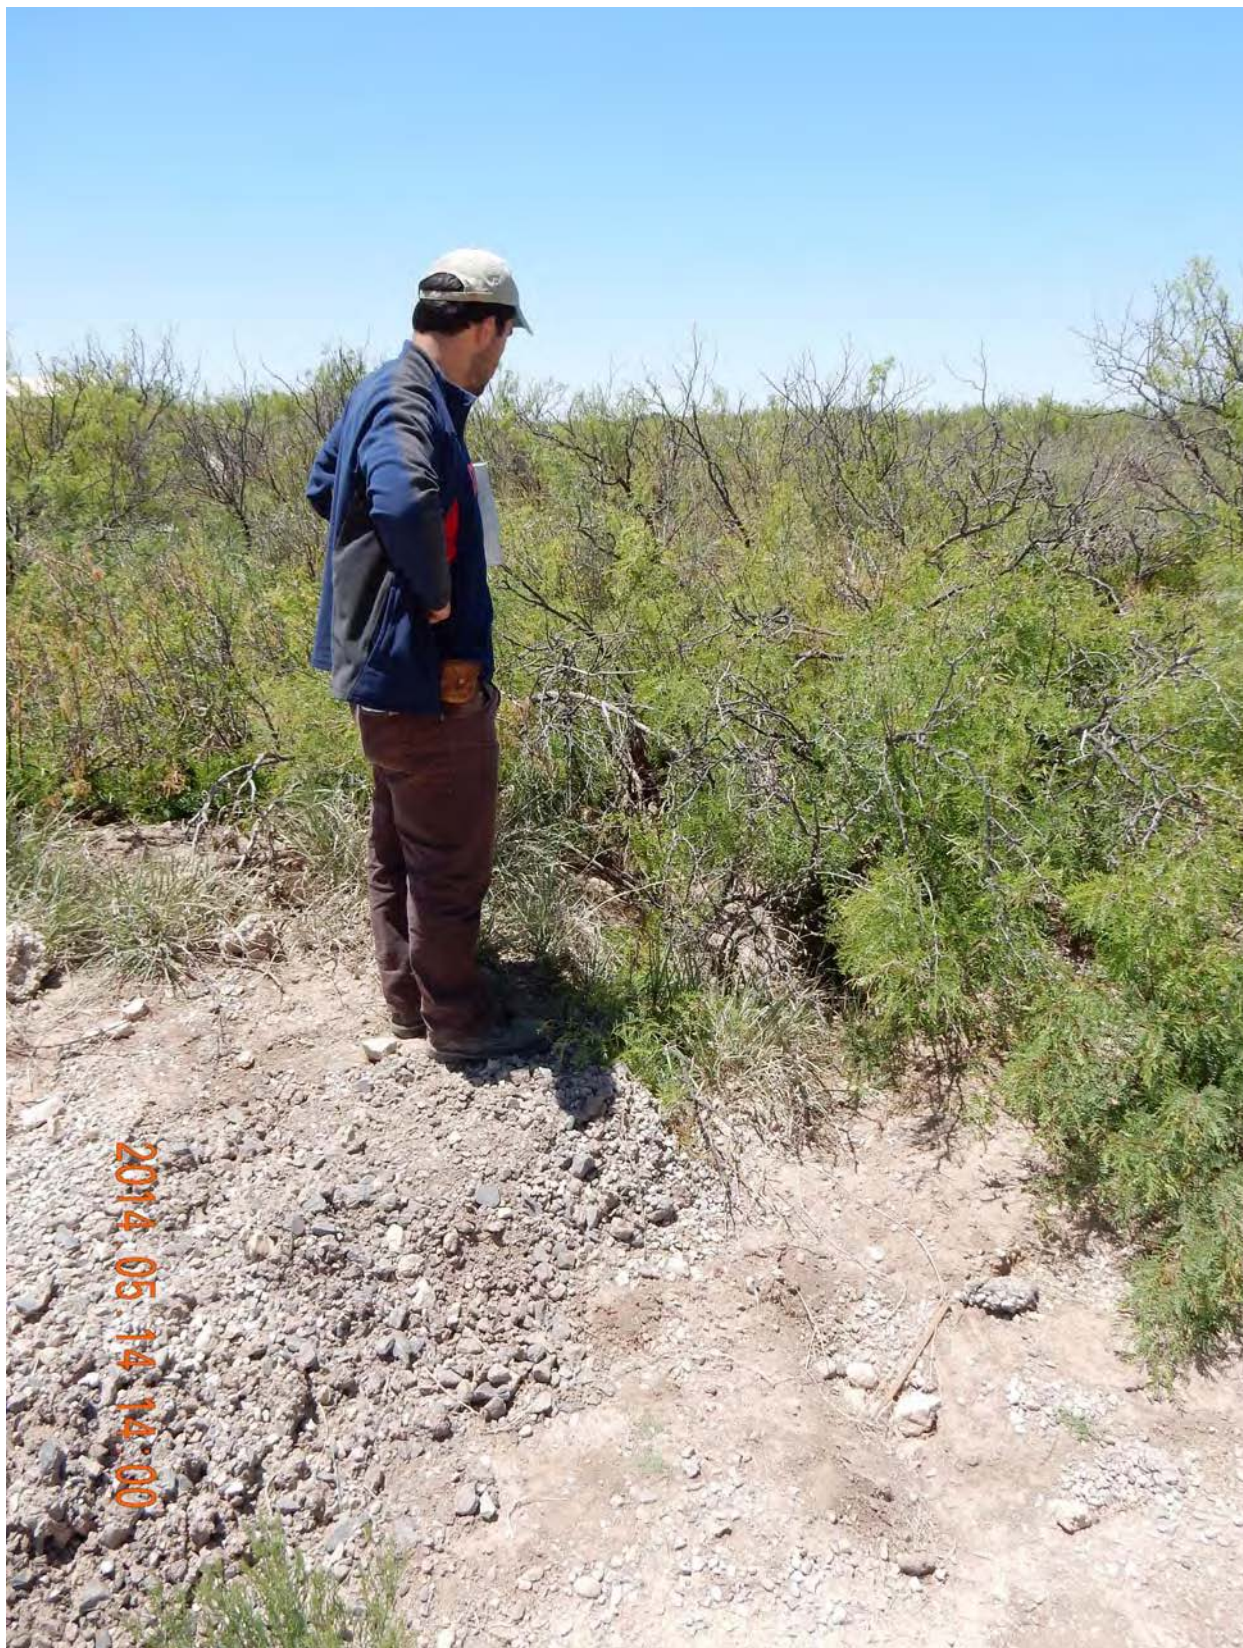
Figure A-14. Discontinuous soil fracture, mostly concealed by dense mesquite, west side of Lake Road. Length ~20 m, maximum width 1.55 m, maximum depth 1.37 m, azimuth 97°. 559128, 3610938, 4 m.

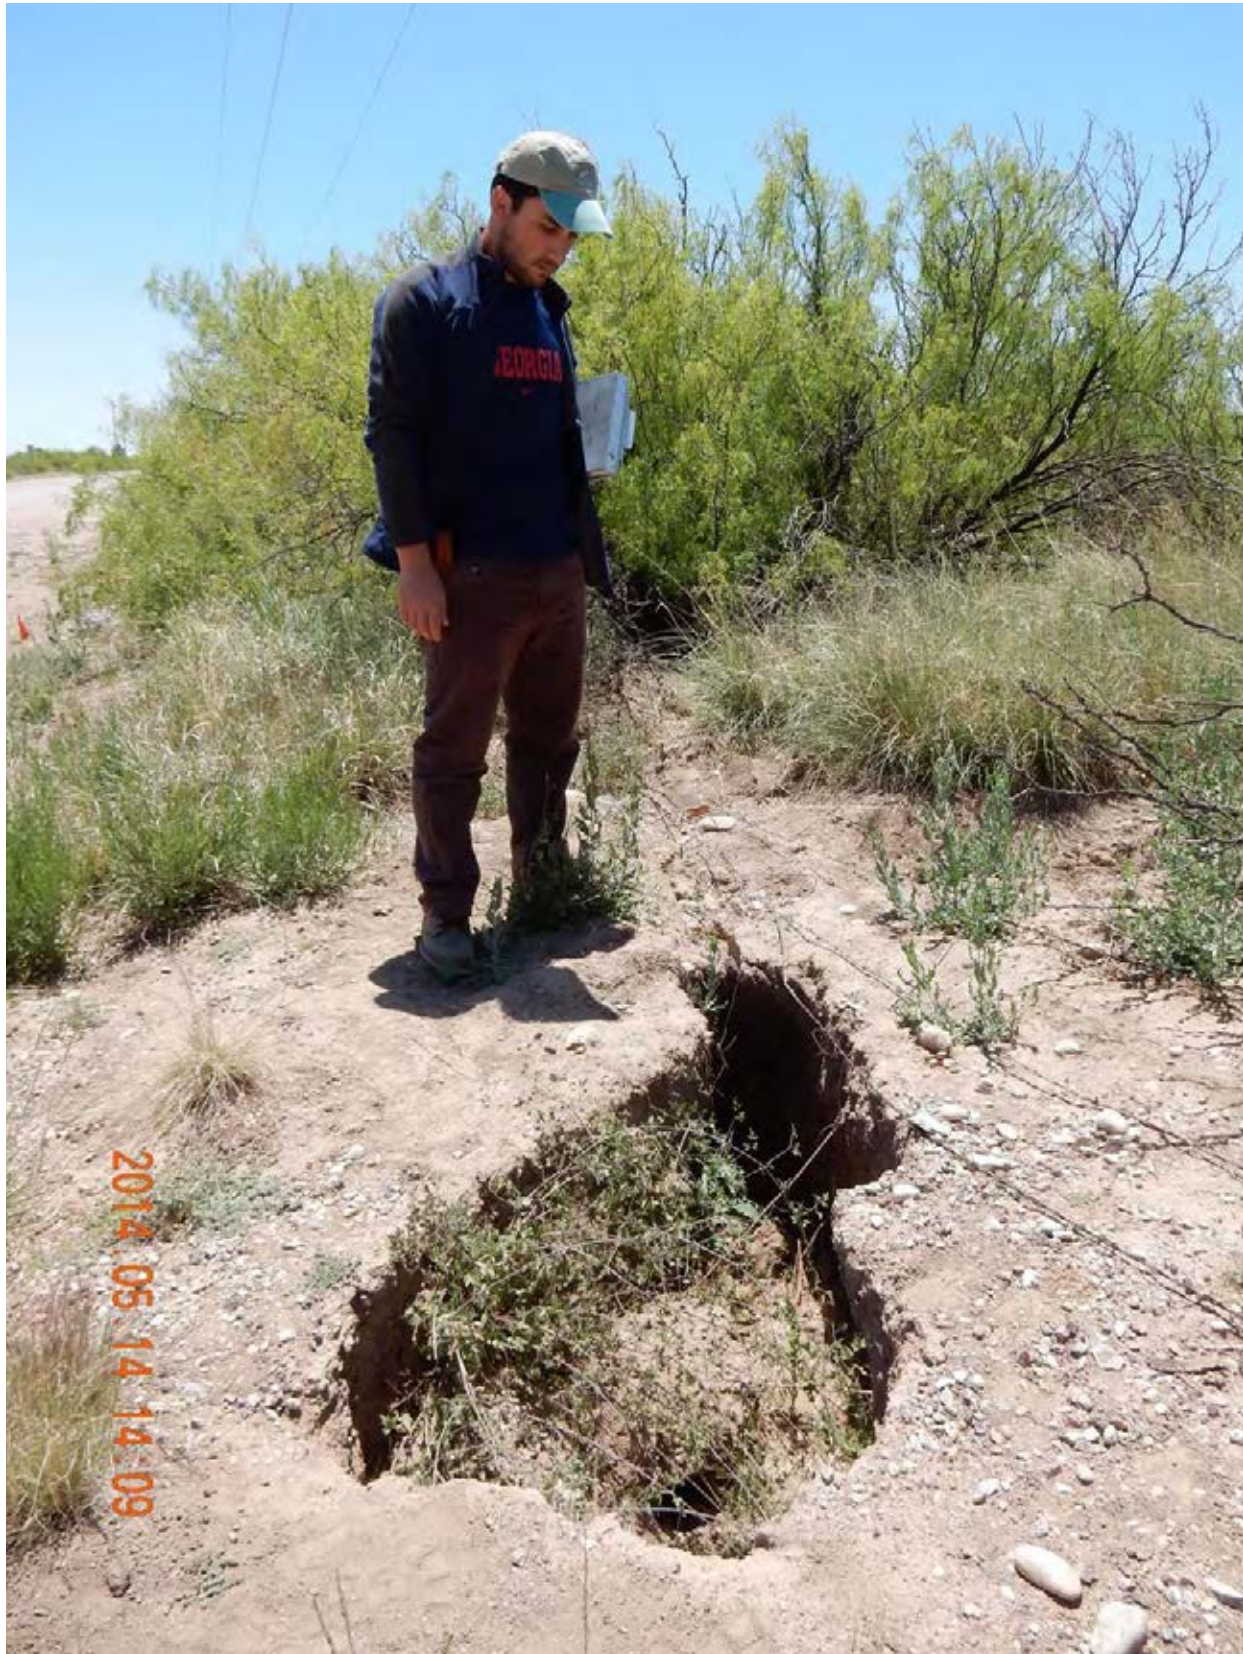
Figure A-15a. First of two sinkholes following fracture, west side of Lake Road. Length 1.65 m, width 1.1 m, depth 0.7 – 1.6 m. Fracture azimuth 2°. 559133, 3610963, 3 m.

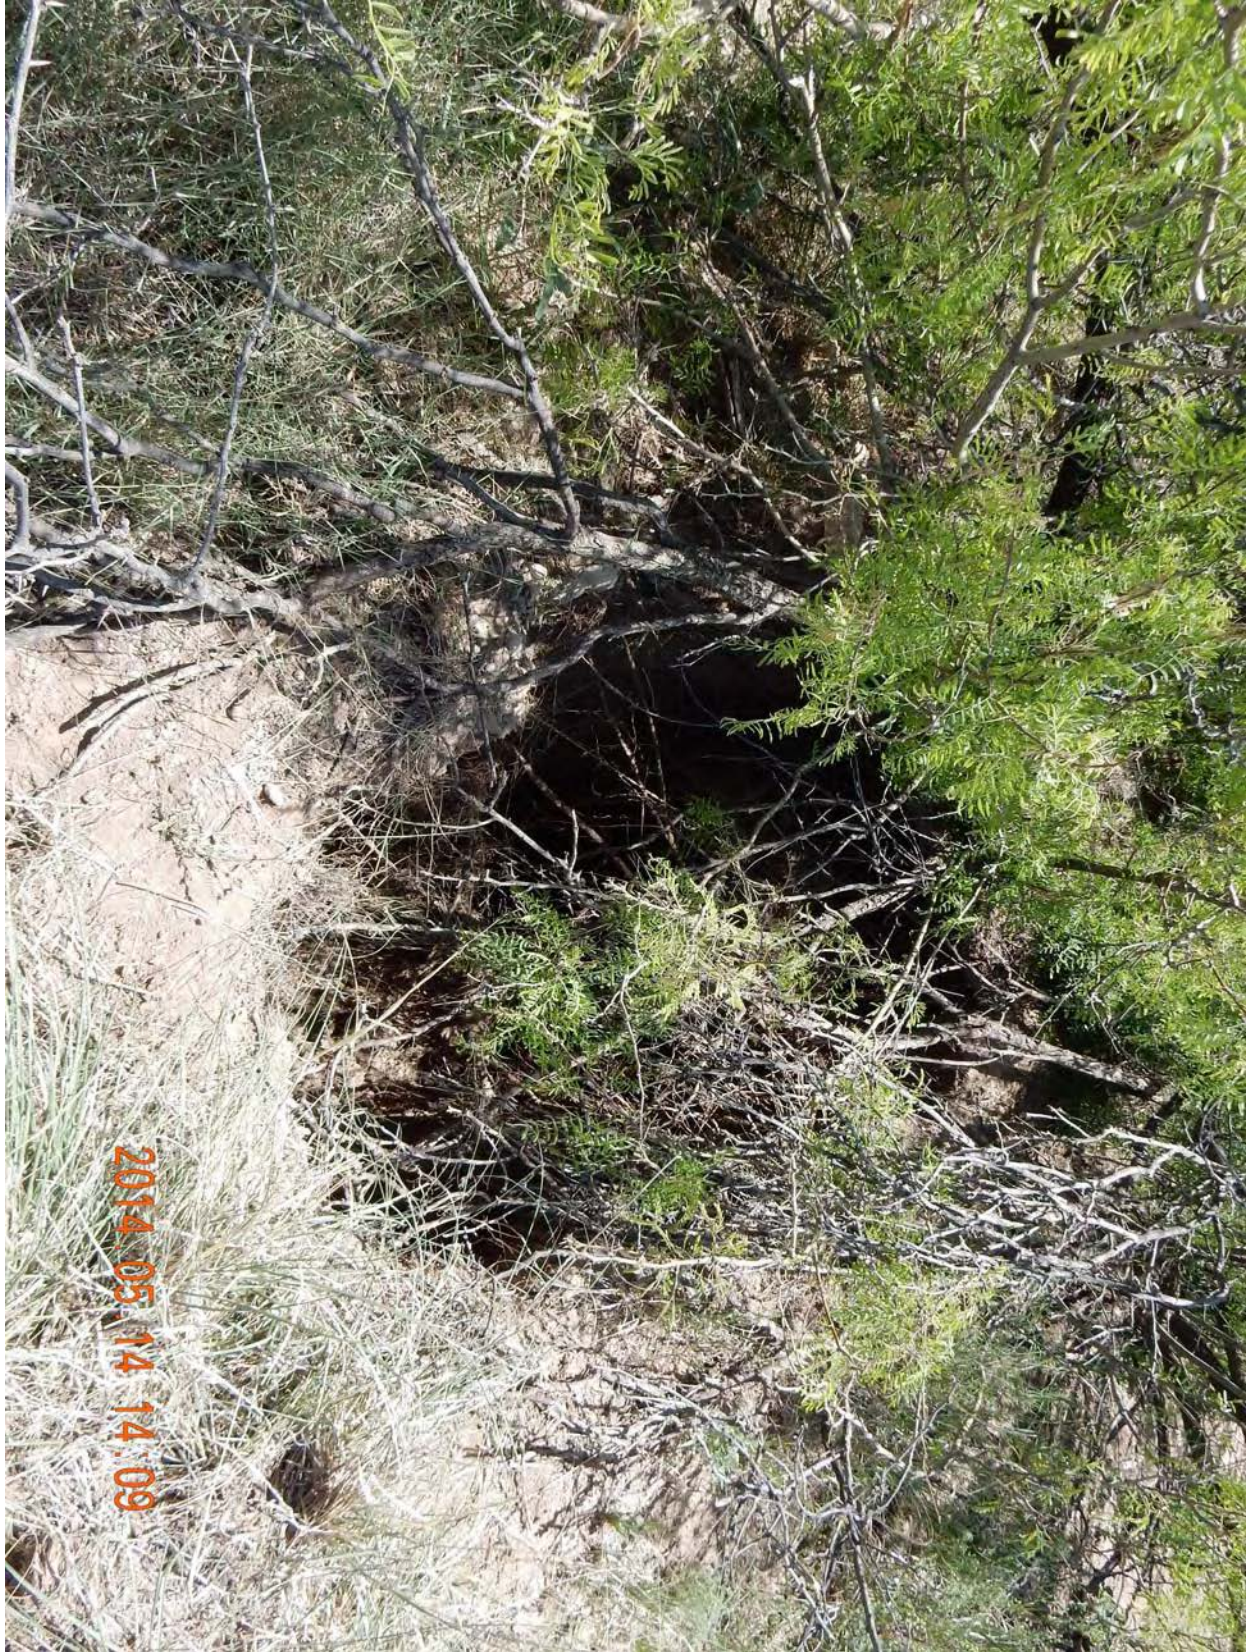
Figure A-15b. Second of two sinkholes following fracture, west side of Lake Road. Length 1.62 m, width 0.54 m, depth 0.7 m. Fracture azimuth 2°. 559133, 3610963, 3 m.

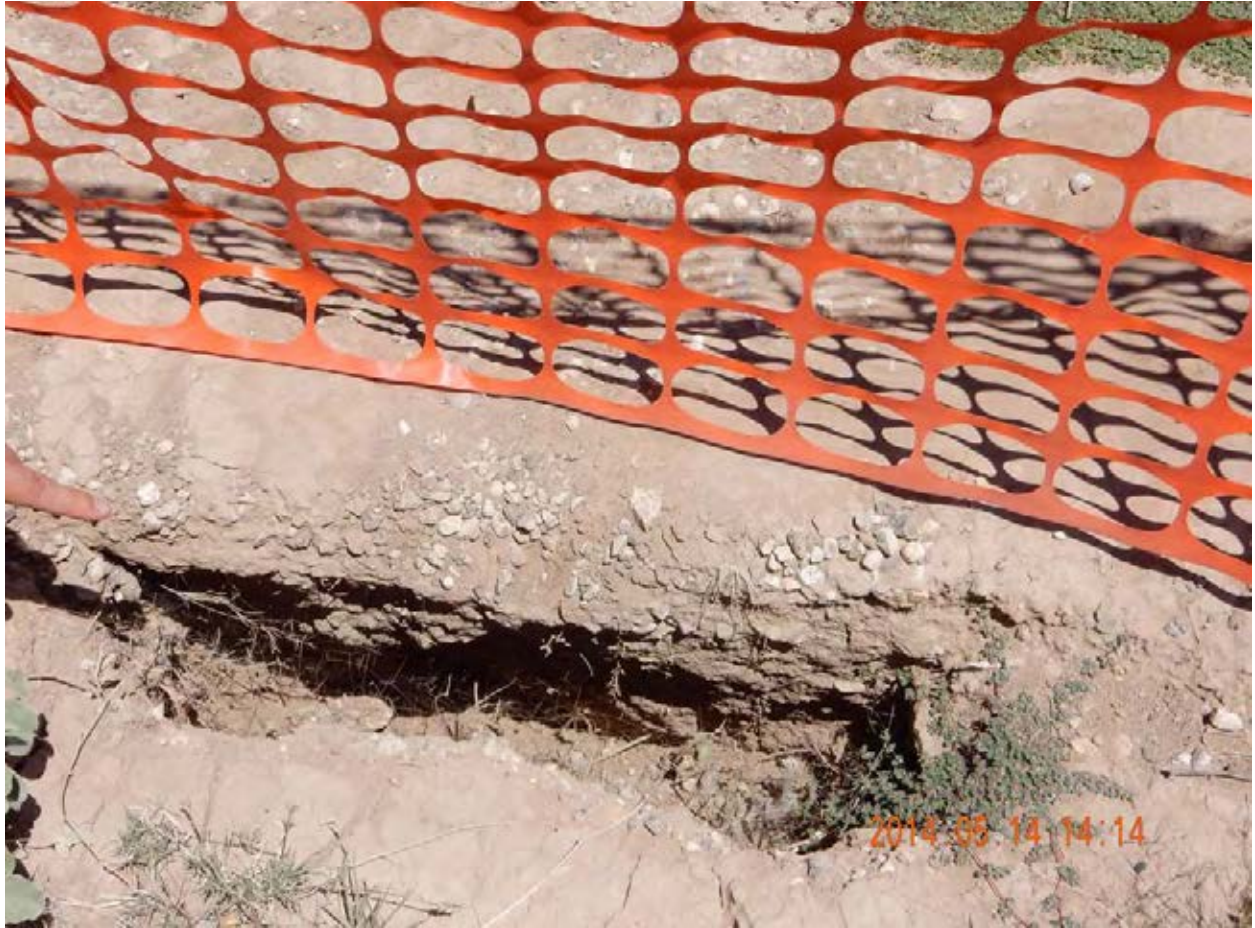
*Figure A-16. Soil fracture, west side of Lake Road. Length 0.66 m, width 0.1 m, depth 0.4 m, azimuth 172°. 559138, 3610973, 4 m.*

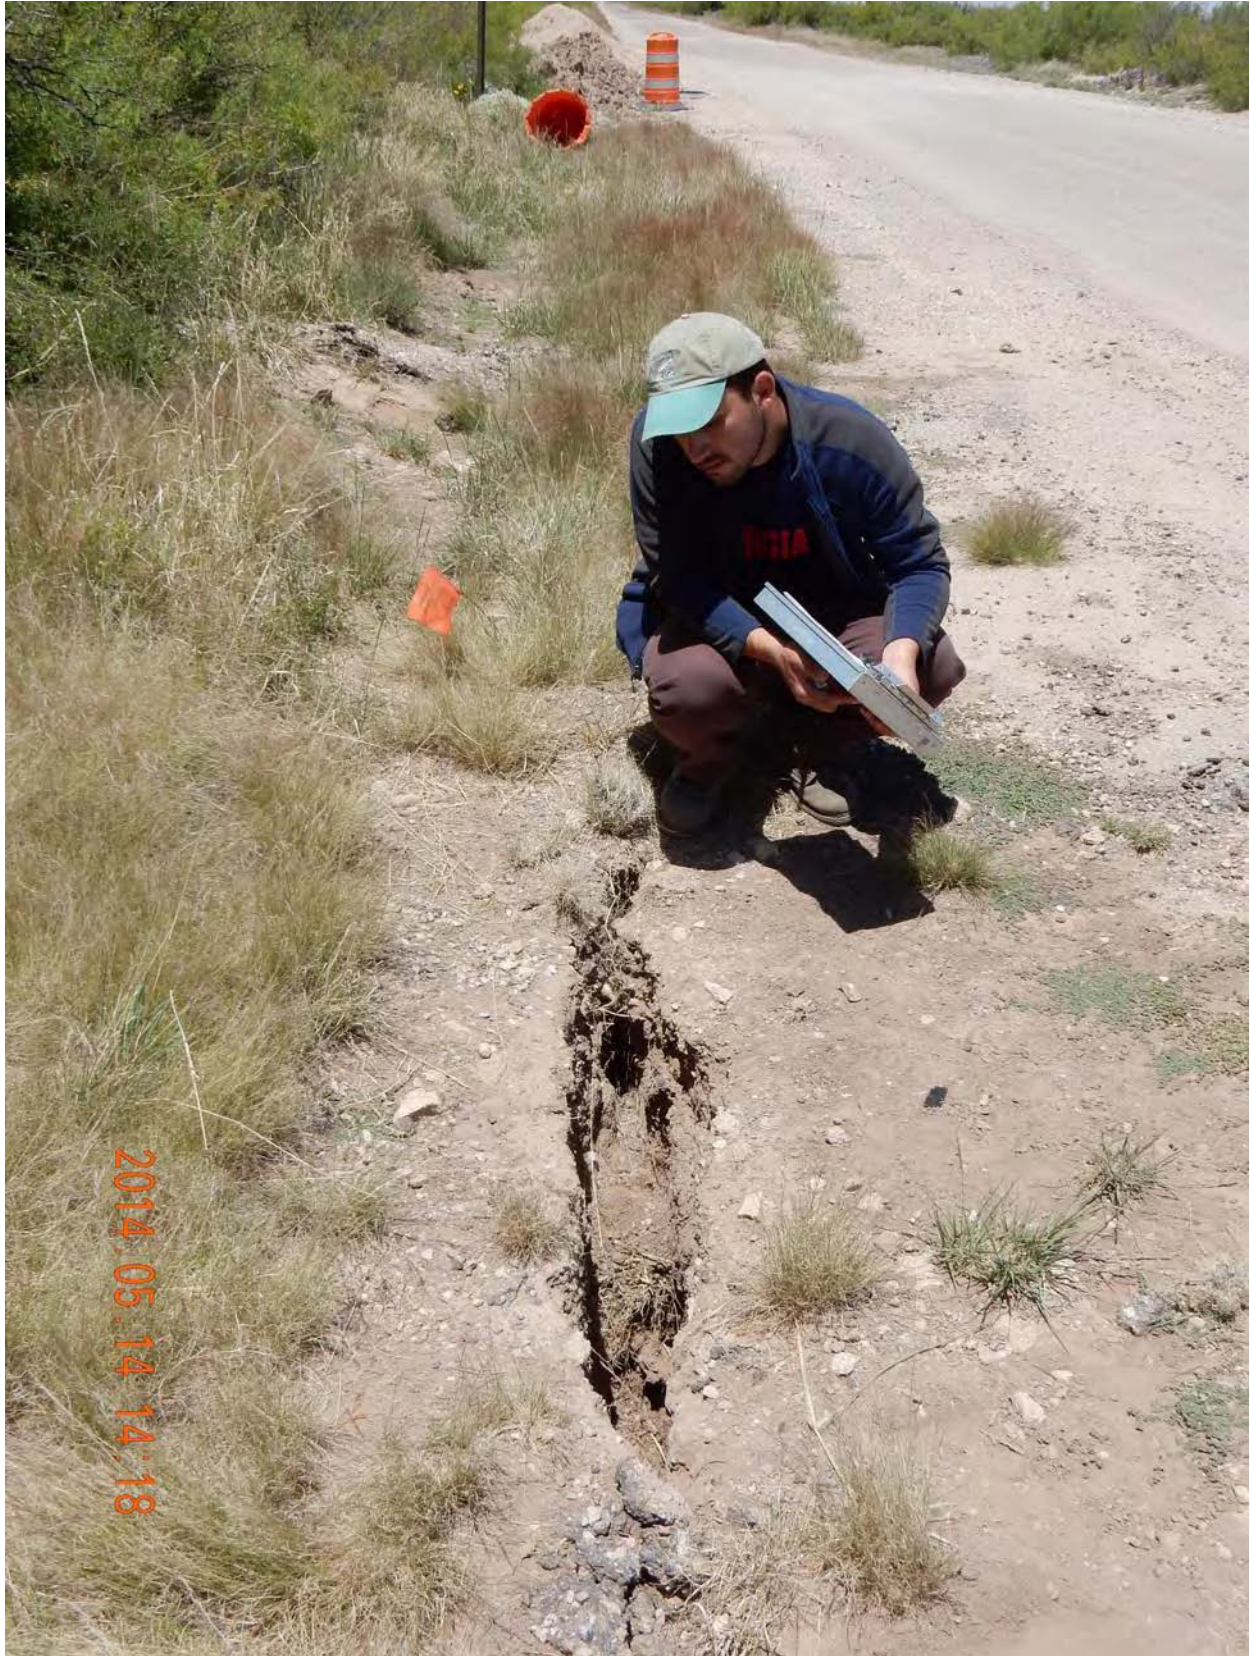
Figure A-17. Soil fracture, west side of Lake Road. Length 2.0 m, width 0.19 m, depth 1.8 m, azimuth 172°. 559137, 3610990, 4 m.

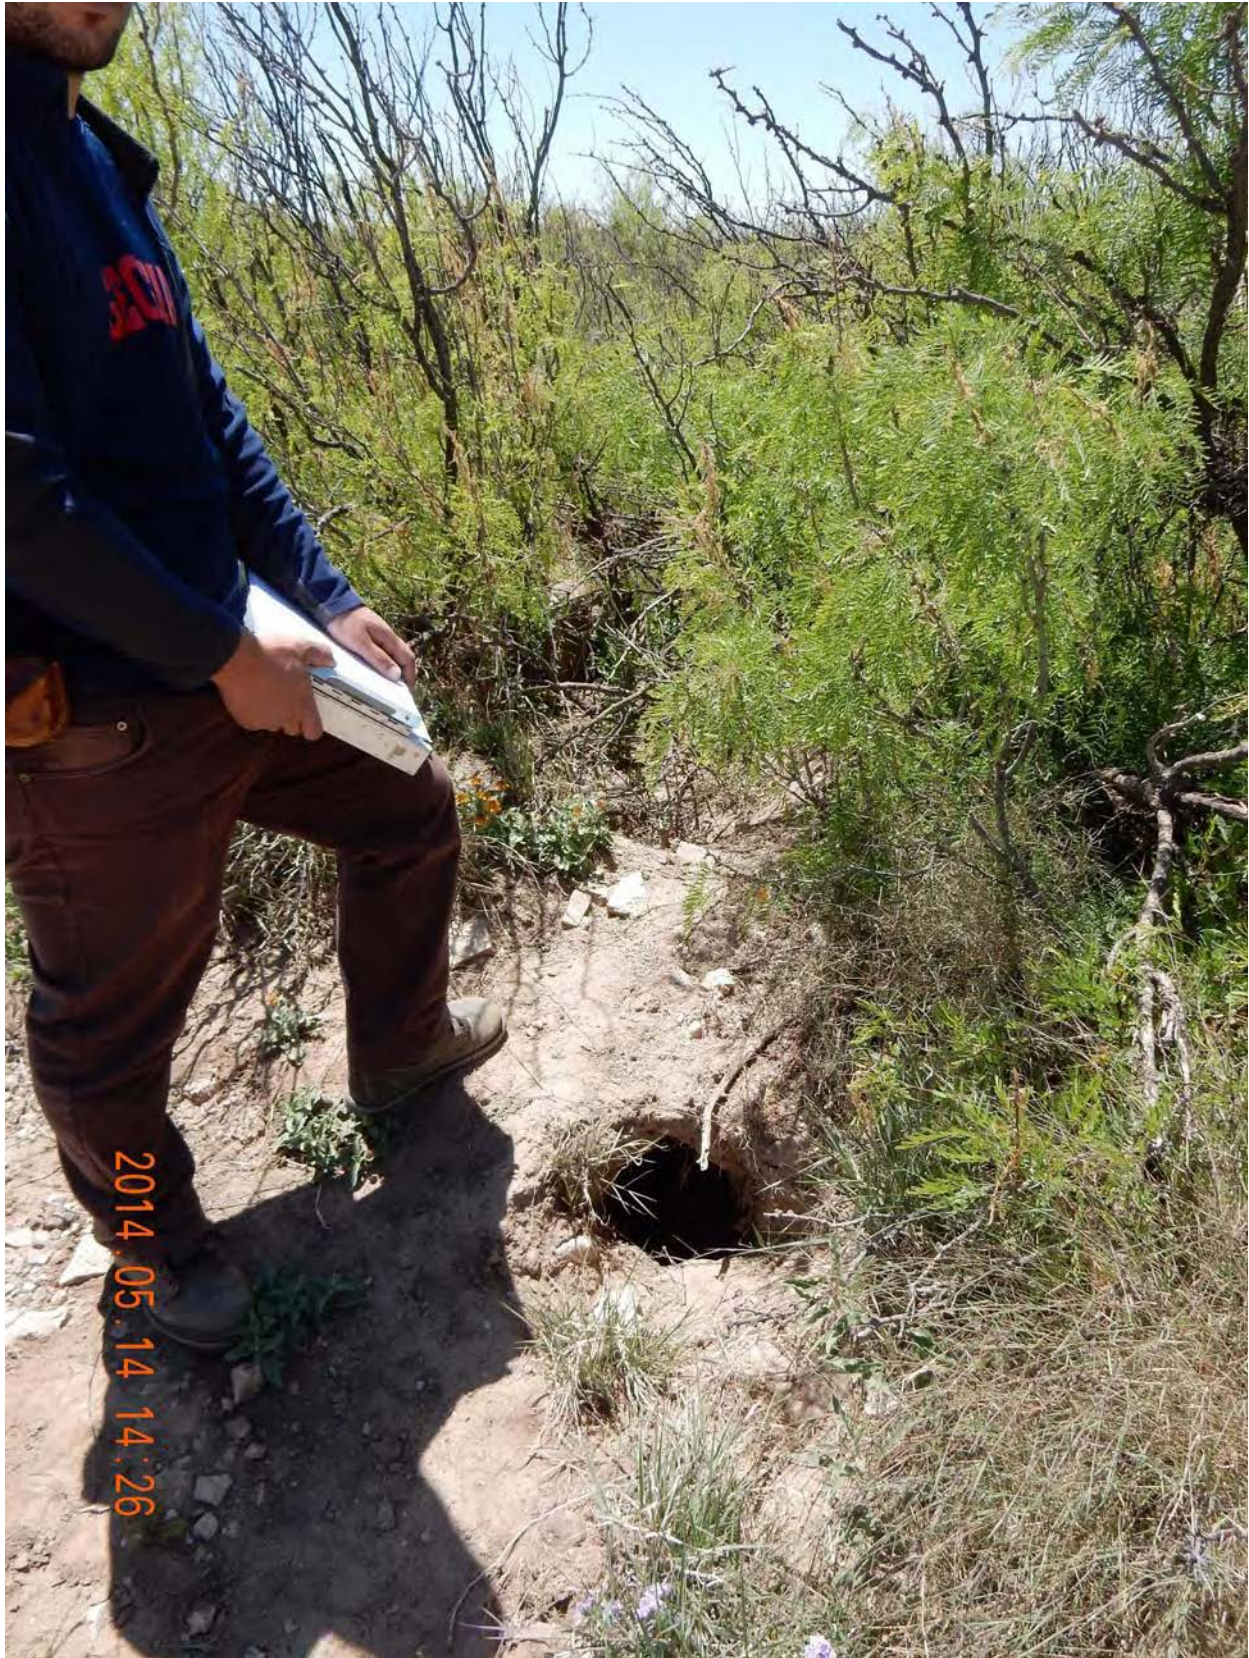
*Figure A-18. Poorly exposed, irregular and discontinuous soil fracture extending into mesquite. Length >20 m, width ~0.5 m, depth ~0.5 m. 559133, 3611008, 4 m.*

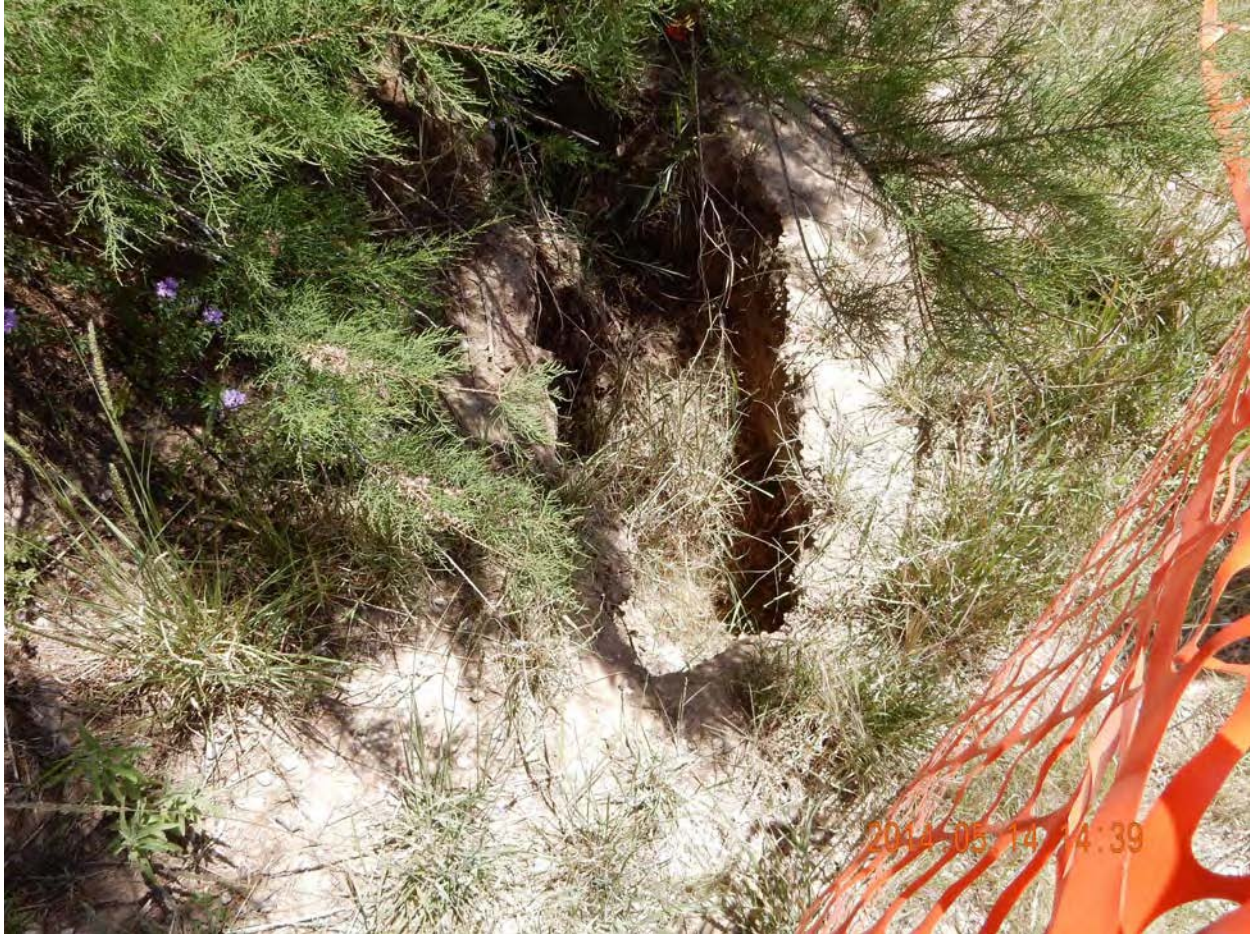
*Figure A-19. Soil fracture, west side of Lake Road. Pavement damage indicates that fracture extends beneath road to opposite shoulder, where a poorly exposed fracture with the same orientation extends into mesquite. Length ~15 m (assuming fracture extends beneath road), width ~0.5 m, maximum depth 1 m, azimuth 112°. 559135, 3611177, 3 m.*
