## NCKRI REPORT OF INVESTIGATION 6

# GEOPHYSICAL INVESTIGATION OF FLOOD-INDUCED SINKHOLE COLLAPSES, LAKEWOOD REGION, EDDY COUNTY, NEW MEXICO

Lewis Land  
Lasha Asanidze

June 2014

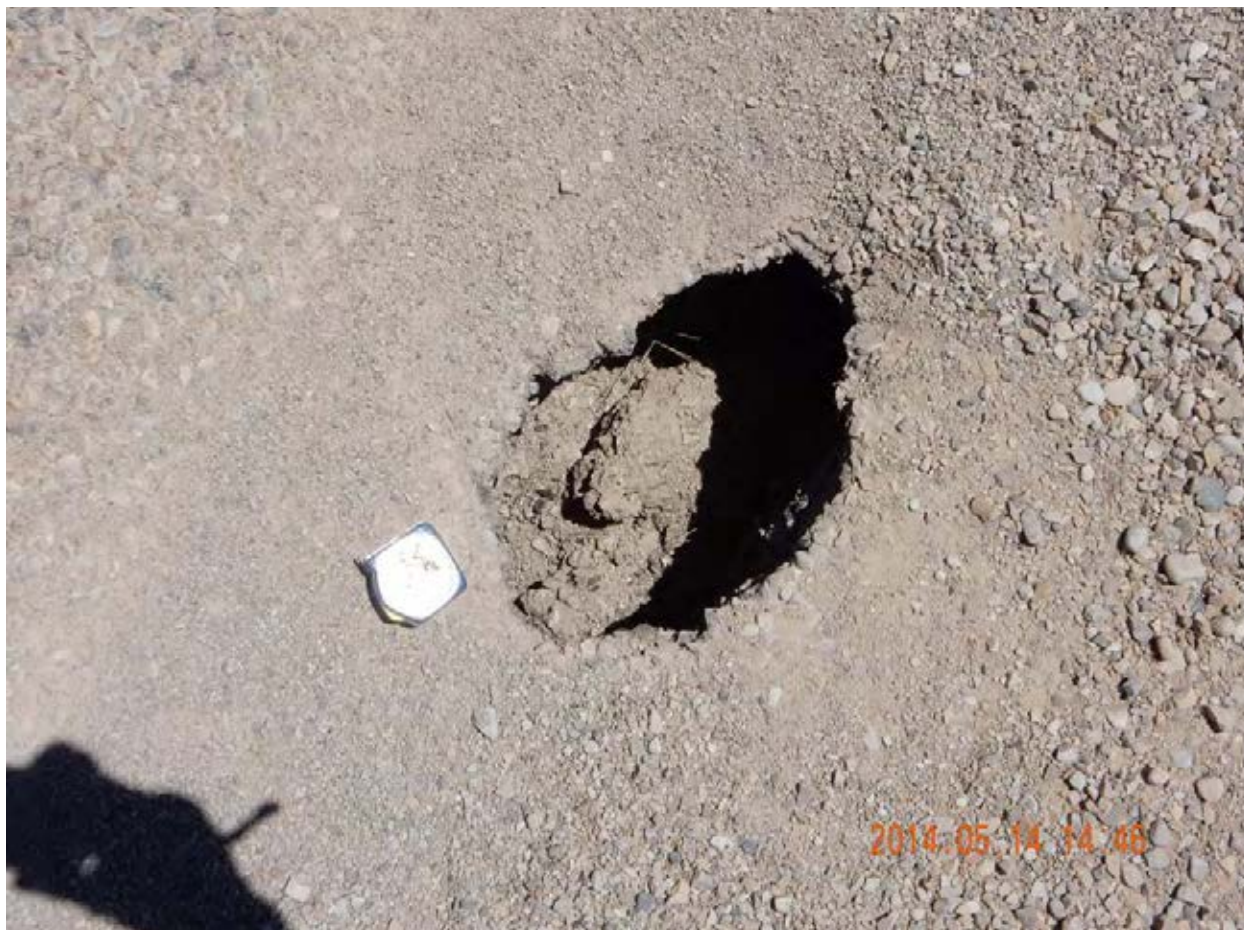
*Figure A-20. Sinkhole in asphalt, west shoulder of Lake Road. Length 0.33 m, width 0.2 m, depth 0.3 m. This sinkhole aligns with asphalt patches in road that are probably filled sinkholes, and another sinkhole on the opposite shoulder. Orientation of these features is azimuth 27°. 559134, 3611322, 3 m.*

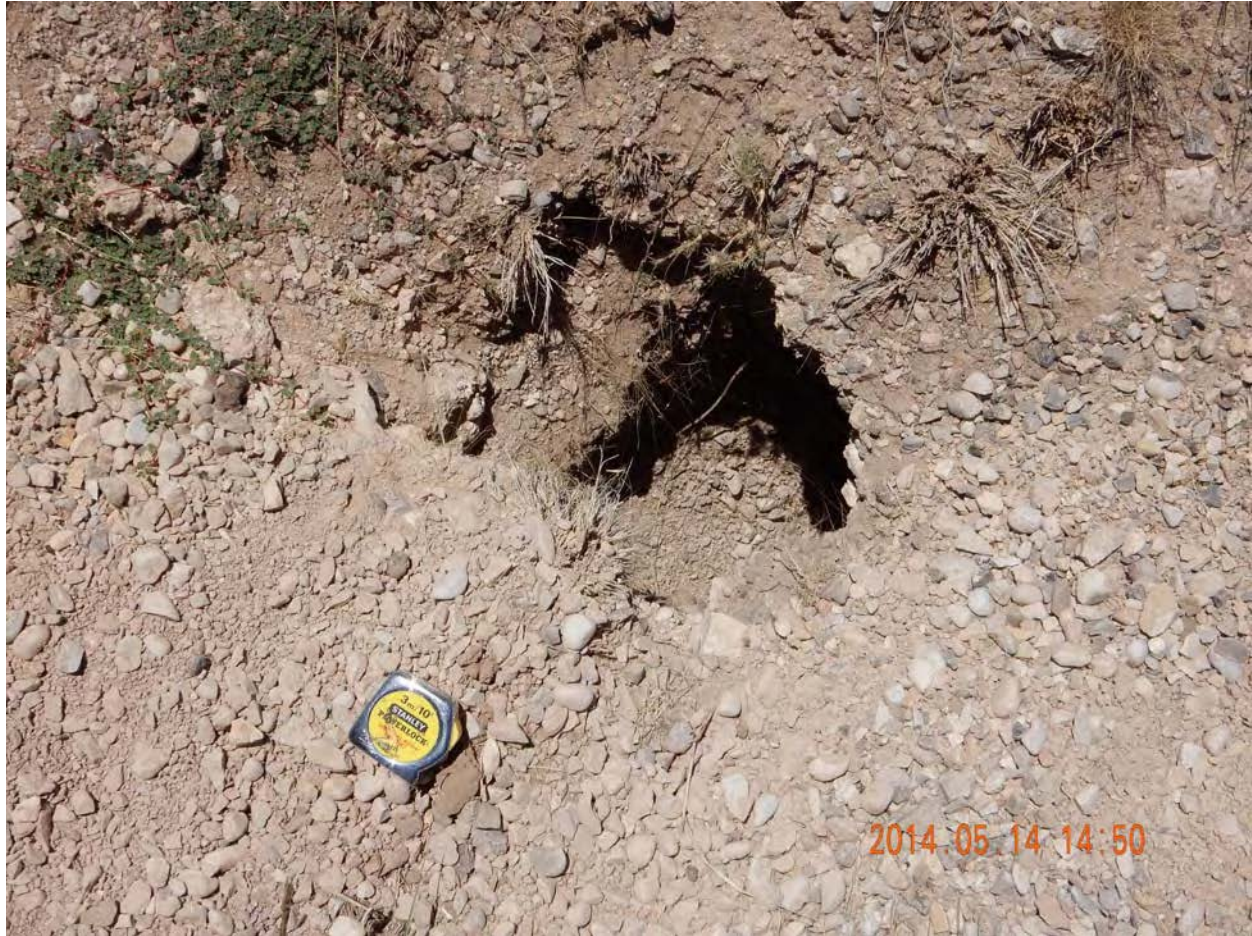
*Figure A-21. Sinkhole, east side of Lake Road. Length 0.3 m, width 0.23 m, depth 0.43 m. This sinkhole aligns with asphalt patches in road that are most likely filled sinkholes, and another sinkhole on the opposite shoulder. Orientation of these features is azimuth 27°. 559144, 3611341, 3 m.*

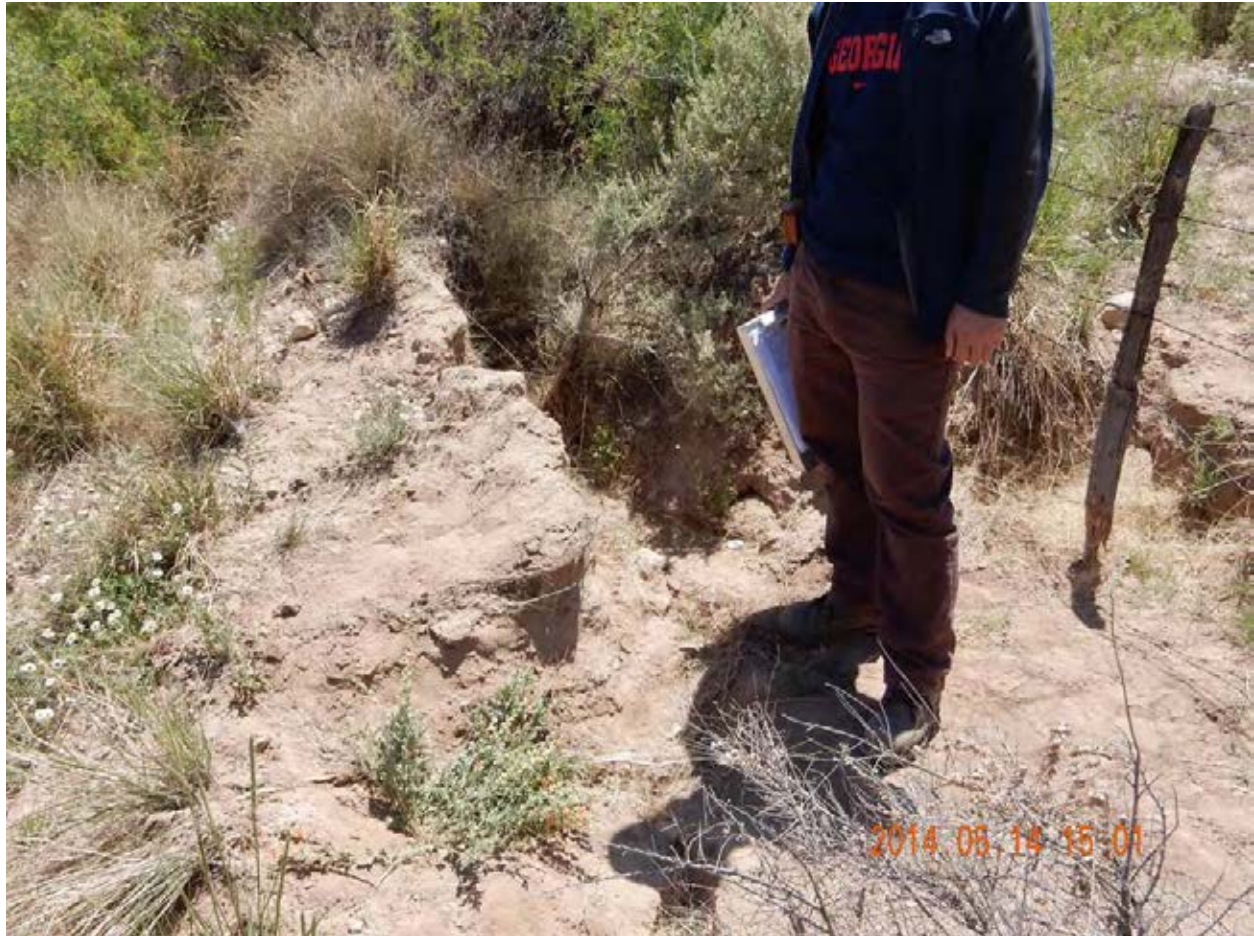
*Figure A-22. Soil fracture extending into dense stand of mesquite, west side of Lake Road. Length ~3 – 4 m, width 0.66 m, depth 0.4 m, azimuth 22°. 559132, 3611532, 3 m.*
