First Year Morphological Evolution of an Artificial Berm at Fort Myers Beach, Florida

by Katherine E. Brutsche and Ping Wang

PURPOSE: This Coastal and Hydraulics Engineering Technical Note (CHETN) documents the sediment characteristics and first year morphological evolution of an artificial berm placed just offshore in Fort Myers Beach, Florida, based on a series of field data collection periods during the first year after the berm construction.

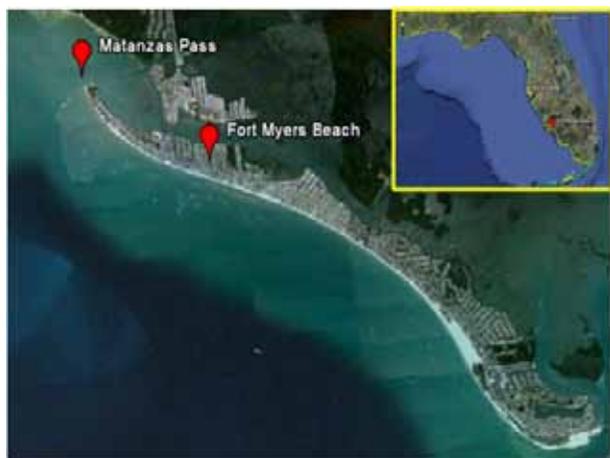
Figure 1. Fort Myers Beach and Matanzas Pass at the north end of Estero Island, Florida.

Matanzas Pass (Figure 1), located along Fort Myers Beach at the northern tip of Estero Island in west-central Florida, is a federally maintained navigation channel. The inlet has been dredged in 1986, 1996, and 2001, with the dredged sand placed along the adjacent beaches, as well as in the nearshore zone. Since the dredging in 2001, the channel had shoaled to the extent of blocking the entire channel, which prompted a new dredging cycle in 2009 (Florida Department of Environmental Protection, 2009). A hydraulic dredge was used and the material was placed in the form of a nearshore berm, 1.5 miles southeast of the dredging area (Figure 2). This report documents the sediment characteristics of the berm and examines the first year morphologic evolution.

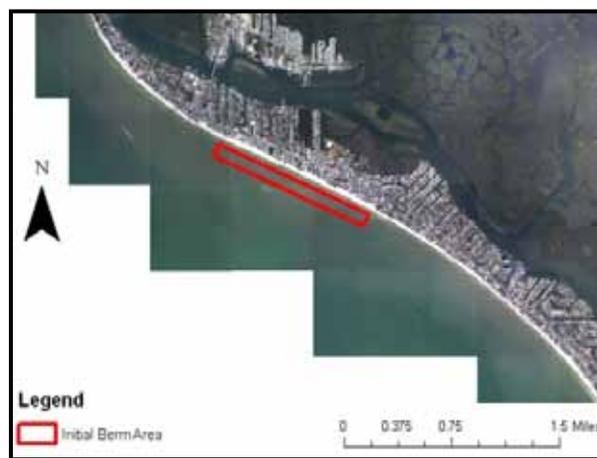
Figure 2. Designed berm placement location.

BERM CONSTRUCTION: The 2009 Fort Myers Beach berm was constructed using material dredged from Matanzas Pass. An 18” suction cutter dredge was used and the material was placed roughly 600 ft offshore in 6 ft water depth. Considerable longshore variation of the berm height occurred during the construction. The dredging took place in 3 stages. In Stage 1, the shoaled upland material at the northeastern tip of Estero Island, located within the previous navigation channel, was dredged. The Stages 2 and 3 dredging included the shoaled channel offshore and along the bay side of the island, respectively. Fill began in the northern portion of the project area during Stage 1 and moved south. Several gaps of less than 50 ft wide were left during the construction.

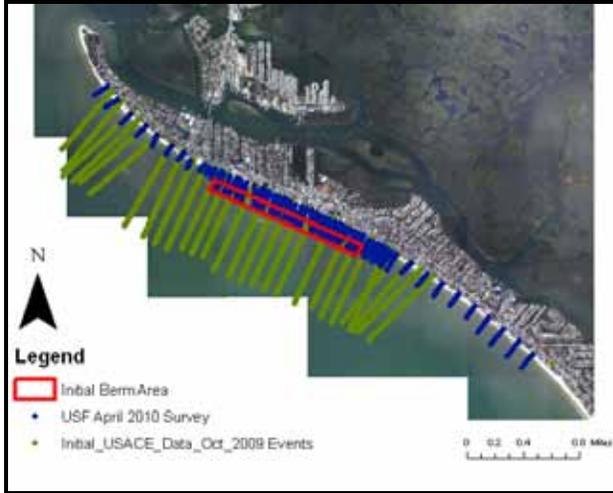
Figure 3. USACE (including offshore survey) and USF survey line locations.

METHODOLOGY: This study is based on sediment and morphology data collected in the first year. An initial post-construction survey was conducted by the Jacksonville District (USACE) in October 2009. Since April 2010, an intensive field data collection method was conducted by the Coastal Research Lab at the University of South Florida (USF). The USF study area includes the artificial berm area and control areas 1 mile northwest and southeast of the berm, respectively (Figure 3). Beach profiles in the control areas were set at roughly 600 ft intervals, while lines over the artificial berm were set at about 150 ft intervals. The 57 beach profiles, extending to roughly 8 ft water depth, were surveyed using an electronic total station following standard level-transect procedures. Two time-series surveys were conducted in April 2010 and October 2010. Surface sediment samples were collected along 11 of the 57 beach profiles, including 5 across the artificial berm and 6 in the control areas (Figure 4).

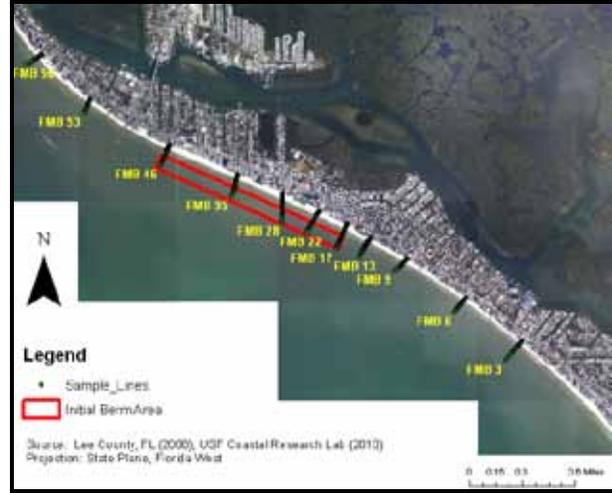
Figure 4. Locations of the sediment-sampling transects.

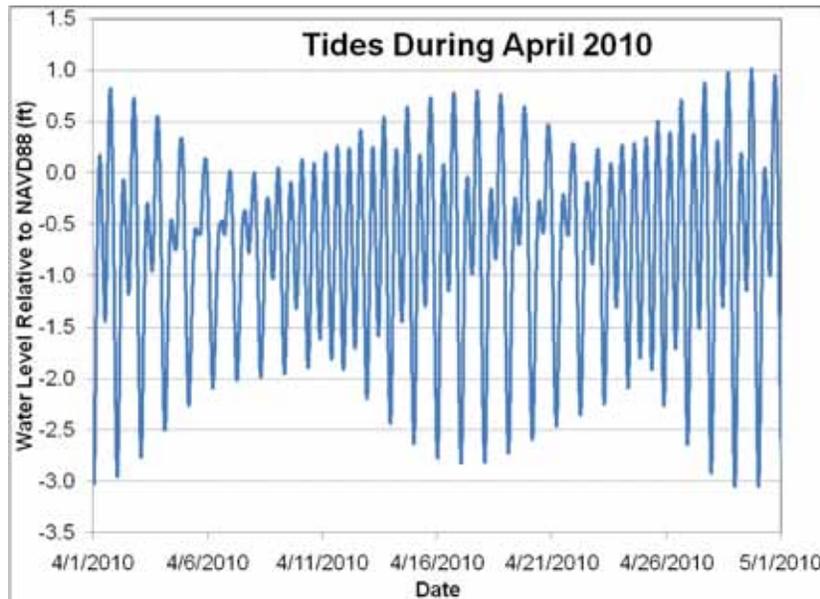
Figure 5. Measured tides during April 2010 at the NOAA Naples Station, approximately 20 miles south of the study area.

GENERAL OCEANOGRAPHIC AND METEOROLOGICAL CONDITIONS: The study area is influenced by a mixed tide regime. Spring tides tend to be diurnal with a range of nearly 4 ft, while neap tides are semi-diurnal ranging about 2 to 2.5 ft (Figure 5). Waves in the study area are mostly generated by local winds, except during rare extreme events such as tropical storms. Table 1 summarizes the post construction wind conditions from October 2009 to October 2010, including only onshore-directed winds. Onshore wind, averaging slightly less than 13 ft/sec (9 mph), occurs 32 percent of the time. The relatively stronger winds approach from southeast (130-175 degrees) and northwest (266-310 degrees). These winds are highly oblique relative to the shoreline orientation (130-310 strike). The overall intensities and occurrences of

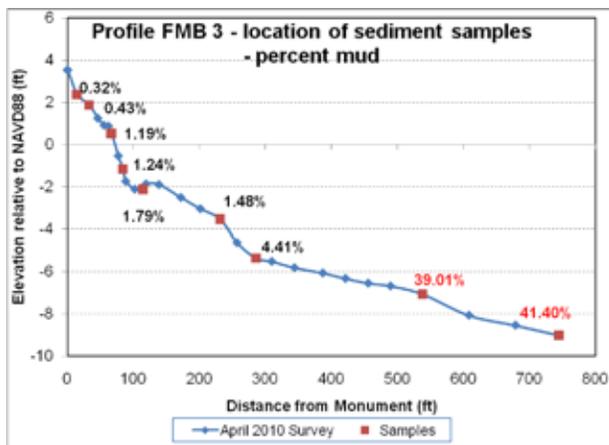
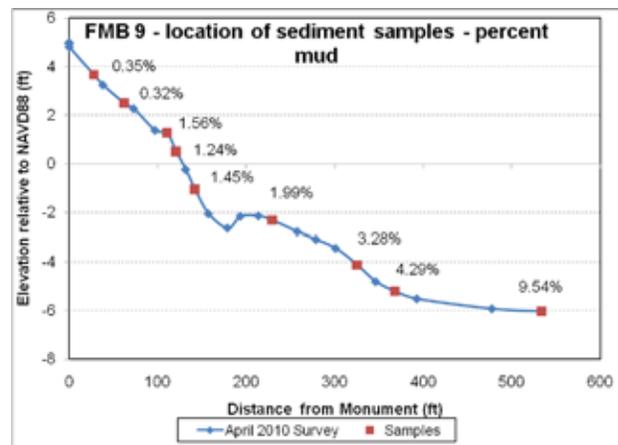
Figure 6. Beach profile of FMB3 (control), locations of surface sediment samples, and the percent of mud.

Figure 7. Beach profile of FMB9 (control), locations of surface sediment samples, and the percent of mud.

SEDIMENT CHARACTERISTICS: Typically, nine sediment samples were collected along transects in the control areas (Figures 6, 7, 10, and 11) and 11 samples along the profiles in the project area (Figures 8 and 9). Since the mud content is a key sediment quality parameter for this project, the following discussion focuses on the longshore and cross-shore variations of mud contents. Figures 6 and 7 show the percent of mud contents along representative profiles in the control area southwest of the artificial berm. Little mud, mostly less than one percent, was found on the dry beach. Some mud, mostly less than four percent, was found between mean sea level and about 4 ft water depth. Significant mud content of up to 40 percent was found in surface sediments seaward of the 4 ft contour.

Less than two percent mud was found on the beach above mean sea level in the artificial berm area (Figures 8 and 9). Typically, less than three percent mud was found in the surface sediment on the berm. The highest mud content was found in the trough between the berm and the shoreline, ranging from one to four percent. A localized patch of muddy sediment was found in the trough of profile FMB22, with mud content of up to 41 percent. Compared to the control area to the southeast, the surface sediment in the offshore area is much less muddy, with less than four percent mud versus up to 40 percent mud. The surface sediment in the control area to the northwest of the artificial berm contains little mud, typically less than two percent, across the entire profile (Figures 10 and 11).

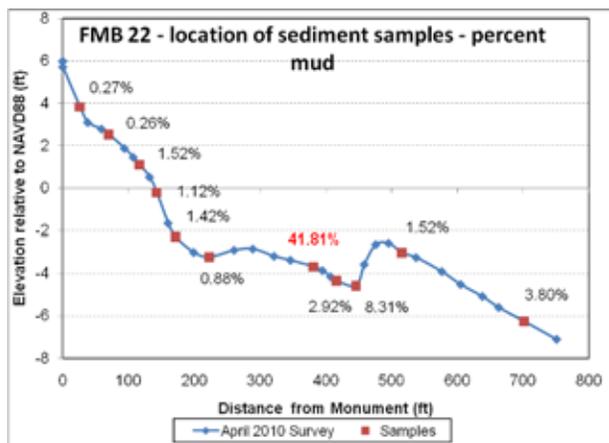
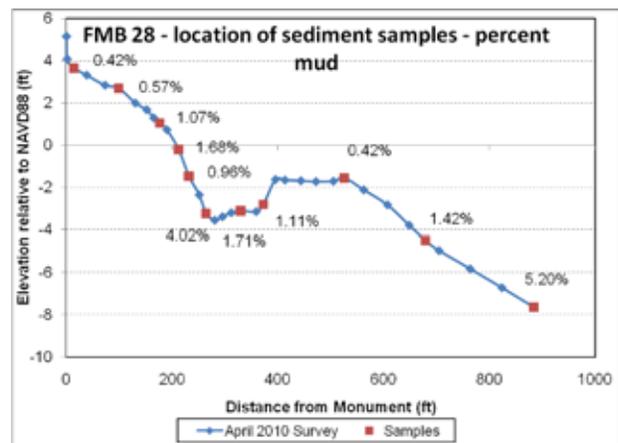
Figure 8. Beach profile of FMB22 (berm), locations of surface sediment samples, and the percent of mud.

Figure 9. Beach profile of FMB28 (berm), locations of surface sediment samples, and the percent of mud.

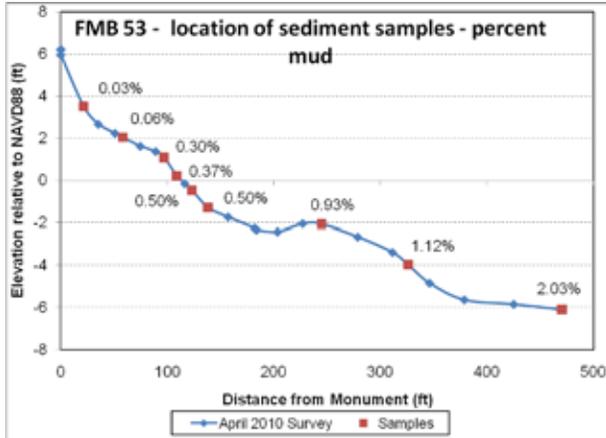
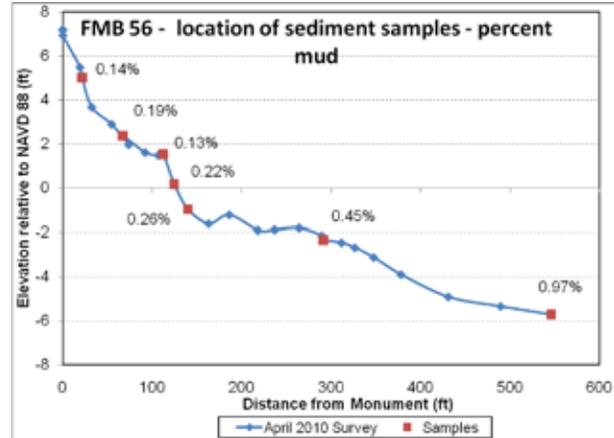
Figure 10. Beach profile of FMB53 (control), locations of surface sediment samples, and the percent of mud.

Figure 11. Beach profile of FMB56 (control), locations of surface sediment samples, and the percent of mud.

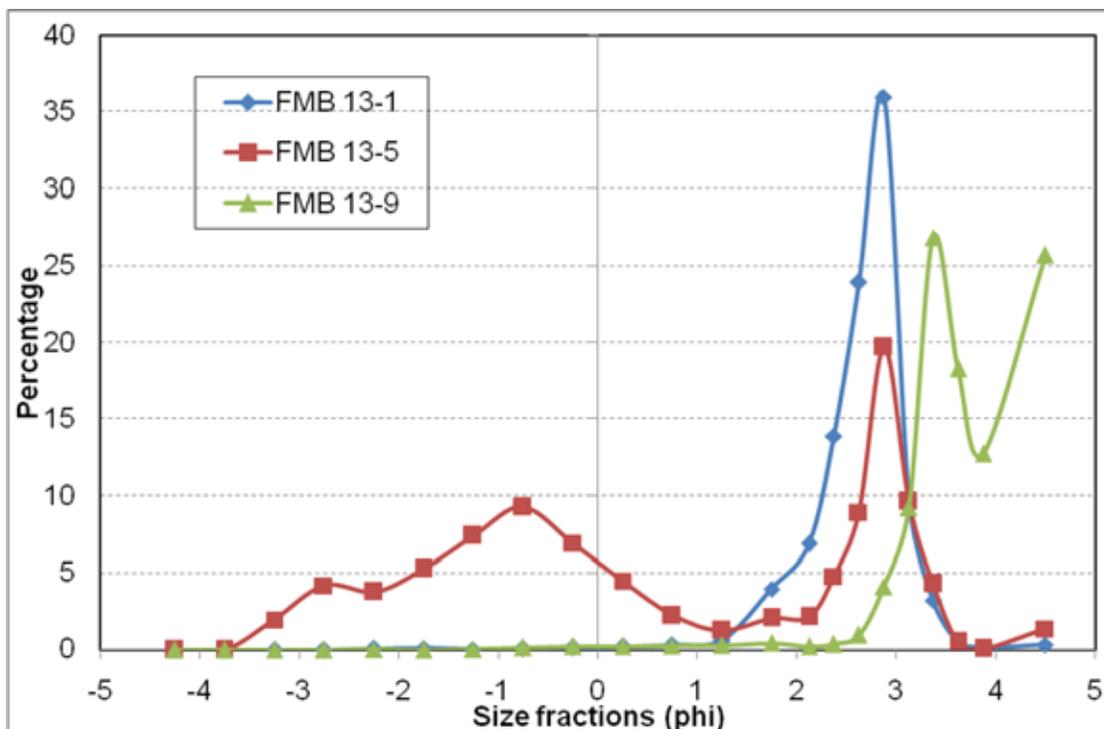
Figure 12. Typical grain-size distribution of the surface sediment. FMB13-1 is an example of well-sorted fine sand. FMB13-5 illustrates poorly-sorted shelly sand. FMB 13-9 shows poorly-sorted muddy sand.

Generally, three types of sediment grain-size distribution patterns are distinguished in the surface sediments (Figure 12). Well-sorted fine sand is the dominant type of surface sediment on the dry beach, in the intertidal zone, and over the berm crest. Poorly-sorted shelly sand is found often in the swash zone. Poorly-sorted muddy sand is found on the surface of the offshore area southeast of the berm. Patches of muddy sand are found in the trough between the berm and shoreline.

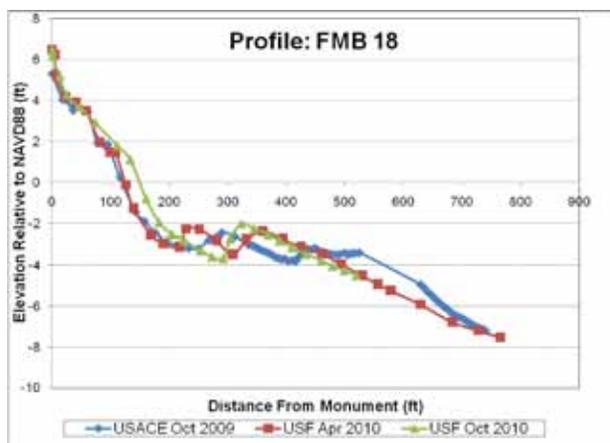
Figure 13. Time series beach profile at FMB 18

MORPHOLOGICAL EVOLUTION: The first-year morphologic evolution was examined by comparing the Jacksonville District (USACE) October 2009 post-construction survey with the USF April and October 2010 surveys. Figure 13 shows profile FMB18, located on the southeastern edge of the berm. The berm height at FMB18 is relatively low at about 2 ft and remains constant during the first year. The overall profile-volume stays rather constant, indicating that cross-shore sediment transport dominates in the first year. During the first 6 months, the overall morphology, i.e., the two bars, was maintained while the entire system migrated onshore for about 100 ft. The beach and nearshore area landward of the artificial berm remained stable over the initial 6-month period. The beach profile evolution during the second 6 months was different from the first 6 months, in that the small bar that was close to the shoreline migrated and attached to the shoreline, resulting in a modest beach accretion at this site (Figure 13).

Different from the case at the southeastern edge (FMB18), throughout most of the project area, the berm height measured from the bottom of the trough to the crest of the bar is approximately 3 ft (Figure 14). The lower berm height near the terminus of the project (Figure 13) is controlled likely

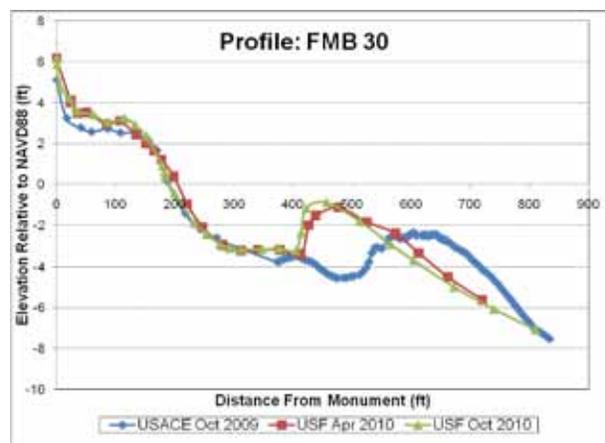
Figure 14. Time-series beach profile at FMB30.

by the construction. The constructed berm height was maintained during the first year. Within the central portion of the project area, most of the profiles over the berm illustrated an onshore migration of nearly 200 ft during the first 6 months (Figure 14). Profile FMB30 is located roughly in the middle of the artificial berm project area. In addition to onshore migration, the berm crest elevation has increased by approximately 1.5 ft at this location, while the berm height remained largely similar. The shape of the berm has changed from a roughly symmetrical bell curve to a sharply skewed bar with a steep landward slope. The total volume of the berm was roughly maintained as it migrated landward and upward, with erosion on the seaward slope and deposition

in the prior trough location. The landward migration continued during the second 6 months but at a much reduced rate, while maintaining the skewed shape of the berm (Figure 14). The beach and nearshore area landward of the artificial berm remained stable over the first year after the construction.

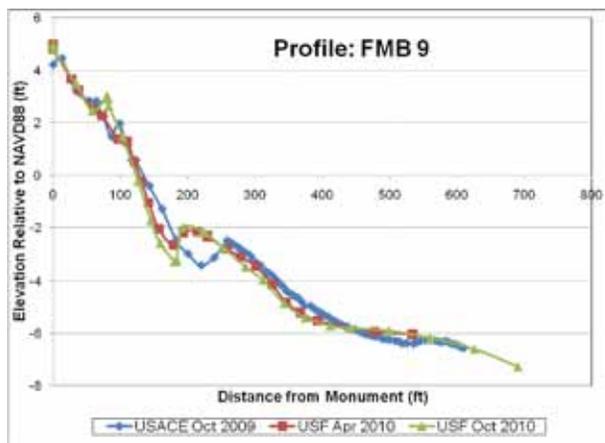
Figure 15. Time-series beach profile at FMB9.

A small nearshore bar less than 2-ft high exists along the beach profiles in the control area southeast of the artificial berm (Figure 15). The height and volume of this bar are much smaller than those of the artificial berm. The bar migrated approximately 60 ft onshore during the first 6 months. Different from the artificial berm case, the onshore migration of the bar resulted from modest erosion at both the seaward slope and in the nearshore zone, instead of just at the seaward slope for the artificial berm. The dry beach remained stable. Nearly no change occurred during the second 6-month period.

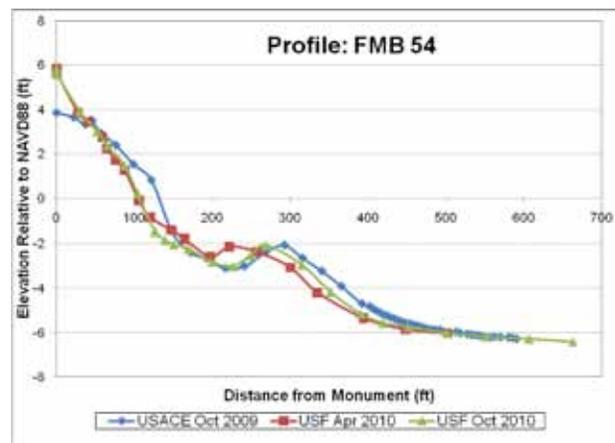
Figure 16. Time-series beach profile at FMB54.

Compared to the profiles discussed above, FMB 54, located to the northwest of the artificial berm, demonstrates a different trend of evolution (Figure 16). Except for a small amount of accumulation in the trough area, erosion occurred across nearly the entire profile during the first 6 months. This profile is rather close to the recently dredged Mantazas Pass and may be influenced by inlet processes. During the second 6 months, the small bar (less than 1 ft high) that was developed in the previous trough moved offshore to roughly the location of the prior bar, while the dry beach remained stable. Overall, the magnitude of the profile changes during the year is small.

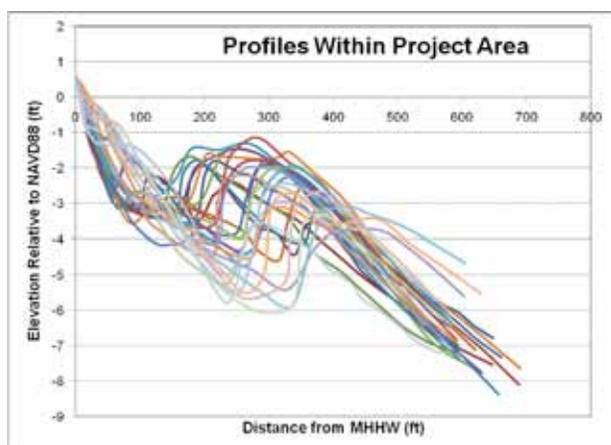
Figure 17. All 30 profiles across the artificial berm, referred to the MHHW line. Note the substantial longshore variation of the morphology.

Substantial longshore variation of the artificial berm was measured. Figure 17 shows all 30 profiles across the artificial berm referred to the mean high high water level (MHHW). Based on the NOS tide station at Naples, the MHHW is at 0.58 ft NAVD88 for the study area. As evident from the

plot of all the profiles referred to the MHHW line (Figure 17), longshore variations occur in every part of the profile, including from land to sea, the foreshore slope, the location and depth of the trough, the location, height, and width of the berm, and the depth and slope of the seaward flank.

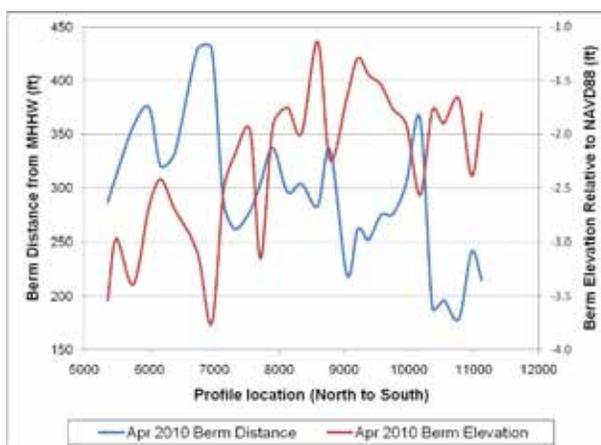
Figure 18. Longshore variation of the distance of the berm crest to MHHW line (berm distance) and the berm crest elevation. Profile location is referred to the distance to the northeastern most profile.

A relationship is identified between the distance of the berm crest to the location of the MHHW and the elevation of the berm crest: a lower berm crest corresponds to a longer distance to the MHHW line, while an increasing berm elevation corresponds with a decreasing distance to the MHHW line (Figure 18). However, the relationship is qualitative and localized. Similar berm height does not correspond to similar distance to MHHW line at a different longshore location. Figure 18 also illustrates that there are several locations where the berm crest elevation is relatively low. These gaps are not exactly spaced equally but are not completely irregular, and also tend to vary in elevation (or water depth). It is worth noting that some gaps were constructed during the berm placement.

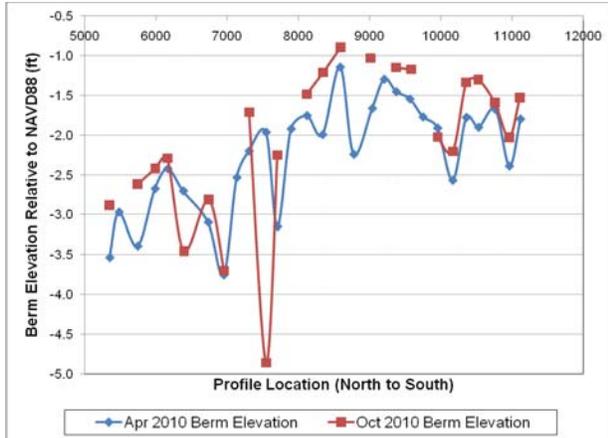
Figure 19. Longshore variations of berm crest elevation in April and October 2010. Profile location is referred to the distance to the northeastern most profile (FMB57).

Considerable changes in longshore variations of the berm crest elevation occurred between April and October 2010 (Figure 19). Overall, the berm crest elevations have increased, reflecting the general trend of onshore and upward migration. Several of the profiles were not surveyed in October 2010. Despite some missing data, it is apparent that the locations of some of the gaps have changed from April to October 2010 (Figure 19), indicating that the gaps are dynamic. They are likely maintained as rip channels during high-wave conditions. The movement of the gaps may be driven by the spatial variations of the rip cells. Future studies will verify the presence and dynamics of the rip cells. Given the generally low-wave conditions of the study area, significant rip cells should occur only under high wave-energy conditions.

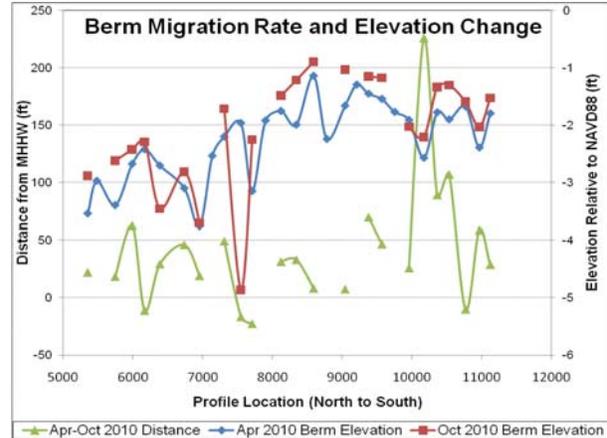
Figure 20. Longshore variations of berm crest elevation, and changes in distance from berm crest to MHHW line (green line). Profile location is referred to the distance to the northeastern most profile.

Overall, the artificial berm has moved onshore, mostly less than 50 ft, during the second 6 months, with considerable longshore variations (Figure 20, green line). Abnormal distance changes were measured in the vicinity of the gaps due to the longshore movement of the gaps. The above spatial analysis was not conducted for the immediate post-construction survey due to a lower spatial resolution.
