CAVE BREAKDOWN BY VADOSE WEATHERING

R.A.L. Osborne

ABSTRACT

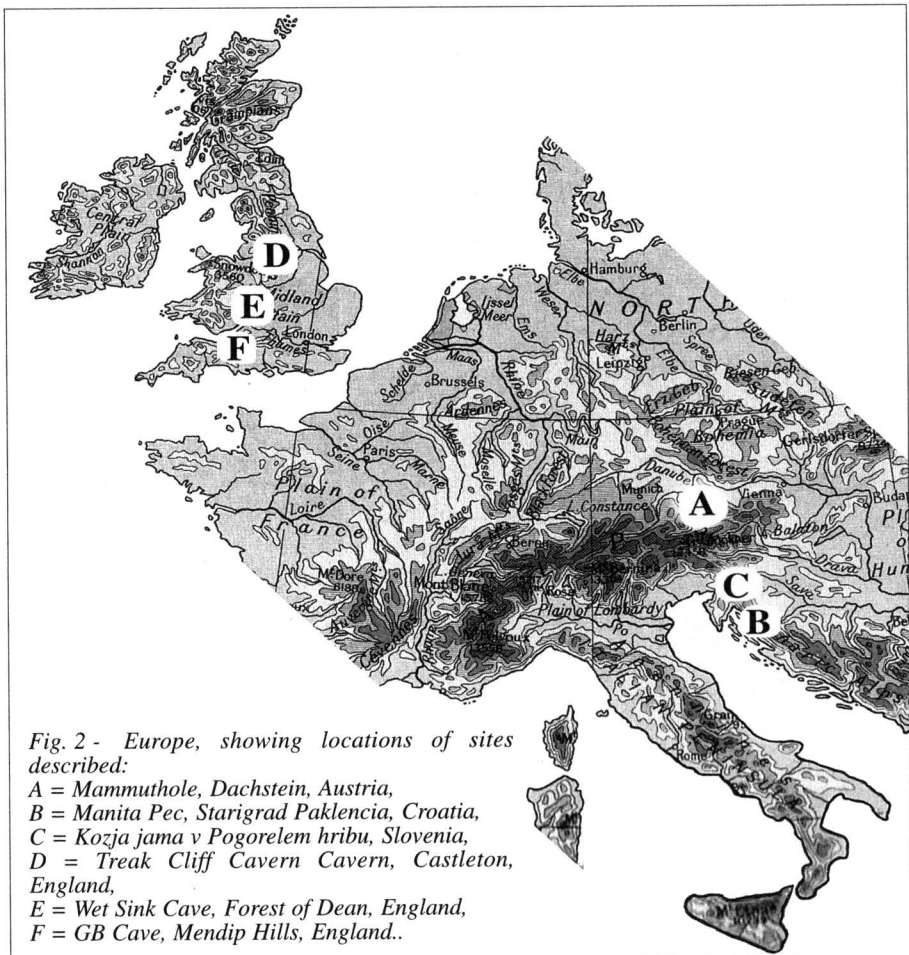
In Treak Cliff Cavern, Castleton, England (Fig.2D), heaving of bedrock can be observed at the wall-floor junction. At Jenolan Caves, N.S.W. Australia (Fig.1), gyp-

sum wedging is resulting in active failure by exfoliation of thin scales of limestone around the walls and ceiling surfaces of a circular-section passage with a diameter of about 1.5m.

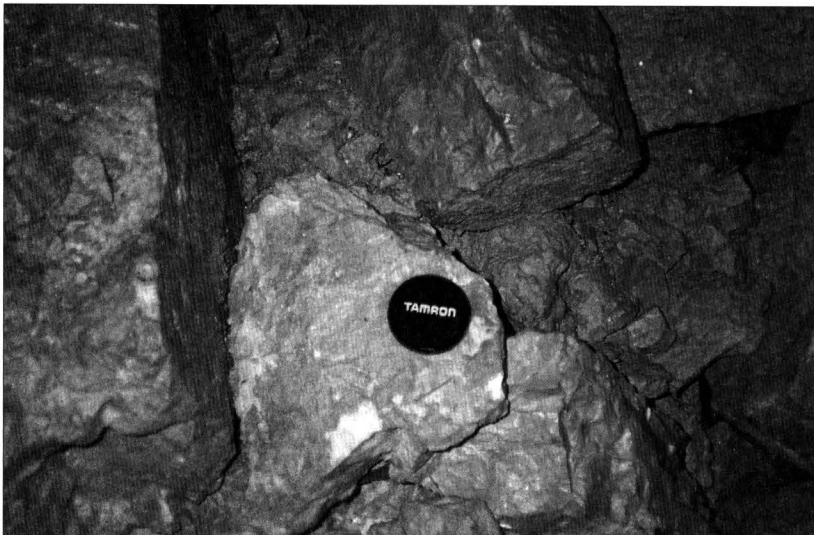
Fig. 4 - Limestone blocks in breakdown pile, Kozja jama v Pogorelem hribu. Note "weathered" surface of blocks. Blocks show continuing post-fall disintegration. Lens cap 55mm.

At many of the localities examined (e.g. Kozja jama v Pogorelem hribu), fallen blocks in breakdown piles were found to be in the process of disintegration. This disintegration was clearly taking place after the rocks had fallen (Fig.4). This continuation of fragmentation, principally due to crystal wedging, plays an important role in the removal of breakdown material from cave voids.

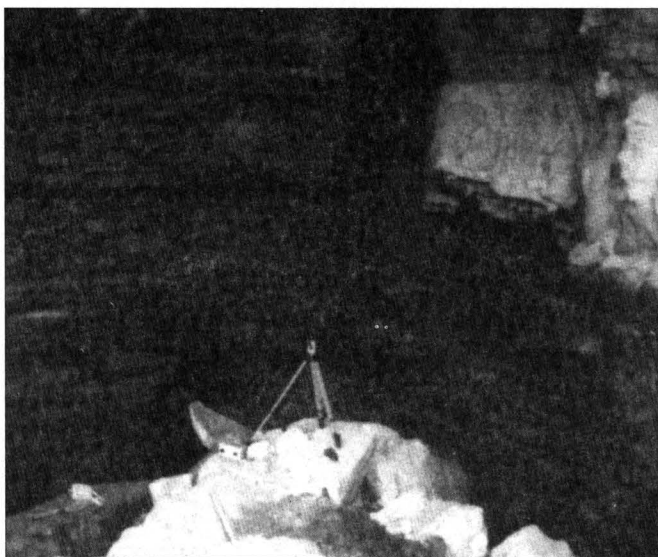
Fig. 8 - St Michael's Cave, looking west. The dyke is the vertical dark band in the background just right of centre. The tripod is on top of a fresh breakdown cone produced by major ceiling failure along the dyke in 1980. Blocks in the pile are sandstone, the clastic dyke material weathers to form black silty sand. Note failure along horizontal bedding planes in the upper right of the image.

This process can be seen in St Michael's Cave, a sandstone sea cave at Newport, N.S.W. Australia (Fig.1). The cave is an elongate chamber developed along a pyroclastic dyke that intrudes a sequence of sandstones and mudstones. The dyke now forms the keystone for the cave ceiling (Osborne and Branagan, 1992).

A significant breakdown event in 1980 raised concern about stability of the cave itself, and of houses constructed above it. The event appears to have been triggered by heavy rain and sullage seeping down the dyke, leading to its failure close to the cave ceiling (Fig.8). As a consequence, a significant quantity of sandstone and mudstone slabs detached from the cave ceiling along bedding planes (Fig.9).
