A Comparison of Ecological Conditions and Relationships in an Altered Wetland and an Unaltered Wetland

A thesis submitted in partial fulfillment
of the requirements for the degree of
Master of Science
Department of Geography, Environment, and Planning
College of Arts and Sciences
University of South Florida

Keywords: hydrology, vegetation, birds, swamp, marsh, Colt Creek

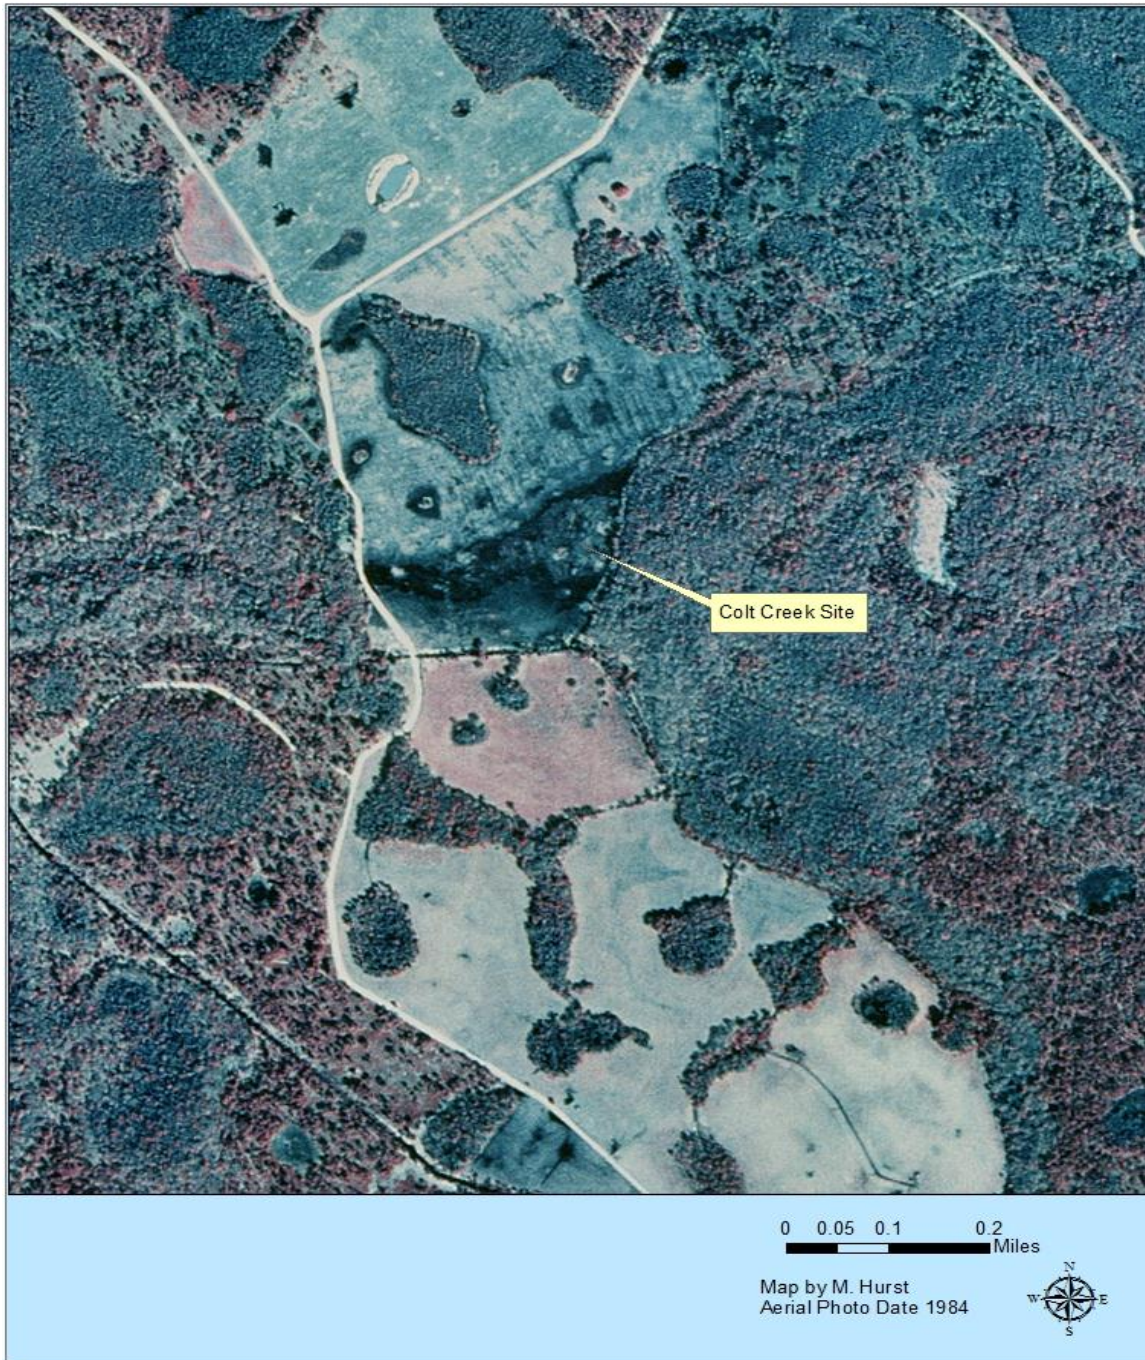
Figure 13. 1984 aerial photograph (false color infrared). The cleared Colt Creek swamp is evident in this photograph. The darker signature in the historic flow way between the bypass ditch and the roadway on the west side appears to be surface water. The configuration of the dark signature follows the lowest topographic elevation (87.0' NAVD) of the flow way.

In the 1984 aerial photograph, the section of the logged swamp between the bypass ditch and the road crossing appears to be completely cleared of all trees and the floodplain and adjacent uplands north and south of the swamp has been converted to improved pasture; the condition it is in currently (Figure 13.).

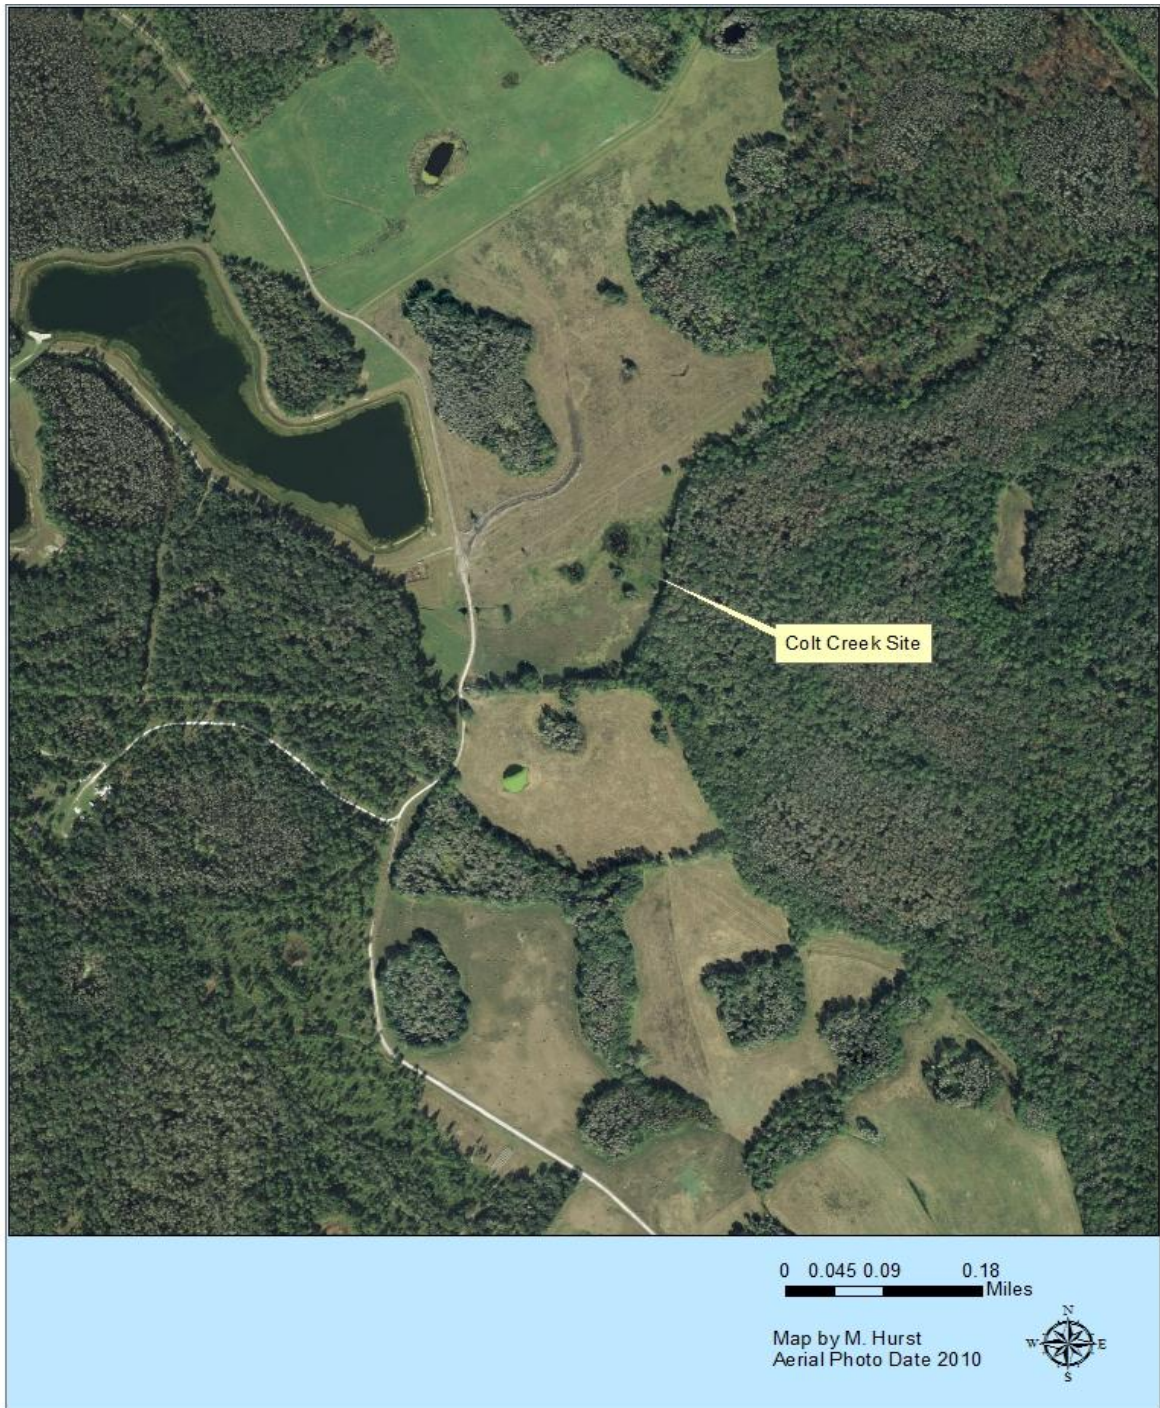
Figure 15. 2010 aerial photograph. Although now known as Colt Creek State Park, the restoration of the creek had not begun at this time and the site is little changed from 1984.

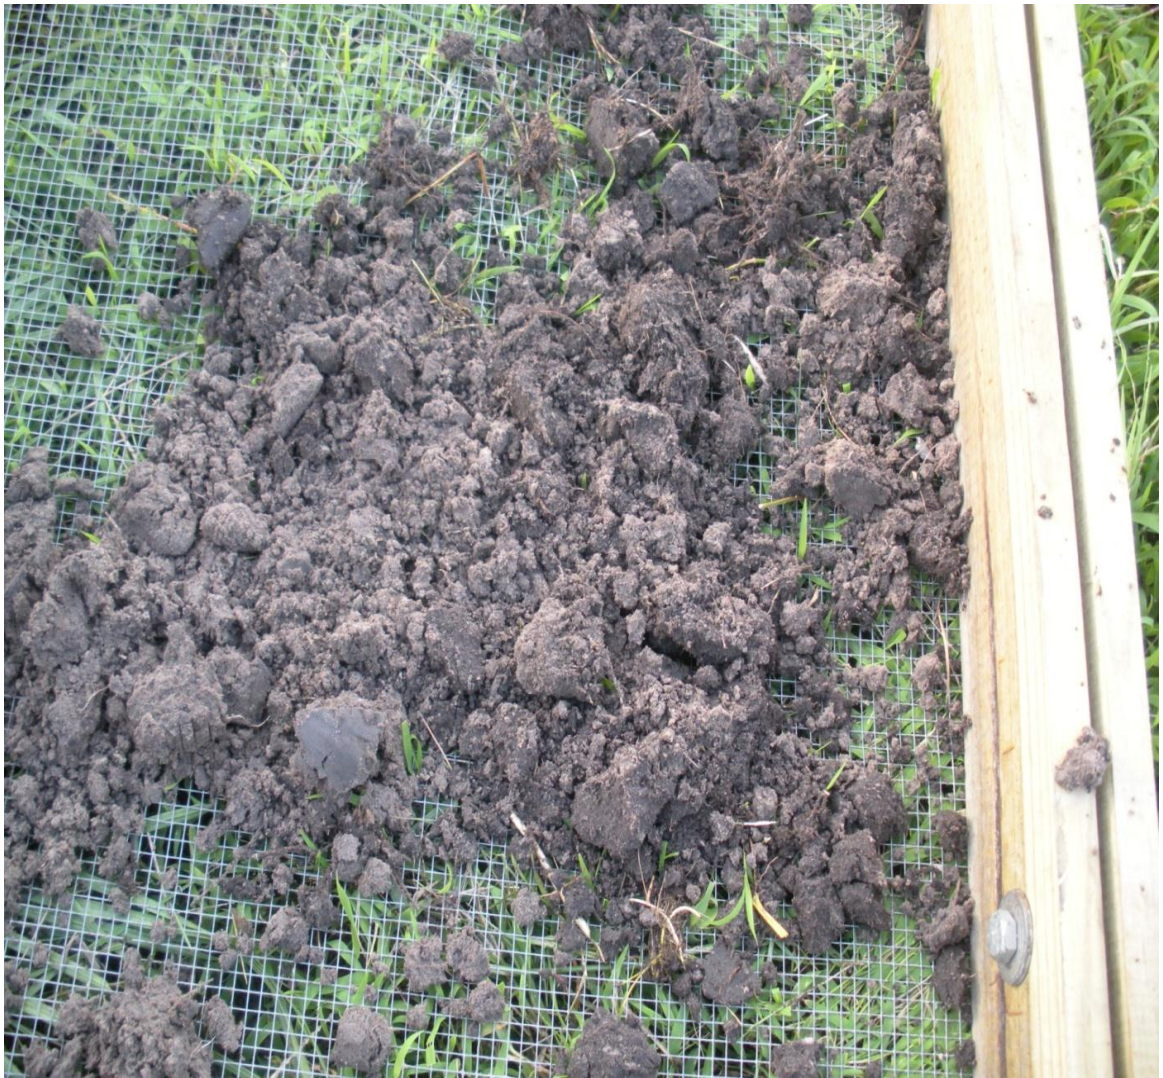
Figure 16. Topsoil in marsh.

During installation of the monitor well, a 2-inch diameter bucket auger was used to bore the hole. The topsoil, approximately six inches thick, was primarily sand, but also included some organics and a small amount of clay (Figure 16.).

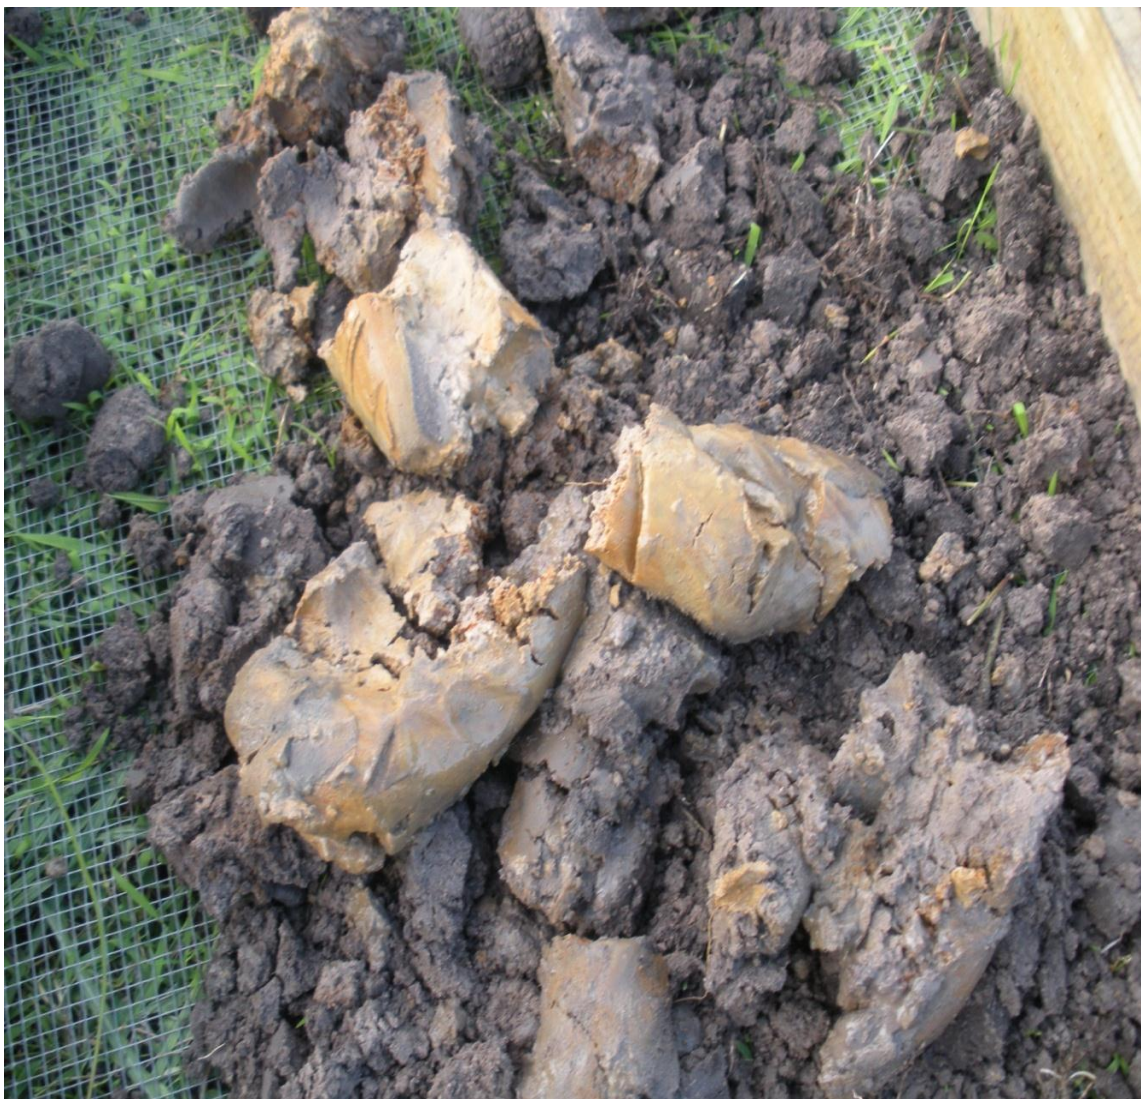
Figure 17. Subsurface clayey soil in marsh.

Immediately below the topsoil and continuing to the bottom of the boring at approximately five feet, the soil had some sand but was very clayey (Figures 17. and 18.)

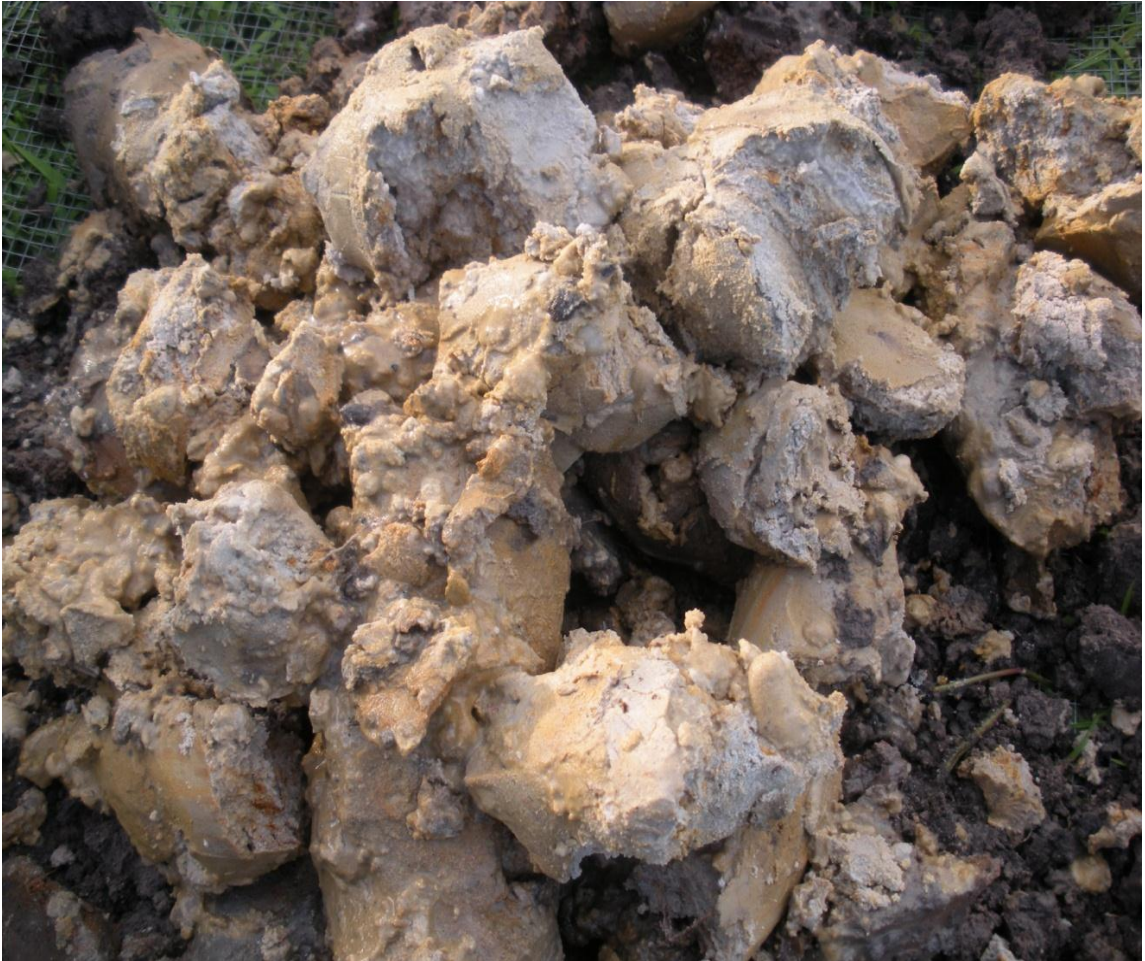
Figure18. Clayey soil 3 feet to 5 feet below ground surface in marsh.

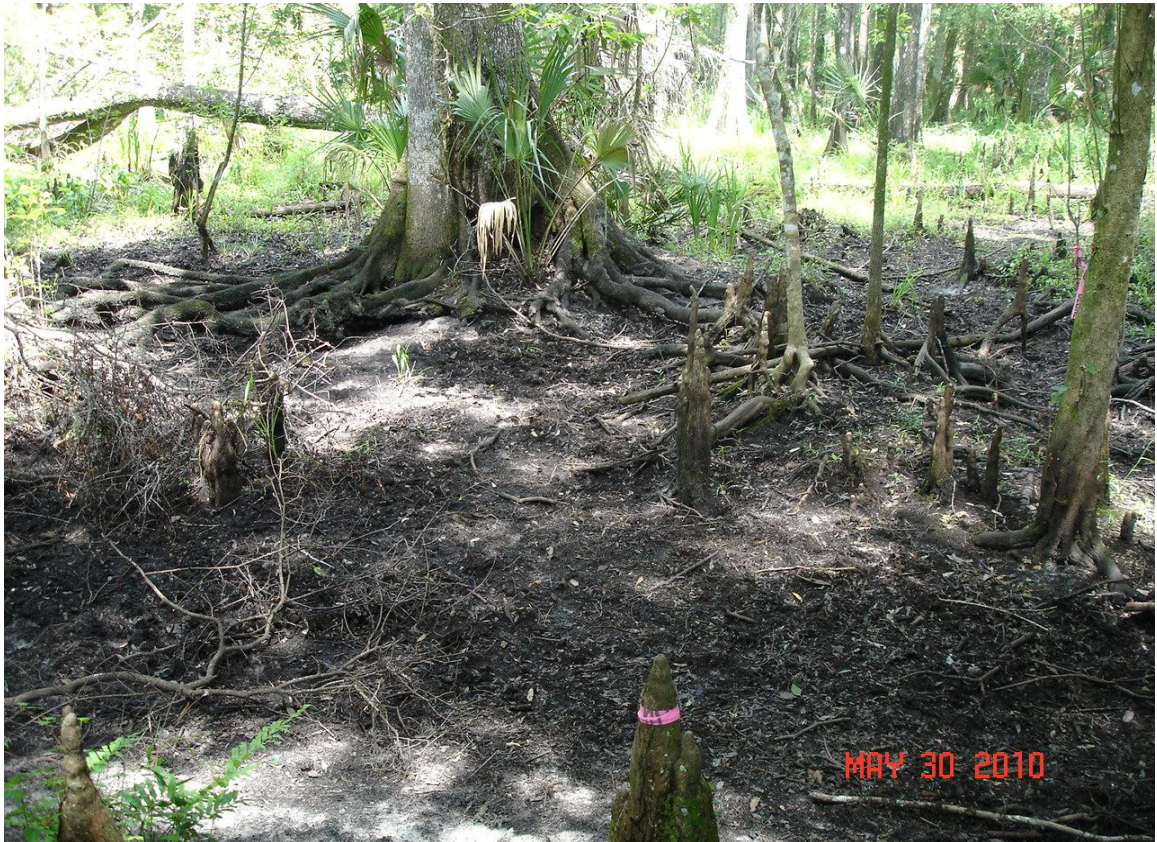
1. Looking upstream at the unaltered flow way of Colt Creek. The natural flow way joins the bypass ditch at the bottom of the photo. When flowing, the deepest, main channel flows from the upper left in this photo (under the fallen tree) and into the bypass ditch.

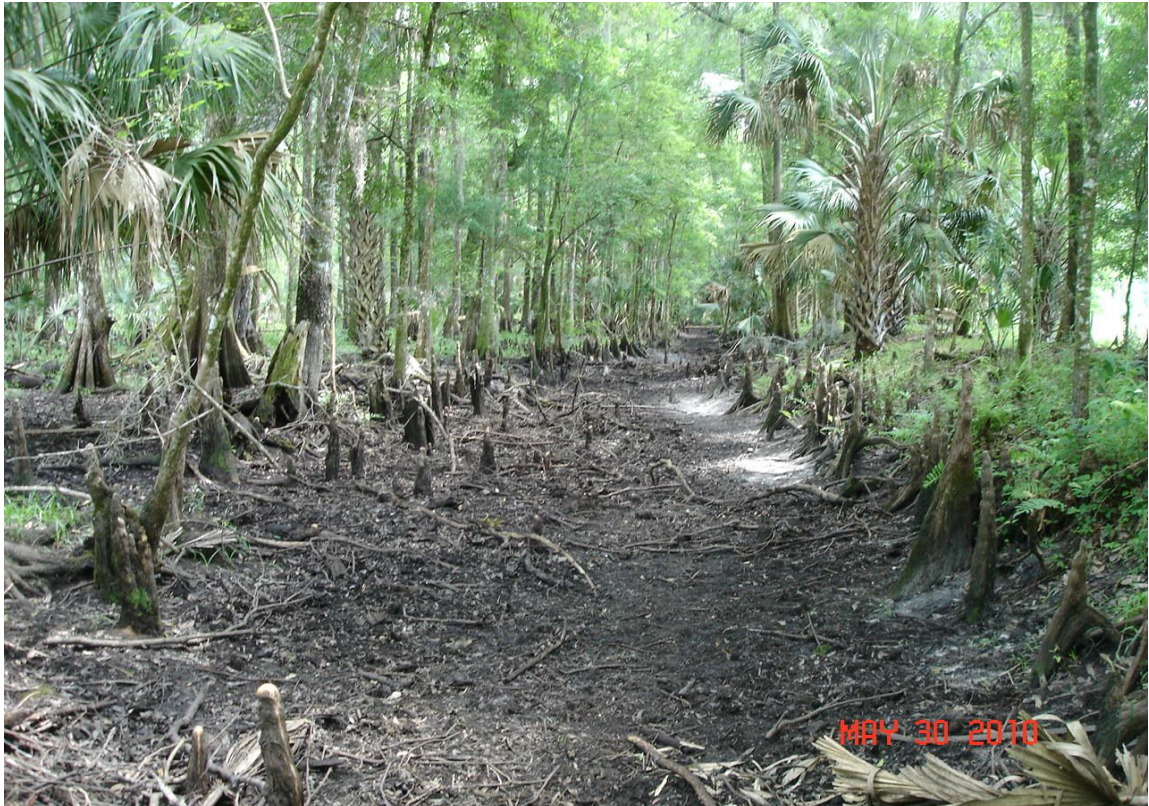
2. Looking downstream along the Colt Creek bypass ditch just downstream of the confluence with the unaltered creek (Photo 1.). The ditch is approximately 15 feet wide by 16 inches deep at this location.

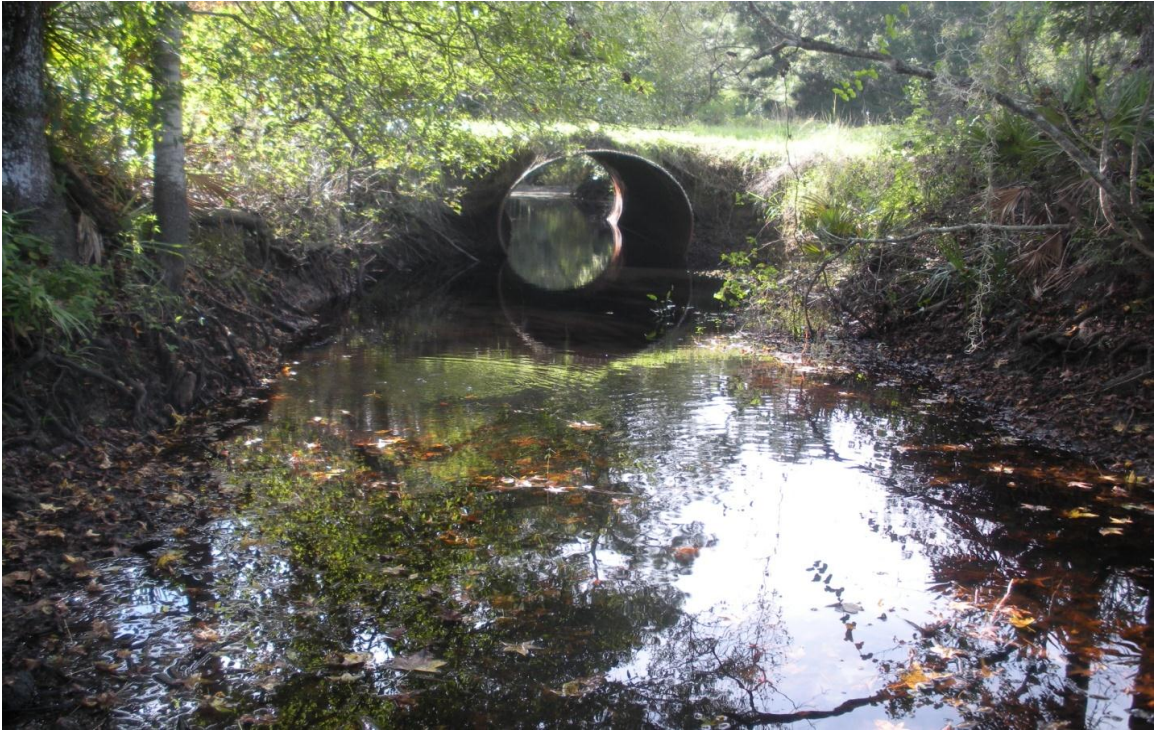
3. Seventy-two inch culvert in the bypass ditch where water levels were measured.

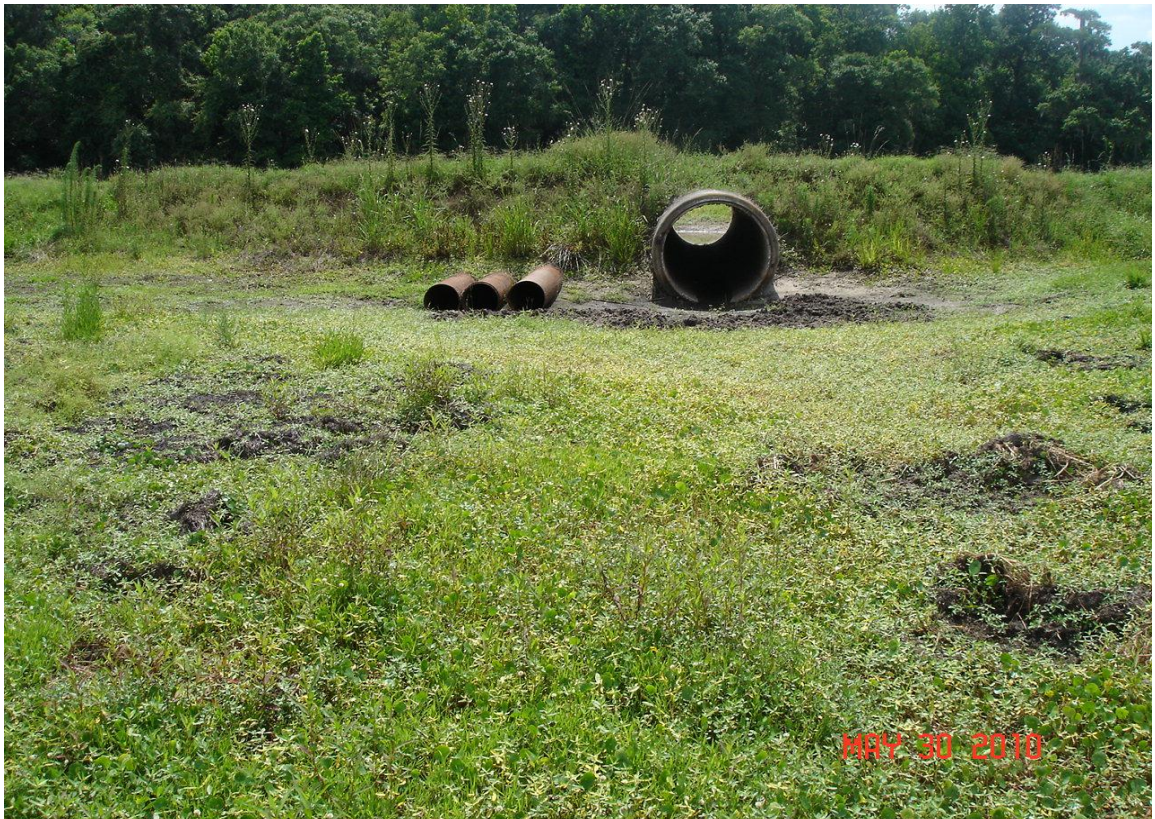
9. North culvert in the historic Colt Creek flow way at the west boundary of the study site.
