Use Of Impact Mapping For Planning The Infrastructure In Tourist Caves - Case Study: Maquiné Cave, Brazil

USE OF IMPACT MAPPING FOR PLANNING THE INFRASTRUCTURE IN TOURIST CAVES - CASE STUDY: MAQUINÉ CAVE, BRAZIL

Luciana Alt

Vitor Moura

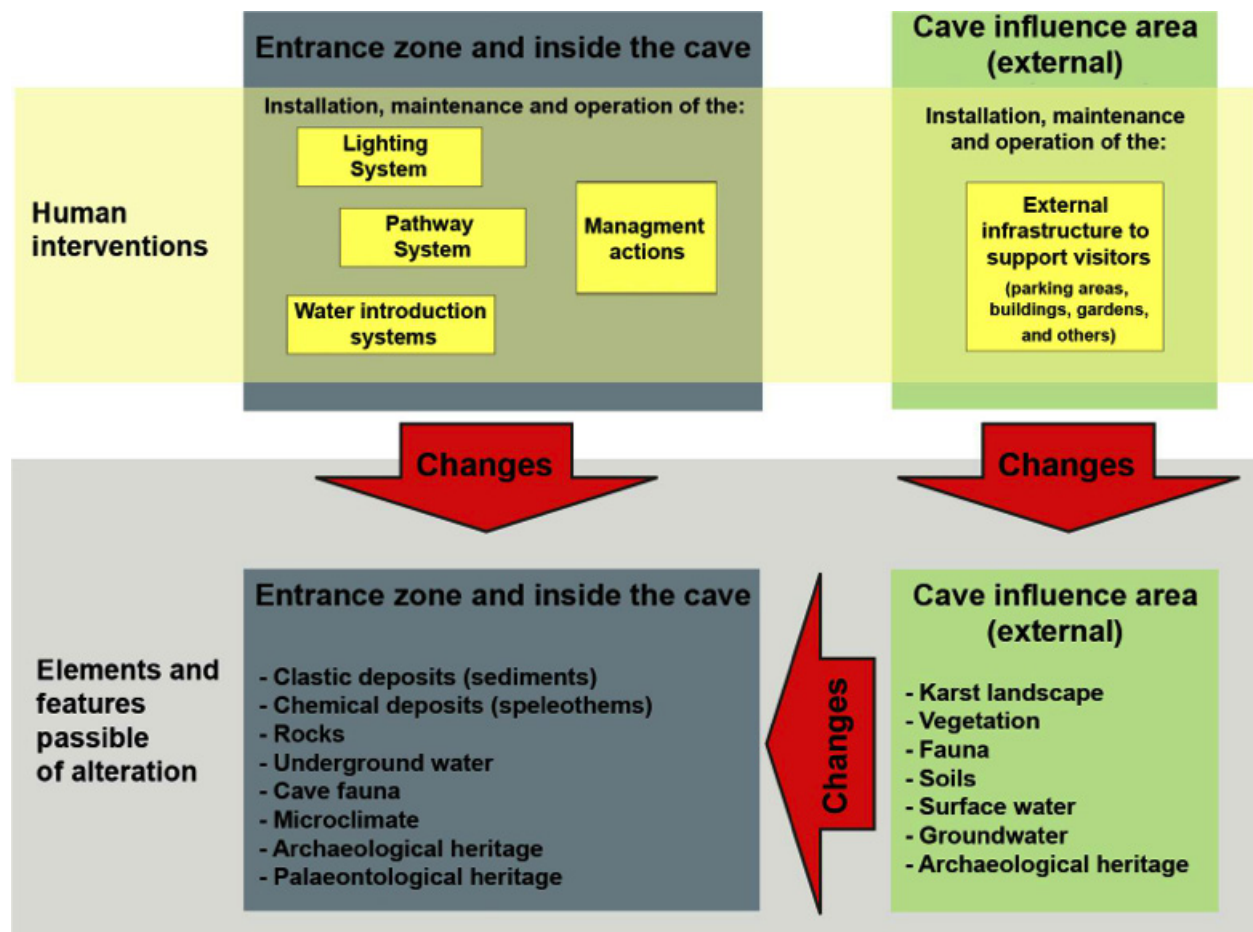
The installation, maintenance and operation of the infrastructure (lighting, pathway, and water introduction systems) and the management of visitor flow generates impacts inside the cave, in their chemical and clastic deposits, on rock surfaces, fauna, microclimate, in paleontological and archaeological heritage. The interference conducted near the cave entrance for installation, maintenance and operation of the external infrastructure (parking areas, buildings and gardens), caused impacts on the karst landscape, vegetation, fauna, and soil. These changes, in their turn, can potentially result in impacts inside the cave, mainly in fauna dynamics and visual impact. The relationship between these impacts is summarized in Figure 6 below.

Figure 6. Scheme of interaction between human interventions and cave environment in Maquiné Cave.
