## NCKRI REPORT OF INVESTIGATION 6

# GEOPHYSICAL INVESTIGATION OF FLOOD-INDUCED SINKHOLE COLLAPSES, LAKEWOOD REGION, EDDY COUNTY, NEW MEXICO

Lewis Land  
Lasha Asanidze

June 2014

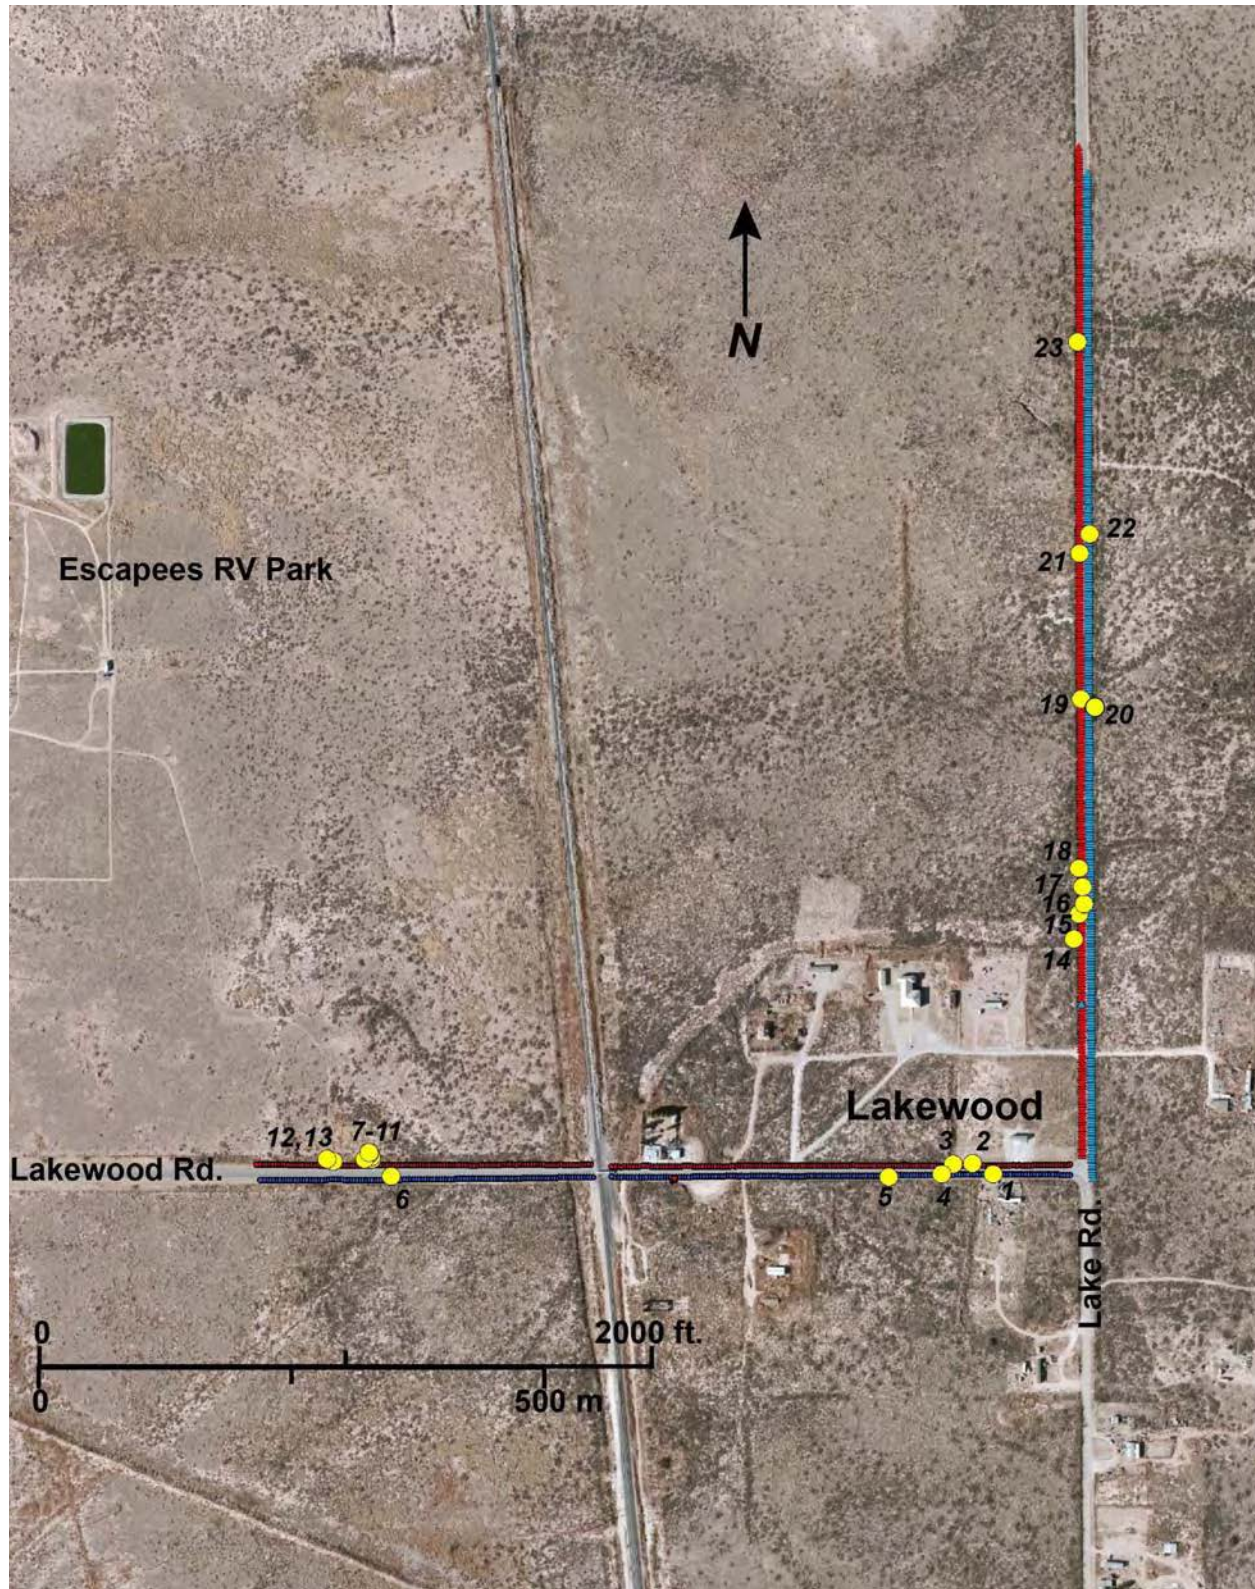
Figure 2. Lakewood, NM, study area. ER survey lines parallel to Lake and Lakewood roads are indicated by red and blue dots; each dot represents one electrode in the array. Yellow filled circles show locations of sinkholes and other karst features photographed during resistivity surveys ([Appendix](#)).

The depth of investigation for a typical ER survey is approximately one-fifth the length of the array of cable. NCKRI staff, assisted by personnel from Madron Services, conducted six electrical resistivity surveys parallel to Lake and Lakewood roads (Figure 2), using 112 electrode arrays at an electrode spacing of 3 m, for a maximum deployment length of 333 m per array and an anticipated depth of investigation of approximately 65 m. This spacing and target penetration depth were selected to determine if substantially larger cavities occur in the subsurface than are indicated by the size of the observed sinkholes, which should be considered in remediation of the sinkholes and repair of the roads.
