Int. J. Speleol., 32 (1/4) 2003: 71-83

HUMAN IMPACT ON KARST: THE EXAMPLE OF LUSAKA (ZAMBIA)

Jo DE WAELE ¹ and Roberto FOLLESA ¹

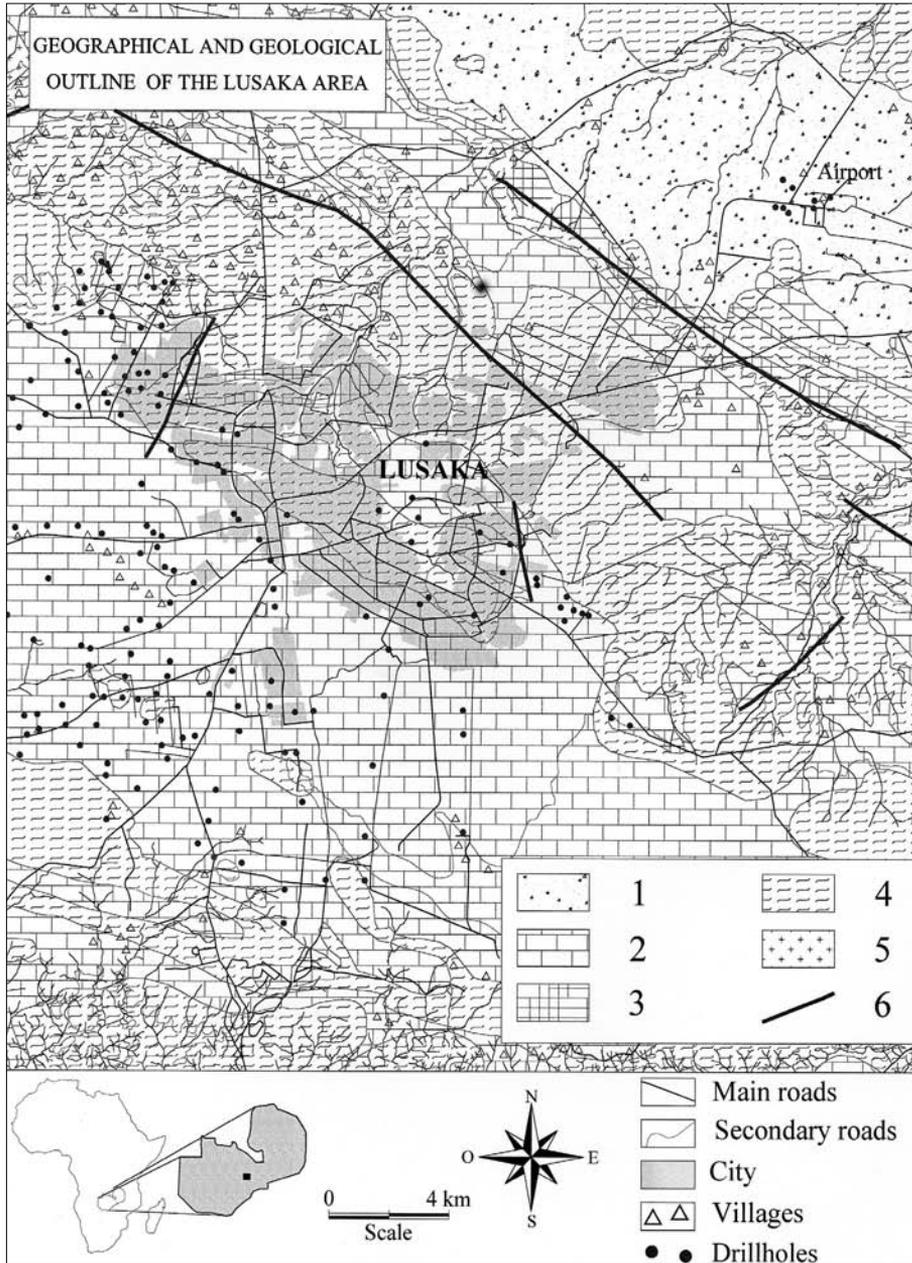
Fig. 1 - Geographical and geological outline of the study area: Quaternary: 1: Old and recent alluvial deposits; Precambrian: 2: Lusaka Dolomite; 3: Matero Quartzite; 4: Ridgeway schist; 5: Granite (modified from De Waele et al., 2002).

Locally upon these ancient rocks alluvial sediments (Quaternary) have been deposited. Furthermore all these rocks are covered with a more or less thick cover of soils, mainly composed of iron-oxide oolites in a clayey matrix on dolomitic lithologies and sandy sediments on schists, gneisses and granites (Fig. 1)

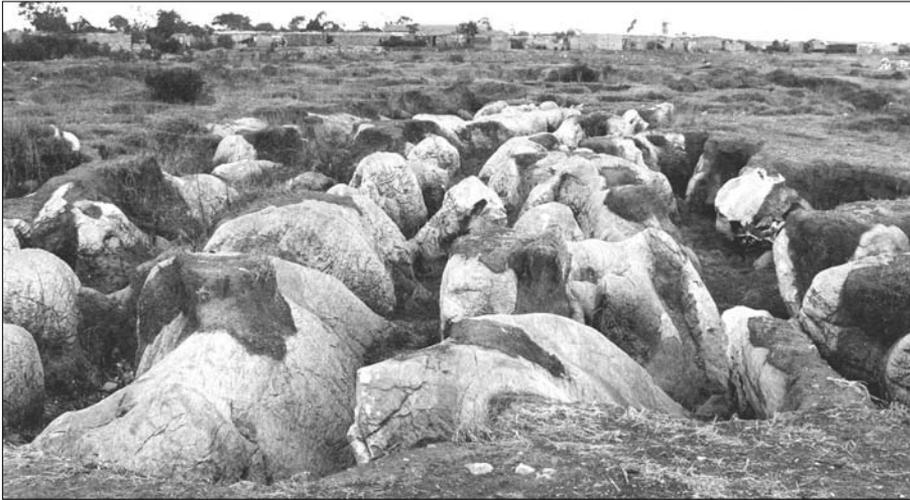
Fig. 2 - Diffuse laterite quarrying all around the capital of Lusaka exposes a rounded karren field oriented along the main fracture directions. These areas, which sometimes are ideal places for illegal waste dumping, are extremely vulnerable places for the pollution of the aquifer.

Surface karst on the dolomitic marble is hidden by a layer of laterite soil which can attain a thickness of a couple of meters. These laterites are extensively exploited by local people and in the places where this cover has been taken away a well karsified surface is exposed. Extensive rounded karren fields, sculpted on the boundary between laterite and carbonatic rock, are clearly visible and go down up to 4-5 meters

from the surface (Fig.2). In the absence of the filtering laterite cover these exposed rounded karren fields constitute places in which surface drainage water easily infiltrates and reaches the subterranean aquifer.

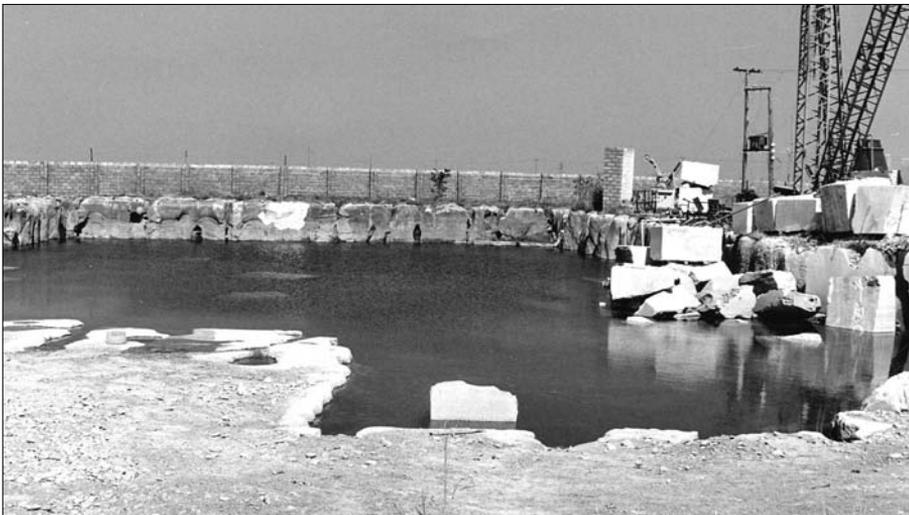
Fig. 3 - Marble quarry East of Lusaka in which the local water table crops out. The excavations expose an intensely karstified marble with solution flutes, rounded karren and phreatic passages in the epikarstic zone.

This karst aquifer is characterised by an epikarstic zone which extends to a depth of 25 m below the surface, composed of solution channels, rounded karren, solution flutes and -cavities which allow water to descend rapidly to the water table, situated at an average depth ranging from -2m to -25 m and lowering year after year due to overexploitation and general diminishing of annual rainfall (Nkhuwa, 2000; Maseka & Nyambe, 1999; Nyambe & Maseka, 2000). The base of karstic aquifer is thought to be at -150m and solution cavities have been found at depths of -65-80m and -125-150m. The Lusaka dolomitic marble aquifer has an estimated thickness of 15-20 m and an average specific capacity of about 50 m²/d, representing the best water supply of the city (Simpson et al., 1963). Average borehole yields are between 4-8 l/s, and some drillholes have reached yields of 100 l/s. Underground water flows from SE to NW with branches to the NE and SW, and the highest potentiometric levels (1300 m a.s.l.) have been observed in the Southern Lusaka Forest Reserve which is the main recharge area of the entire karstic aquifer (Maseka & Nyambe, 1999). In this area the watertable is visible in several quarries (Fig. 3).

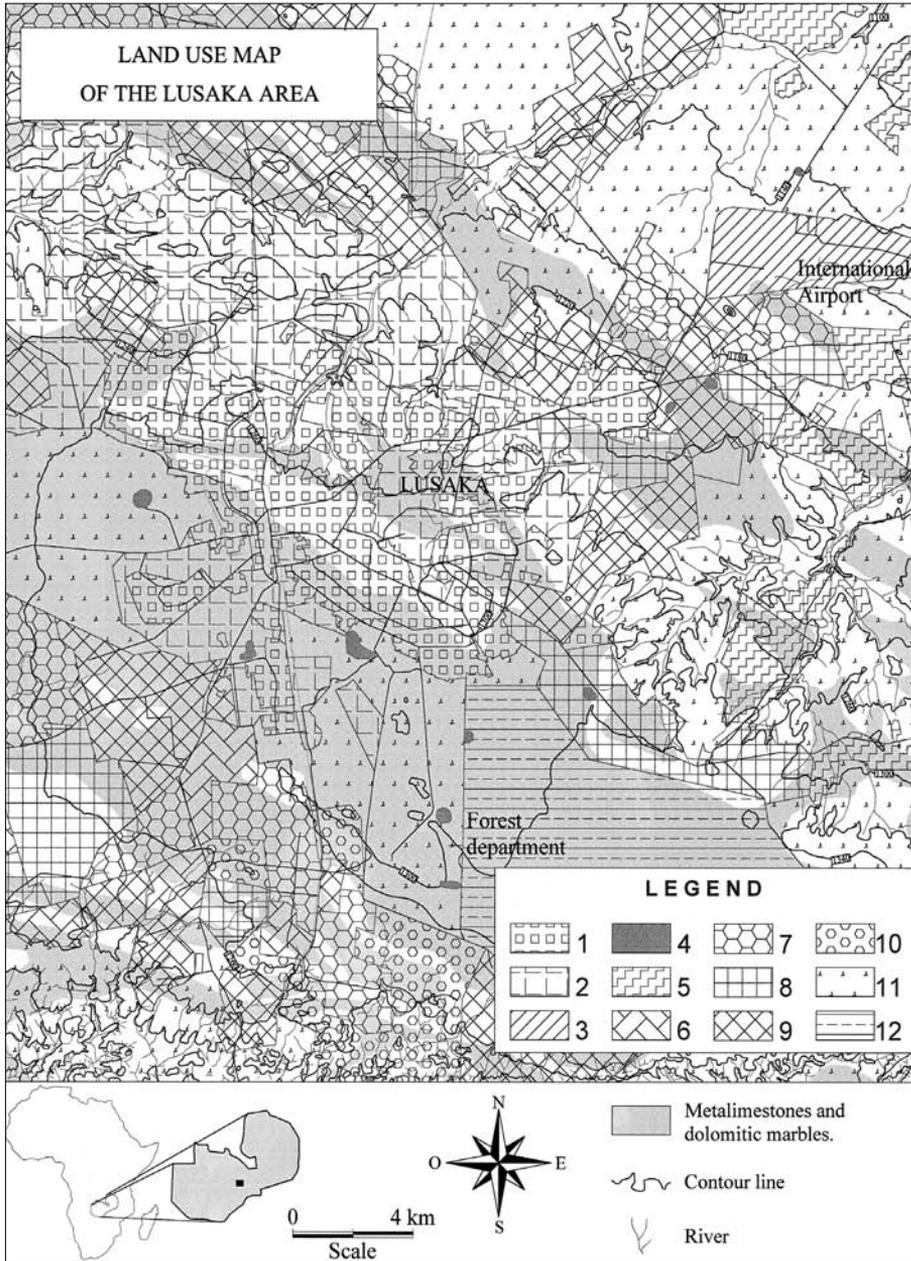
Fig. 4 - Land use map of the area of Lusaka: 1: urbanised area; 2: small villages; 3: Airport; 4: Marble quarries; 5: Medium sized farmlands; 6: Irrigated farmlands; 7: Big cultivated farmlands; 8: Small farms; 9: urbanised areas with kitchen-gardens; 10: Savanna with scattered trees; 11: Savanna; 12: Forest and woodland.

In Fig. 4 has been represented the land use map of the area of Lusaka.

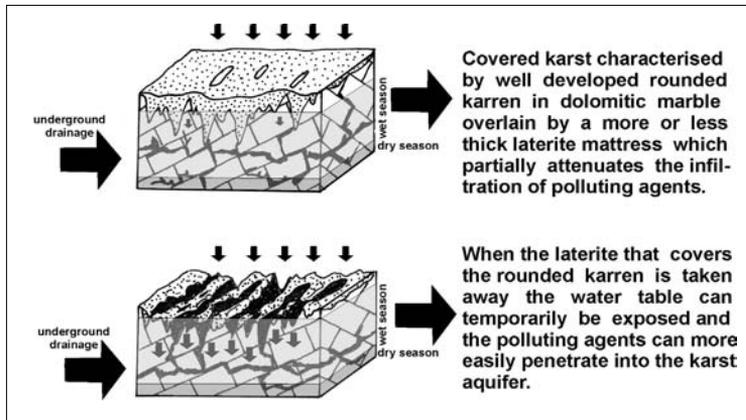
Fig. 5 - Aquifer vulnerability in relation with the laterite cover.

The epikarstic zone of the Lusaka dolomitic marble Formation is overlain by a more or less thick layer of laterite that covers a well developed subcutaneous karstified surface. This laterite, composed of oolithes embedded in a clayey matrix acts as a shield for polluting agents to penetrate directly into the aquifer. Once this protecting layer is taken away, by excavations and laterite quarrying, the pollution

has its free way, furthermore enhanced during rainy season when the water table surfaces in the open excavated karren fields (Fig. 5).

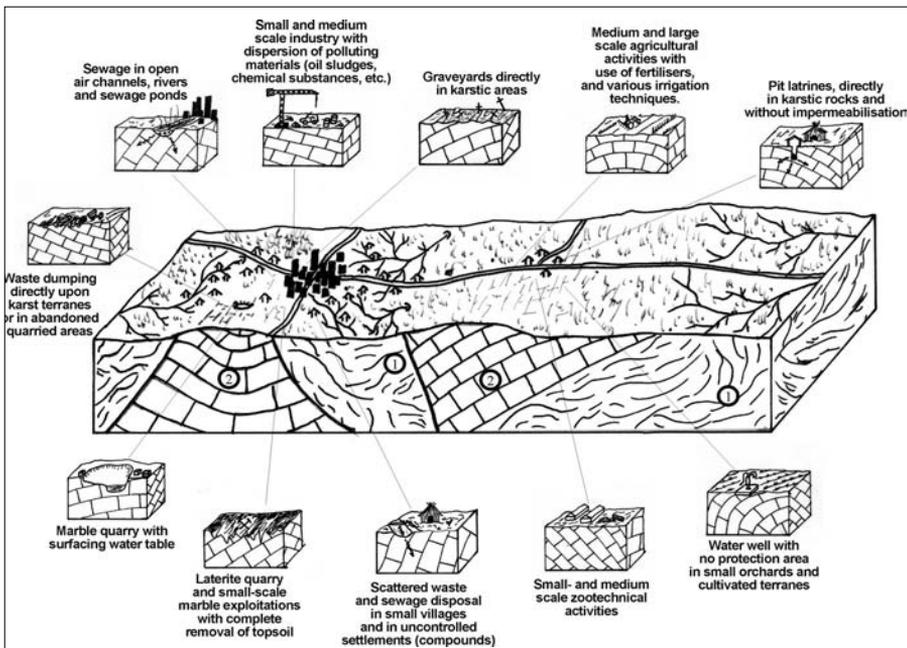
Fig. 6 - Block diagram schematising the various polluting activities in the Lusaka area: 1. Clastic metasediments; 2. Marbles of the Lusaka formation.

Many human activities in Lusaka make the karstic aquifer extremely vulnerable to pollution (Fig.6).
